# Assessment of Deterioration Risk of Maijishan Grotto under the Radiation Difference Based on Heat and Moisture Transfer Model

# Assessment of Deterioration Risk of Maijishan Grotto under the Radiation Difference Based on Heat and Moisture **Transfer Model**

8th International Building Physics Conference	(IBPC 2021)	IOP Publishing
Journal of Physics: Conference Series	<b>2069</b> (2021) 012082	doi:10.1088/1742-6596/2069/1/012082

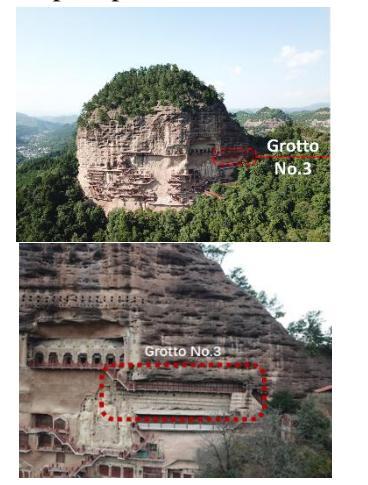
Figure 1. Grotto No.3.

Grotto No. 3 is a semi-open grotto in the middle of the south façade of Maiji Mountain (Figure 1). It is with a length of 36.5 meters and a height of about 50 to 60 meters from the ground. The Buddha statues are stone-based sculptures upon which are clay and drawings. The outer front eaves have collapsed and been damaged. During the field research, it is observed that there are differences in the shadow area on different layers of Buddha statues in a day, and the preservation condition showed some difference between the upper (better) and lower rows of the Buddha statues. Therefore, it is preliminarily inferred that solar radiation is a key factor affecting the preservation.

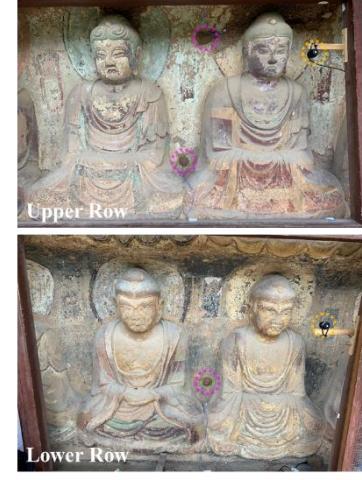
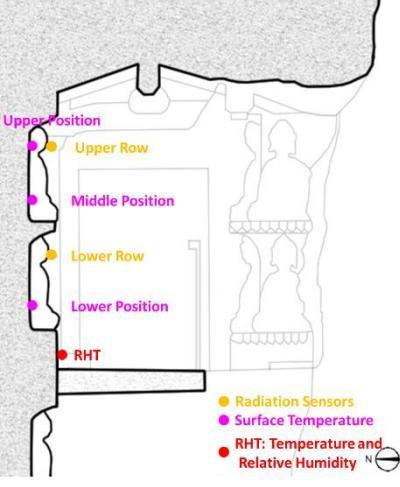
Figure 2. Buddha statue.

To clarify the risk and related factors of deterioration, a monitoring scheme was designed (Figures 2 and 3). Two vertical radiation sensors were set in the same direction and height as the heads of the statues (type: HOBO S-LIB-M003, precision:  $\pm 10 \text{ W/m}^2$  or  $\pm 5\%$ ; measurement range:  $0 - 1280 \text{ W/m}^2$ ). Three K-type thermocouples were put at different heights of the two rows of statues (upper, middle, and lower points) to measure the surface temperature (type: TESTO 176 T4; precision:  $\pm 0.3^{\circ}$ C; measurement range: -195 - 1000 °C). The sensors were applied to the bedrock with 1-2cm thick clay. The clay was also used to repair the paintings, which has been desalinated, thus no risk of damaging the statues or the drawings. Both recorders were set with an interval of 10 minutes.

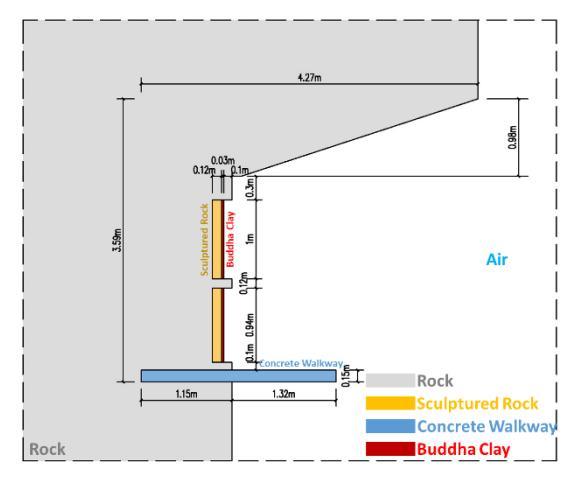
**Figure 4.** The distribution of materials used in the model (Around the Buddha area).

A HAM model with temperature and water chemical potential as driving forces put forward by Matsumoto is the theoretical basis of our model [9]. At present, simulation and analysis on architectural heritages from the perspective of hydrothermal transfer based on this theory have been fully applied [10–12]. The model is established compiling with FORTRAN language on the platform of Intel Visual Studio. In the model, a simplified north-south section (facing South-southeast 15 degrees) and abstracted outlines were selected for calculation. A selected area (grotto part) of the whole model was shown in the figures for illustration. There are three kinds of materials (Figure 4): the rock (grey and yellow part), the clay (red part), and the concrete walkway (blue part). Considering the calculation accuracy and efficiency, the mesh is divided (Figure 5). Thus, each node has a corresponding length, width, and material properties. The calculation time step is 30 seconds.

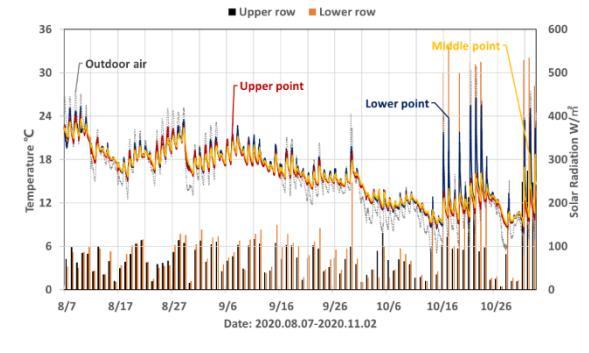
Figure 6. Monitored data of three months.

Three months of data (from August 7, 2020, to November 2, 2020) was obtained after the monitoring (Figure 6). Before October 15th, limited direct sunlight reached the surface of the two rows of Buddha statues (less than  $100W/m^2$ ) and the surface temperature of the three points fluctuates with the ambient air temperature. After that, the sunlight began to shine on the lower row of statues, with the maximum at 560.6W/m<sup>2</sup>. It is observed that both the solar radiation and the surface temperature are widely divergent from those in the upper row, with instant temperature differences reaching 12.10 °C. Taking

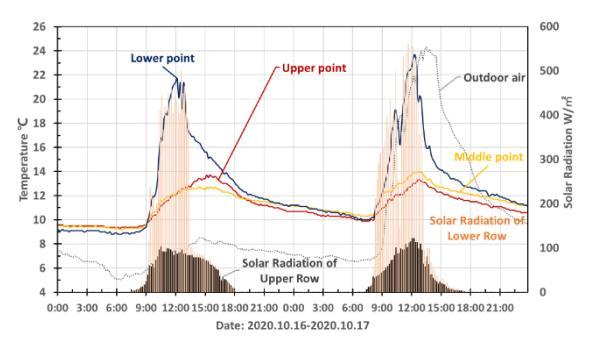
Figure 7. Monitored data on 10.16-10.17, 2020.

October 16th and 17th as an example (Figure 7), it can be found that the surface temperature is positively correlated with the amount of solar radiation. The lower point experiences a greater temperature difference between day and night, for example, rising 12 °C in 3 hours.

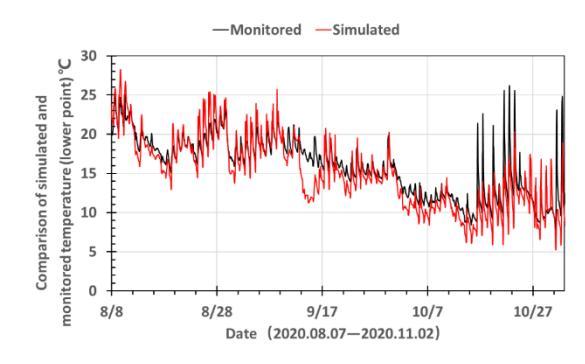
Figure 8. Verification of the model (simulated and measured temperature at three heights.

The whole period of weather and monitored data were used for model validation. Thus, the characteristic values (maximum, minimum, average) are compared over the same period. Table 1 shows the results of the comparison between the measured and simulated surface temperature, while Table 2 shows the comparison of the solar radiation. The simulated values of the three points showed the same trend as the measured ones (Figure 8). Due to some simplification in the calculation model (the uneven eave and the effect of the barbed wire), the temperature difference is observable but considered within the acceptable range for evaluation. Therefore, the current model can be used for subsequent analysis and calculation. (Difference Value = Measured Value - Simulated Value)

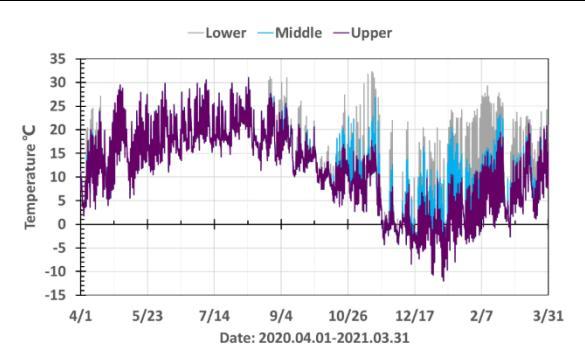
**Figure 9.** Annual variation of simulated surface temperature at upper, middle, and lower points.

3.3.1. Annual variation of simulated surface temperature and solar radiation of the Buddha statues Table 3 show the annual variation of the simulated surface temperature and solar radiation of the Buddha statues at the upper, middle, and lower points. The time of direct sunlight affects the lower part of the statues the most. The difference of the maximum values among the three points indicates that the lower part faces more severe temperature fluctuations, which are 5.53 °C and 10.67 °C higher than the middle and upper ones, respectively. It is also shown in Figure 9 that the high surface temperatures (over 15°C) concentrated in the winter season mainly at middle and lower points. From November 21st to March 1st, the surface temperature of each point began to drop below zero, and the upper point stays below 0°C the longest, and then the middle and lower points. It is deducted that the heat from solar radiation during the day increased the surface temperature of the lower point. As a result, the temperatures drop more slowly to below zero (less duration) during the cold night (Figure 10). In conclusion, the lower point is facing more severe impacts from solar radiation than those of the middle and upper points.

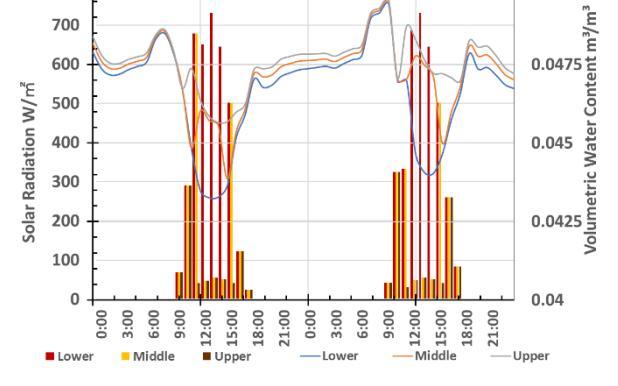
As shown in Figures 10 and 11, January 15th and 16th were taken as an example to explore the variation of temperature and volumetric water content. It is shown in the two days that the surface temperature responds very quickly to the sunlight, as well as the water content. However, this influence shows differences at the three points. The lower point receives the direct sunlight since sunrise and goes on until sunset, while the middle point only has one or two hours after sunrise or before sunset, and almost none for the upper point. This leads to the variation of surface temperature correspondingly. For example, the surface temperature at the lower point was elevated near 24 °C in three hours on the 15th, while at the middle part it was heated to 15 °C in the morning and 20 °C in the

afternoon. As to the volumetric water content, it decreases as the sun shines on the surface, with the greatest evaporation at the lower point. The lower point suffered more severe water content variation.

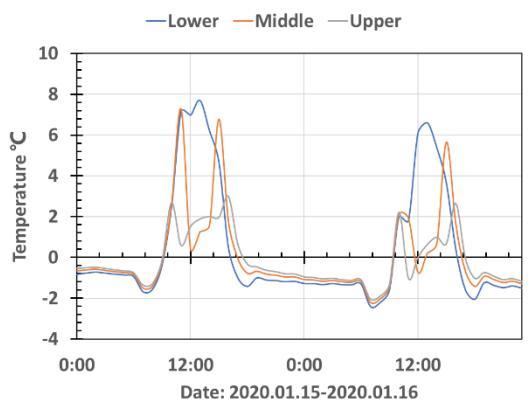
Figure 12. Temperature differences (within clay) on Jan. 15th and 16th.

Table 4 shows the variation of simulated temperature of the clay in the two days. It is shown that the instant temperature difference of different depths at the lower point reaches 7.70°C, while the daily variation of clay1 or clay2 can reach 27.05°C or 18.76 °C, respectively. As shown in Figure 12, the instant temperature difference at the middle and upper points showed the same trend and has less duration time than the lower one when the difference is over 2 or 4 °C. Table 5 shows the diurnal variation of the water content of the two nodes. In the horizontal direction, the deeper the node, the higher the volume moisture content. While in the vertical direction, the higher the position, the higher the volume the difference is structure as Figure 12, that is, larger differences between clay1 or clay2 with longer duration exist at the lower point under direct sunlight.

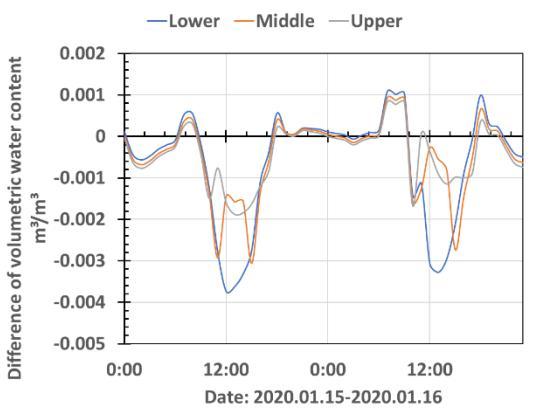
**Figure 13.** Water content differences (within clay) on Jan. 15th and 16th.

To characterize the changes in temperature and water content, the difference between the adjacent nodes (spacing 1 cm) with the same material properties (both clay) was compared at the three heights. In another word, the two most superficial nodes were used in the comparison. From the left (inside) to the right (outside), the nodes are clay2, and clay1 successively. As to the temperature, the differences in the same material are relevant to its thermal stress. As to volumetric water content, the difference of the first and the second nodes was compared to show the diurnal changes of water content.
