# Typical Geo-Hazards and Countermeasures of Mines in Yunnan Province, Southwest China

To cite this article: Xianfeng Cheng et al 2016 IOP Conf. Ser.: Earth Environ. Sci. 44 022008

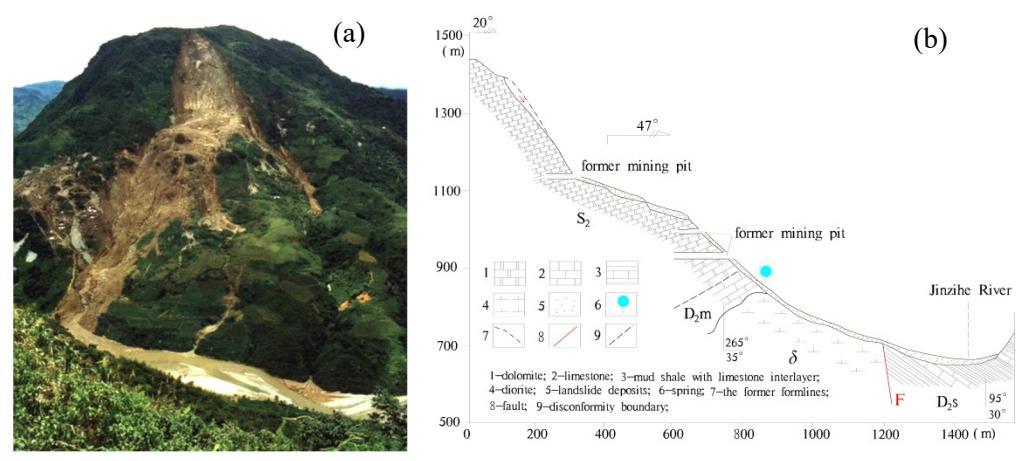
Figure 2. Photo and sectional drawing of Laojinshan Landslide [7, 8]

The source area of Laojinshan Landslide was about  $2.3 \times 10^4$  m<sup>2</sup> with 150-180 m length and 120-200 m width [6]. The maximum thickness of slip mass was 25 m. The total volume of two landslides was about  $4.3 \times 10^5$  m<sup>3</sup> [4]. The material of slide resource was middle to intensive weathering dolomite of S<sub>2</sub> (Fig.2). The longest sliding distance of landslide material was 1600 m with 880 m of vertical slip. The whole process of Laojinshan Landslide included steps of start-slide-disassembly-debris flow in less than one minute [8]. According to the above features, Laojinshan Landslide belonged to high position, high speed, large scale, long distance, middle to deep basement weathering belt, collapse type landslide to debris flow.

Many factors led to the landslide mega-disaster. The basic condition was composed of precipitous landform and rock mass structure, while the inducing factors mainly included heavy rain before the landslide and intensive mining activates. The former landform of sliding resource area was raised and like an eagle's mouth, so unloading separation fractures may form easily in the slope shoulder. The dolomite in sliding resource area was middle to intensive weathering with stratiform cracked structure. Three groups' joints developed with strike 310°-340°, 25°-45°, 70°-85°. The joints with strike 310°-340° were areal tectonic joint and developed very well with dip 55°-66°, which extended several to tens of meters with 3-5 per meter of linear density. In fact, the joints controlled the landslide and developed into major slipping plane [8]. Heavy rain was an important natural factor to induce Laojinshan Landslide. According to data from weather bureau of Yuanyang County, total rainfall in the landslide area was 137 mm in four days from May 27<sup>th</sup> to 30<sup>th</sup>. Intensive mining activity was indispensable manmade factor to destroy stability of the mountain. There were 144 mining pits with more than 120 kilometers of total length in the mass mining area of Laojinshan gold mine [6].

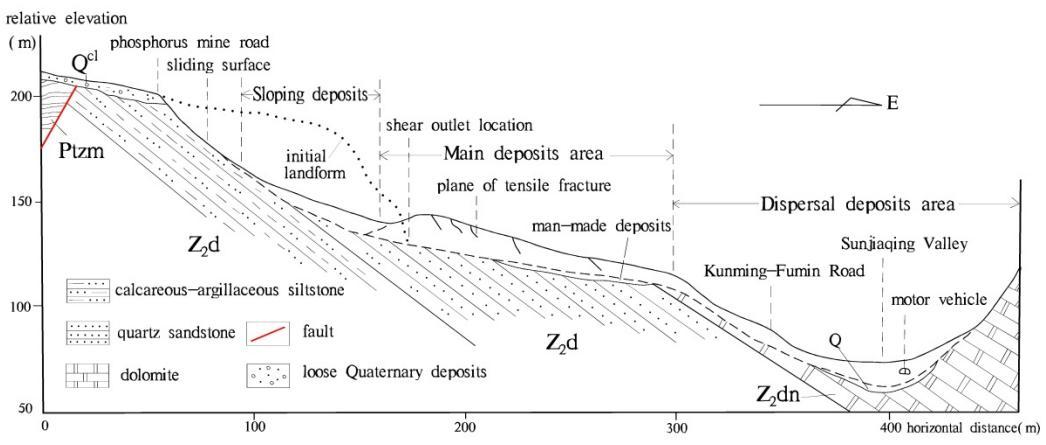
Sunjiaqing Landslide was a middle scale, tractive, deep-bed, weathered bedrock and bedding landslide. The total affected area was about 53 800 m<sup>2</sup> and the deposits volume was 250000 m<sup>3</sup> [9]. The landslide was composed of sliping area and deposit area. The perimeter of sliping area was 380 meters, while the area was  $8300 \text{ m}^2$ . The boundary of slip area was scarp of 5-40 meters high. Shear outlet of the landslide composed its eastern boundary, which trended into  $85^{\circ}$ -95° with dip angle of  $35^{\circ}$ -45°. Most slip area was about 120 meters long and 50~60 meters wide. Deposit area distributed in east to shear outlet of the landslide mass was about 120 meters long and 50~60 meters wide. Deposit area distributed in east to shear outlet of the landslide, and landslide mass was mainly separated from sliding surface. The deposits were composed of principal deposits and dispersal deposits with total 176000 m<sup>3</sup>.

The overall process of Sunjiaqing Landslide could be divided into three moving stages, namely slippingleaping-clastic flowing, and air cushion effect was evident in the moving process of the landslide [10]. The maximum distance of slipping mass was 600 m with altitude distance of 145m. Some of clastic flow mixture of airflow and clastic continued to move northward along Sunjiaqing Valley, and the farthest distance was 200 m. The landslide formation was induced by man-made unreasonable excavation without additional factors such as rainfall, earthquake and load. There was weak structural belt between upper quartz sandstone and lower calcareous-argillaceous siltstone, which became the sliding surface (Fig.3). According to sampling test, peak strength (c) of the weak belt was only 90-450KPa, which was much less than other part, namely 9,590 - 38,000 KPa [9].

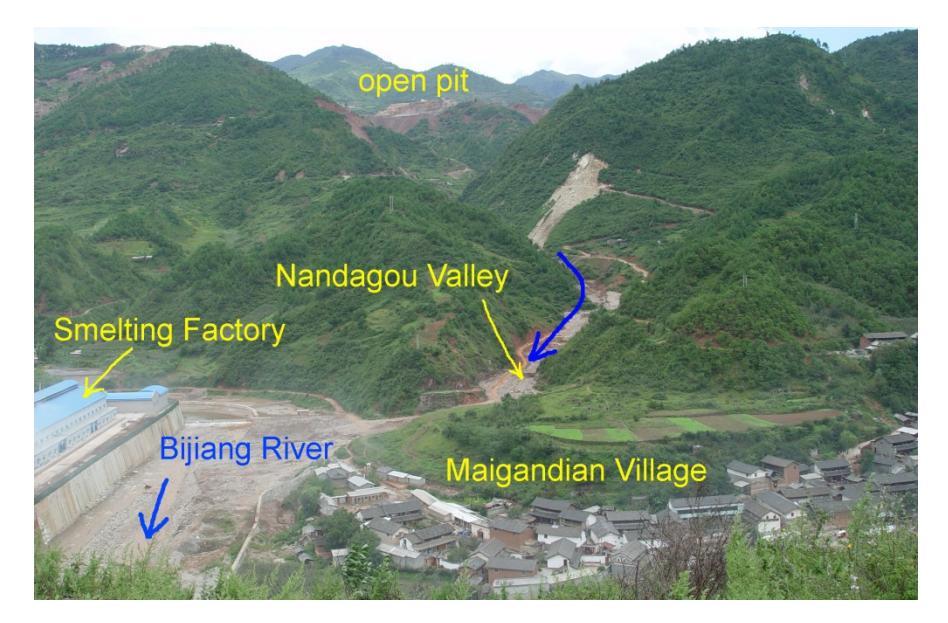
Figure 4. Photo of Nandagou Valley debris flow

Nandagou Valley, located in left bank of Bijiang River, was 3800m long and 15~30 m wide with average (Fig.4). The drainage area was 3.77 Km<sup>2</sup>. There was permanent flow of  $1.29 \sim 2432 \text{ m}^3/\text{d}$ . The debris flow formation region was 3.66 km<sup>2</sup>. The length of flowing area was about 800m with width of 30-60m and longitudinal grade of 90%. The thickness of loosen deposits at the bottom of Nandagou Valley was 3-6m. The Valley always showed as a braided stream. The accumulation area was located in stream outlet of Nandagou Valley, covering  $8.1 \times 10^4$  m<sup>2</sup>.

Slurry density of Nandagou Valley debris flow was 1.59g/cm<sup>3</sup>. There were some characteristics for the debris flow of ultimately flowing to accumulation area, namely existing debris flow head of 1m, big viscosity (slurry density > 1.5g/ cm<sup>3</sup>), long time of duration (5-15minutes), strong carrying capacity at a time (maximum about  $1 \times 10^4$  m<sup>3</sup>) and fast flowing speed (about 10m/s). In a word, Nandagou Valley was a rainstorm stimulating, gully-type, high frequency and large scale debris flow, which was induced by mining activities.
