Application of Structure Monitoring Systems to the Assessment of the Behaviour of Bridges in Mining Areas

To cite this article: Beata Parkasiewicz et al 2017 IOP Conf. Ser.: Mater. Sci. Eng. 245 032018

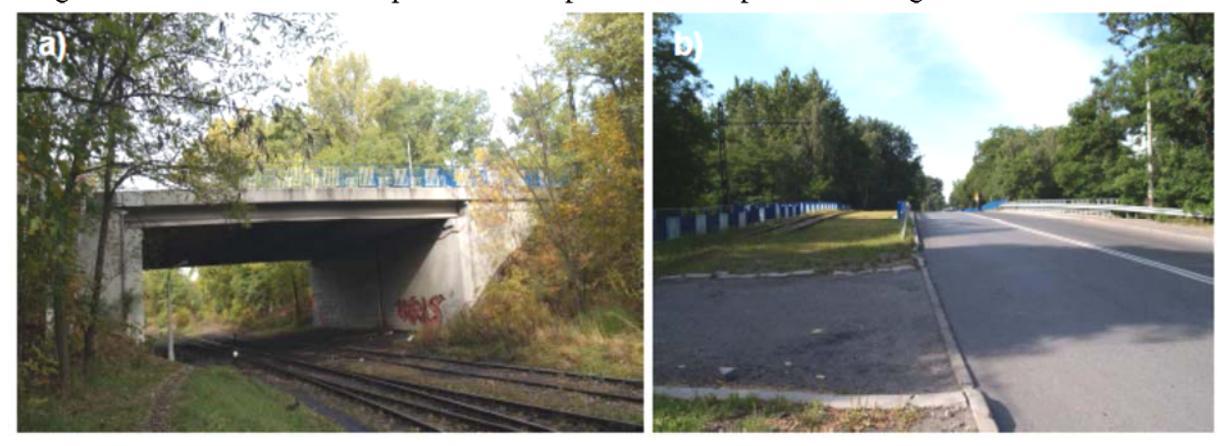
The road and tram bridge is located on the road and tramway line and creates a passage above the obstacle formed by a railway tracks, ensuring the continuity of road and rail traffic – figure 1. The structure was built in 1970s, then modernised and repaired in 2010 and 2013 in order to adapt the bridge's structure to the safe adoption of the impacts from the planned mining activities.

Figure 1. Road and tram bridge: a). view from south-west, b). view from north-east [5]

The bridge is formed by two independent spans of slab-and-beam structure and overall dimensions of \sim 13.5 x 18.1 m and \sim 9.8 x 18.0 m respectively, separated by an expansion joint with a design width of approx. 40 mm.

Each of the bridge's spans is supported by massive reinforced concrete abutments with direct foundations, separated by an expansion joint of a design width of approx. 0.30 m. Spans are supported on abutments via elastomer and elastomer-slide bearings. The planned width of expansion joints between the deck slabs and abutments is 80 mm in the case of northern supports and 140 mm for southern supports.

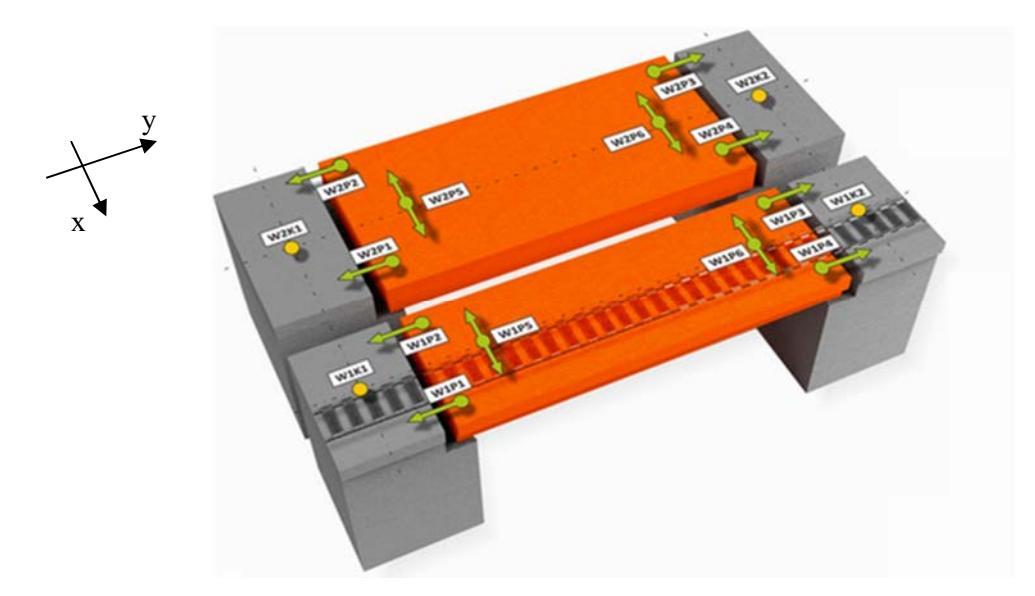
Figure 2. Location of sensors on selected structures after the modernisation of the observation system. Symbols: sensors measuring displacement – WP; sensors measuring angles – WK [5]

Initially the structure monitoring system consisted of 16 sensors (figure 2):

- 8 linear displacement string potentiometers for measuring displacements of deck's slab against abutments in the y direction – WiPj (i=1 for the road bridge, 2 – tram bridge; j=1÷4 – sensor number),
- 8 angular displacement string potentiometers for measuring abutment tilt in two perpendicular planes with 2 sensors per each measurement point WiKj (i, j see above).

In May 2013, 4 linear displacement string potentiometers were added to measure the displacement of the deck slab against abutments in the direction perpendicular to the bridge's structure (x-direction) - WiPj (j=5÷6). The monitoring system was described in detail in [4] and [5].

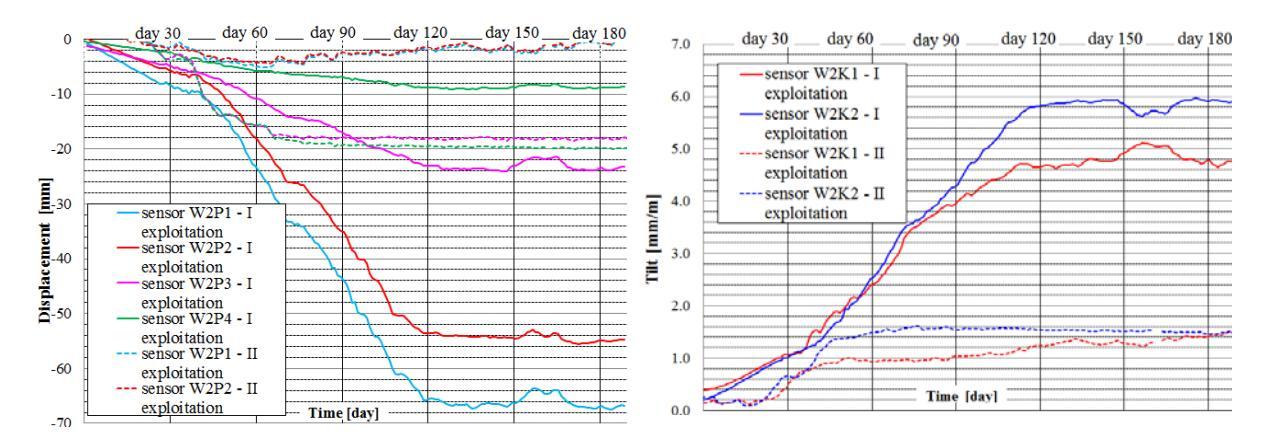
Figure 3 below presents measurement results for the first six months of mining operations as illustrated by the case of the road span.

Figure 3. Results of linear and angular displacement measurements for the road span [4], [5]

Basing on the analysis of diagrams in Figure 3 and numerical values presented in Table 1, it can clearly be seen that the impact of the first longwall is significantly larger than that of the second longwall. This is caused by the location of mining works in relation to the bridge. Larger displacements were measured at southern abutments and larger tilts for northern abutments (Figure 3, Table 1). This observation coincides with geodetic surveys of ground subsidence. Furthermore, during the continuous structure monitoring it was noticed that as the longwall mining operations approached the bridge, relative volume displacements occurred, which was recorded in the form of linear deck displacements against abutments and angular displacements of abutments.

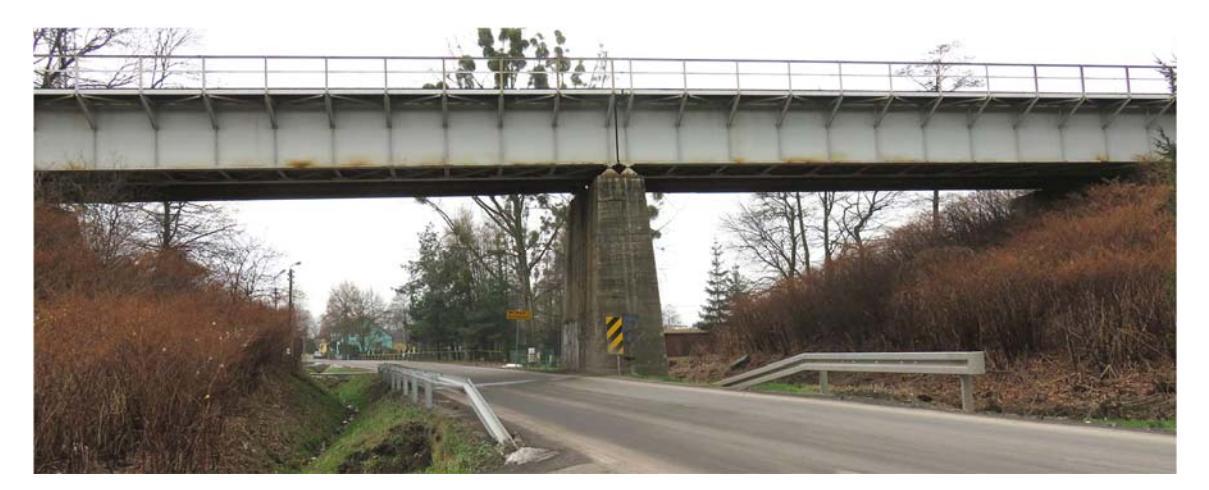
• a welded steel structure (eastern bridge) under track no 2 (Figure 4).

Each part consists of two steel spans, and each of them works statically as a simply supported beam. Spans are made of two plate girders that form an open deck.

Figure 4. View of the eastern (monitored) bridge under track no 2

The (monitored) eastern bridge was built in 1973. Steel structural components are welded. Girder flanges have constant thickness.

- total length of each span: 27.50 m,
- vertical clearance: 8.20 m (above the road),
- operating length of the bridge: approx. 60.00 m (including abutments).

The intermediate support (pier) and abutments are made of concrete. Abutments are founded directly on railway embankments. The pier is more than 8 m high and is also directly founded. Thick horizontal cracks can be seen on the pier. Locally, their width exceeds 1 mm. The behaviour of the cracks is affected both by mining land deformations and the rolling stock (spans under both tracks have open decks without the layer of subbase/ballast that could absorb vibrations).

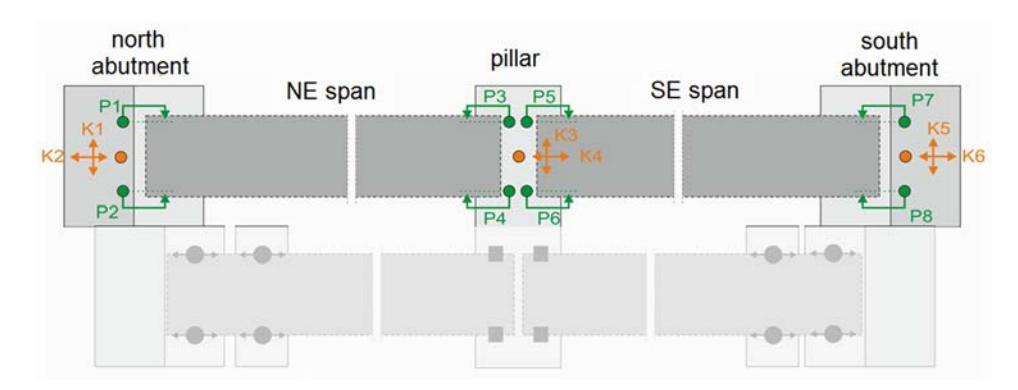
A structure monitoring system was installed in October 2013 on the eastern part of the structure. The system consists of an observation subsystem that is intended to gather and transfer data and a warning system intended to analyse measurement results and inform users of upcoming dangers. The location of measurement points on the structure is shown in figure 5. The structure of the monitoring system from the technical perspective is described in more detail in [6].

Figure 5. The location of measurement points on the eastern bridge: P – linear displacement measurements, K – angular displacement measurements

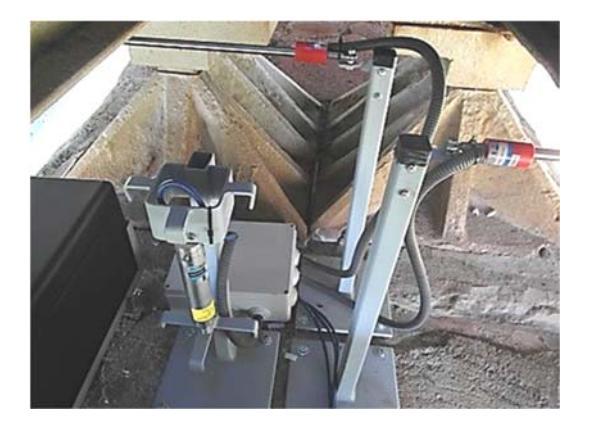
The selected physical quantities whose change significantly affects the technical condition of the structure include displacements of spans in relation to the supports along the structure's axis and angular displacements of supports (tilts) in two perpendicular vertical planes – figure 6.

Figure 6. Support structures for mounting angle sensors and displacement sensors at the intermediate support (view on the west side)

The system's structure uses string potentiometers of displacement with a measuring range of 200 mm and angular displacement string potentiometers. The system is supplied by batteries replaced during periodic inspections of the facility. The readings from the sensors are taken every 15 minutes and once in every 24 hours sent via GSM network to the measurement server, where they are processed and automatically analyzed. The system generates daily reports of the structure's behaviour and sends them to people responsible for its safety. It is worth noting that as yet no emergency situation has occurred.

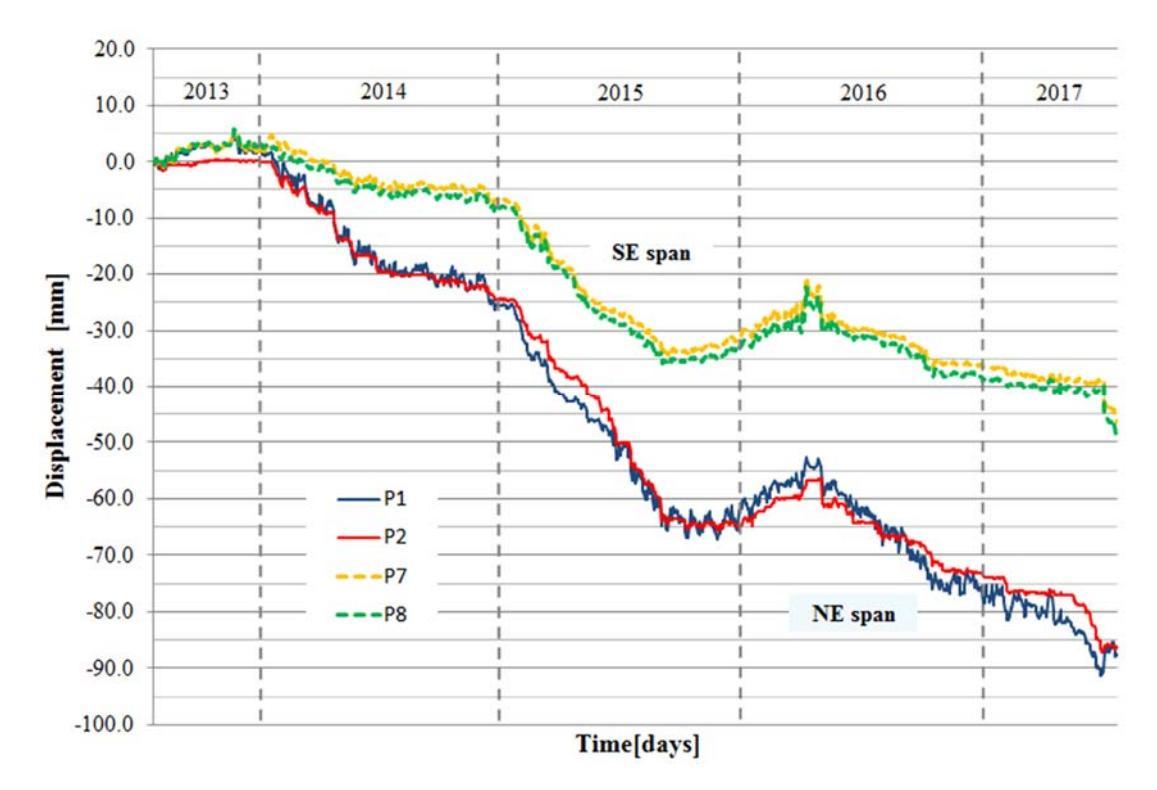
It was assumed that the negative value of measurements on the following diagrams corresponds with the closure of the expansion joint. After the initial period of spread creeps (tension) in the subsoil, the phenomenon of soil creeping down (compression) strongly predominated. The increment of displacements was particularly visible on the northern abutment (sensors P1 and P2 in figure 5). The width of expansion joints between the span and the gravel wall on the northern abutment was approx.

90 mm in mid-April 2015. In the period between mid-October 2013 and end of March 2017 this width (sensors P1 and P2) decreased by approx. 85 mm, which means that the movement of the span against the support was practically impeded – figure 7. The expansion joint on the southern abutment was also reduced by approx. 50 mm. The difference in displacements on the opposite abutments can only partially be attributed to the tilt of the tall pier towards the north-; it can be caused by the direction of the movement of mining operations (north to south) and the variable thickness of plastic clays deposited in several layers between a few up to several tens of meters below the land surface.

Figure 7. Diagram of changes in linear displacements of NE and SE spans against abutments along the structure's axis

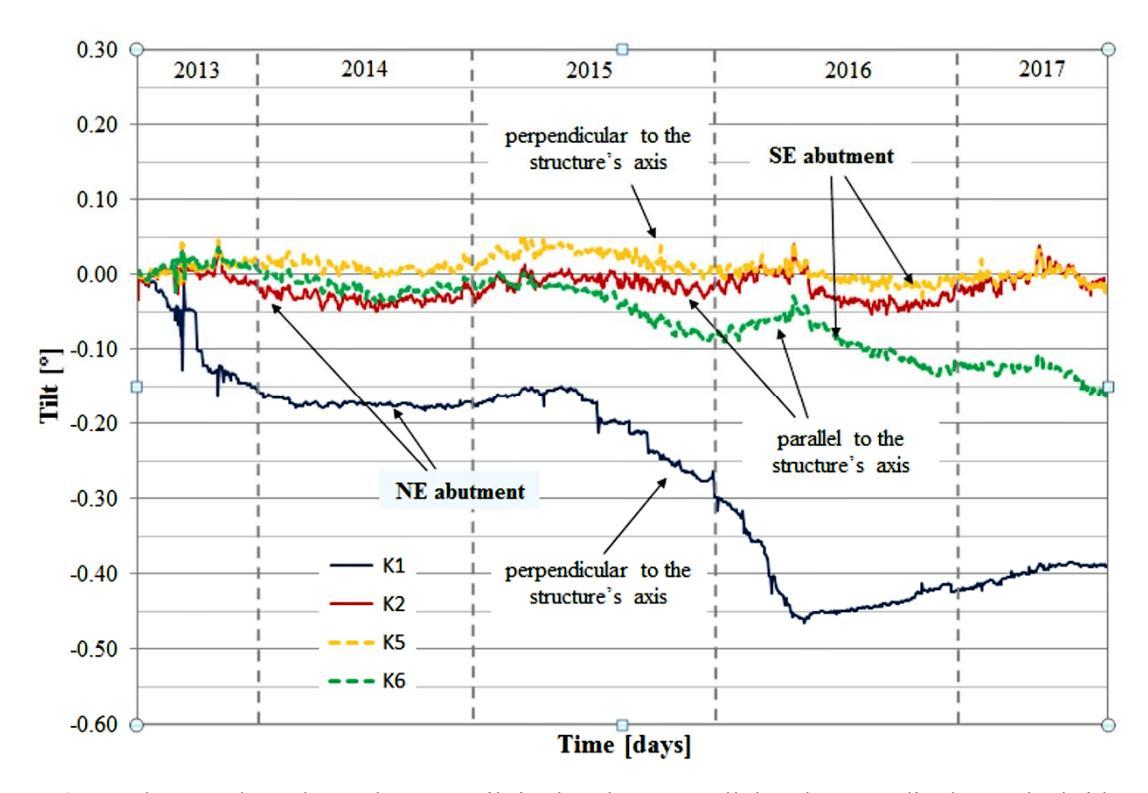
Figure 8 shows diagrams of changes in the tilt of the north-east and south-east abutments in the period between mid-October 2013 and end of March 2017. The analysis of angular displacements (Figure 9) in the vertical plane parallel to the structure's axis (sensors K2 and K6) together with the values of span displacements against abutments measured by sensors P1 and P2 and P7 and P8 shows that abutments have come closer to each other. The value of their relative displacement at the foundation level is larger than at the level of deck support.

Figure 8. Northern and southern abutment tilt in the planes parallel and perpendicular to the bridge's axis (K1 '-' means a westward tilt; K2 '-' means a northward tilt; K5 '+' means a westward tilt; K6 '+' means a northward tilt)

The measurement of the tilt of the north-east abutment in the plane perpendicular to the track axis provides an important observation. The measured angular value is currently $K1\approx-0.39^{\circ}$. It means that the abutment tilted towards the west. However, the pier tilted towards the east: the measured angular value is currently $K3\approx0.18^{\circ}$. This behaviour of the north-east support may result in the observed interlocking of the unidirectional bearing (sensor P2).

The measurement of the tilt of the intermediate support in the structure's axis plane and in the perpendicular plane shows that the pier tilted towards the north so that the displacement of its head now amounts to approx. 25 mm, and to the east, causing a horizontal movement of the head of approximately 24 mm [6].
