Evaluation of the fragmentation of an oxide-silicate material by image analysis

A M Ignatova, M N Ignatov, M A Nikhamkin and LV Voronov

Perm national research polytechnic university, 29 A Komsomolsky ave., Perm, 614000, Russia

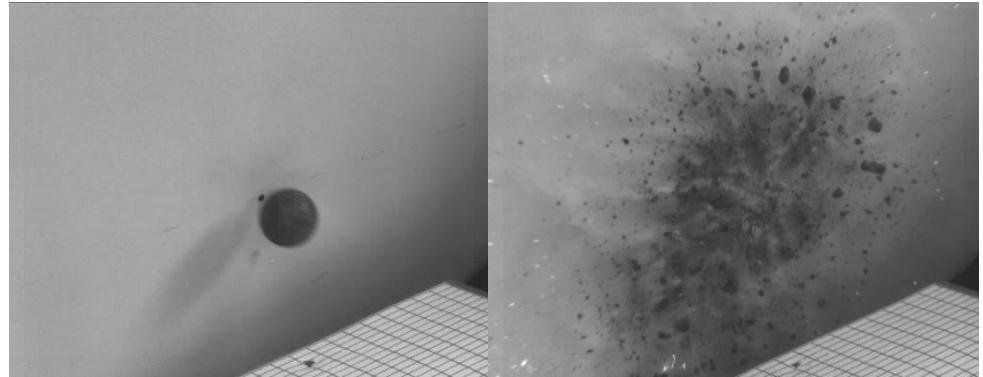
Figure 1. Shots of the experiment: a - before the strike, b - after the strike.

Figure 1 shows the image of video frames. In total, information on 500 frames was analysed according to the results of the impact. It was found that during the collision 3,442 fracture fragments were formed, ranging in size from 0.8 to 5.7 mm. Analysis of the size distribution of fracture fragments made it possible to establish that two groups of fragments are distinguished, the first is 3.5–5.7 mm, the second is 0.5–3.5 mm. The size distribution of the fragments in each group corresponds to the normal distribution (figure 2). It was also established that the total number of fragments in the first group was 1,593, which is less than in the second one, where the number of fragments was 1,849.

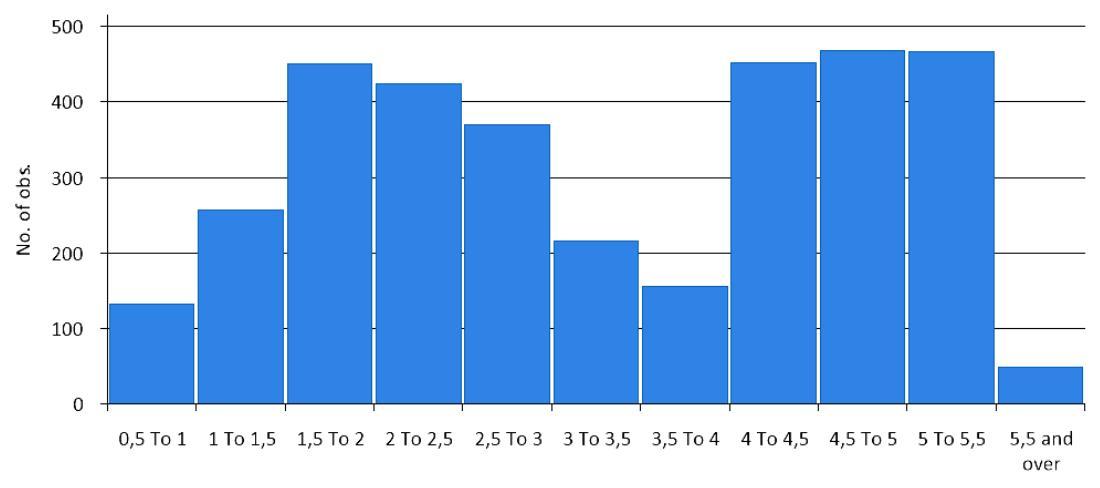
Figure 2. Histogram characterizing the distribution of fragments destruction by size.

The distribution of fracture fragments by size groups indicates that they were formed as a result of various processes, namely, the largest as a result of growth of main cracks, and the smallest as a result of dissipative processes, which is confirmed by studies of predecessors [8-10].

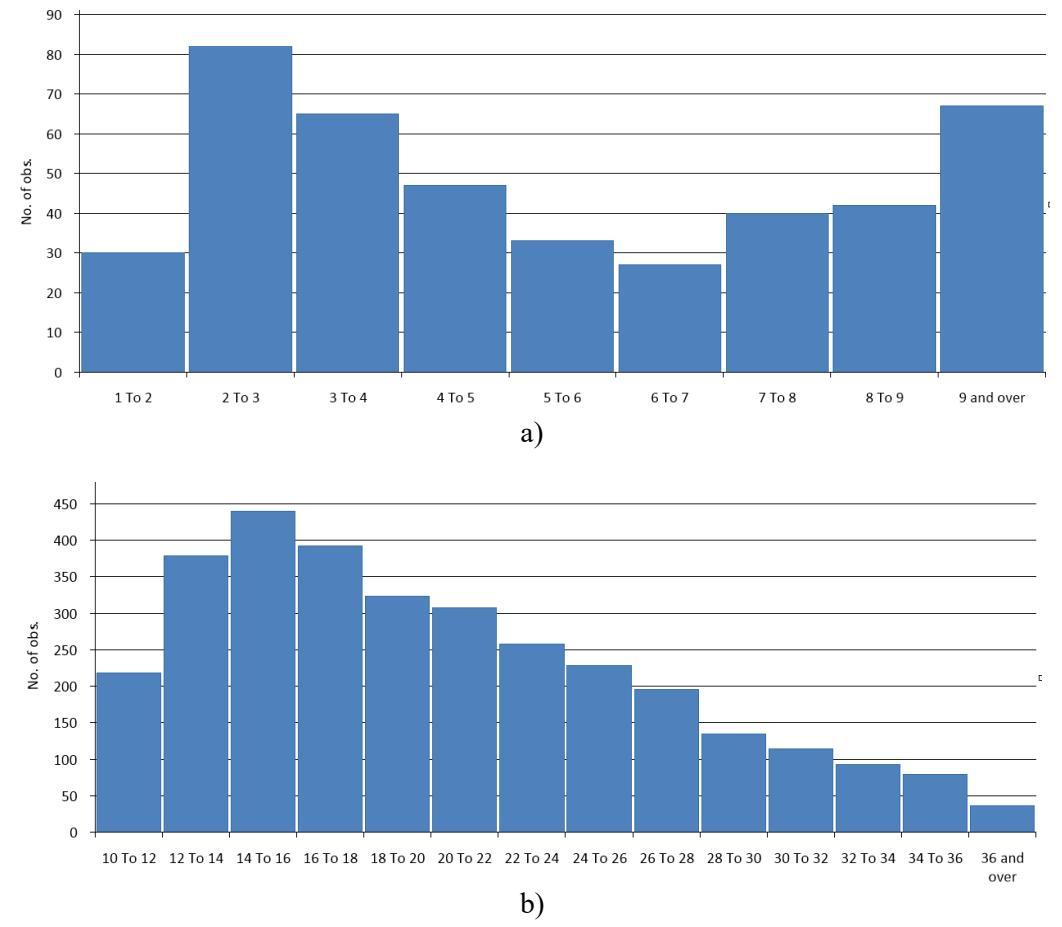
Figure 3. The distribution of the magnitude of the initial speed of movement of fracture fragments for size groups, mm: a) 3.5-5.7; b) 0.5-3.5.

Due to frame-by-frame analysis of the survey, it was found that the initial speed of movement of the fracture fragments was 1.0–40.0 m/s, with an average of 18.5 m/s, and the final one was 0.0–0.5 m/s. Meanwhile, different size groups had a different range of initial velocities. The average initial speed of 5.5 ± 3.2 m/s is characteristic for fracture fragments of size 3.5-5.7 mm. The average initial velocity of 20.2 ± 6.4 m/s (figure 3) is characteristic for fracture fragments with a size of 0.5-3.5 mm.

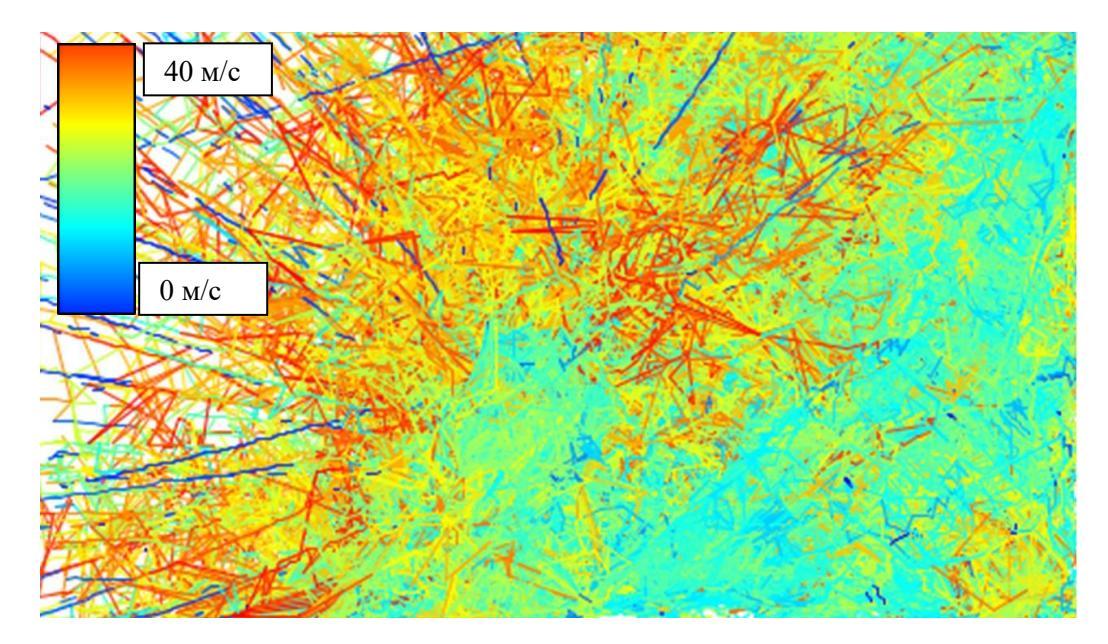
Figure 4. Trajectories of movement of fragments of destruction, painted depending on the magnitude of the initial speed of movement.

When visualizing the paths of movement of fracture fragments with different speeds (figure 4), the following trend was established. Fragments with the size of 0.5-3.5 mm move in the opposite direction from the obstacle, fracture fragments 3.5-5.7 mm in size move along the surface of the barrier.
