Overwater depth inspection on a submerged pile bent

Abstract. In this paper, a foundation inspection strategy was developed to determine the condition on a fully-submerged pile bent foundation supporting an overwater vehicular bridge in Taiwan. The electrical resistivity tomography inspection displayed the overall conditions of the salt-content canal. Using the reciprocal principle-based ultra-seismic inspection could finely determine the foundation depth. The time lapse analysis and traditional frequency analysis provided varying degrees of reliability on the pile length estimate, positively reconfirmed with the design charts. The entire investigation demonstrates the conclusiveness in determining the foundation depths when two testing methods are corroborated with appropriate analysis modes.

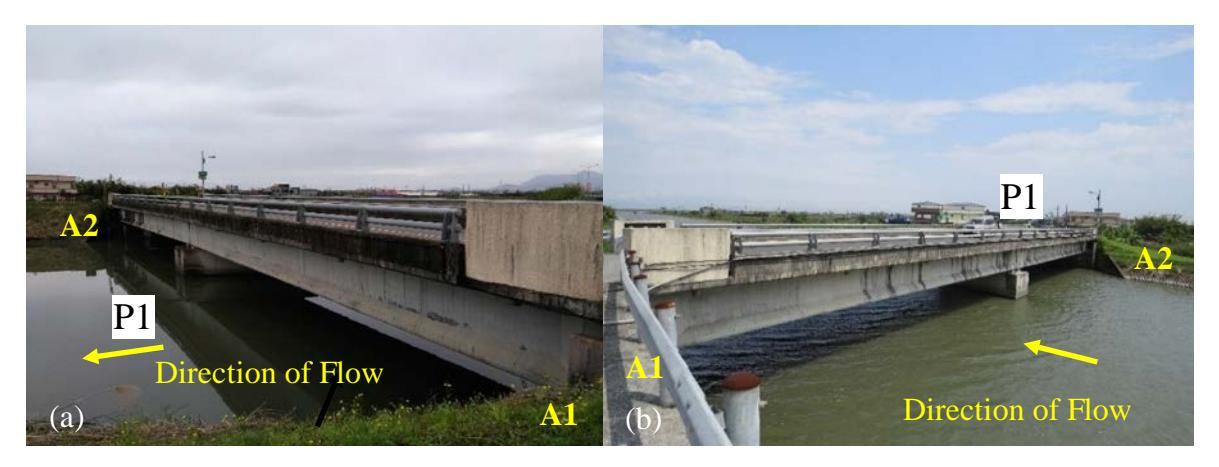
This study inspected a twin-lane vehicular reinforced concrete bridge located in northeastern Taiwan (figure 1). The designated 2-span bridge was part of the access network for local residents and agricultural products transportation. The superstructure consisted of eight 51-m-long I-type girders and was supported by pile bents, which were located within a 45-m-wide tidal reach drainage canal.

Figure 1. Bridge panorama images: (a) downstream side; (b) upstream side.

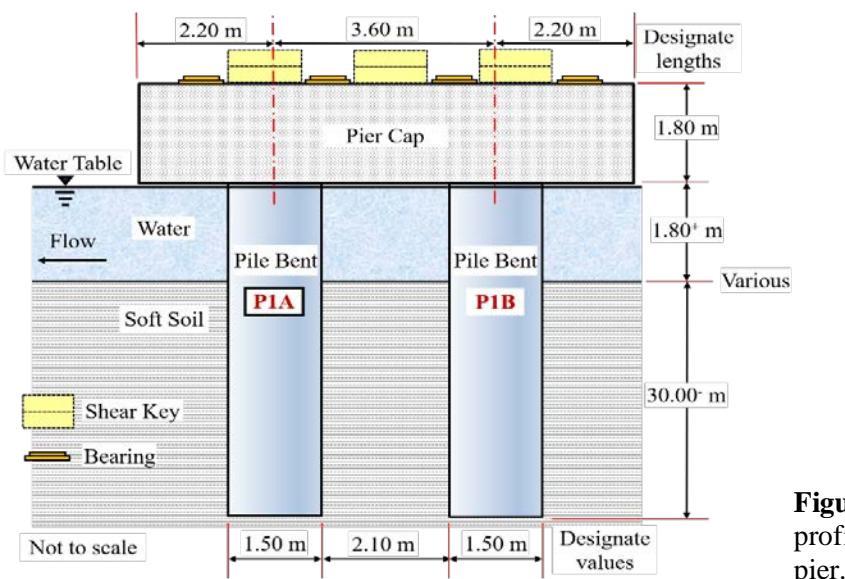
Figure 2. Substructure profile of the submerged pier.

Pile bents (i.e., partially embedded concrete piles) were used for crossing over the drainage canal full of soft clay and silty sand in order to accelerate the bridge construction speed. The pile bents were composed of two cast-in-place piles (drilled shafts) with a diameter of 1.5 m and a length of 31.8 m, as shown in figure 2. The exposure height beyond the riverbed was designated as 1.8 m below the pier cap bottom at its design phase. However, the estuary of the drainage canal merely has a distance of 2 km to the bridge site. The varying tidal level significantly traced back to the upstream, caused the riverbed variation, and also led to the water table approaching the pier cap bottom (i.e., complete submergence on the pile bents) at its highest tidal level.

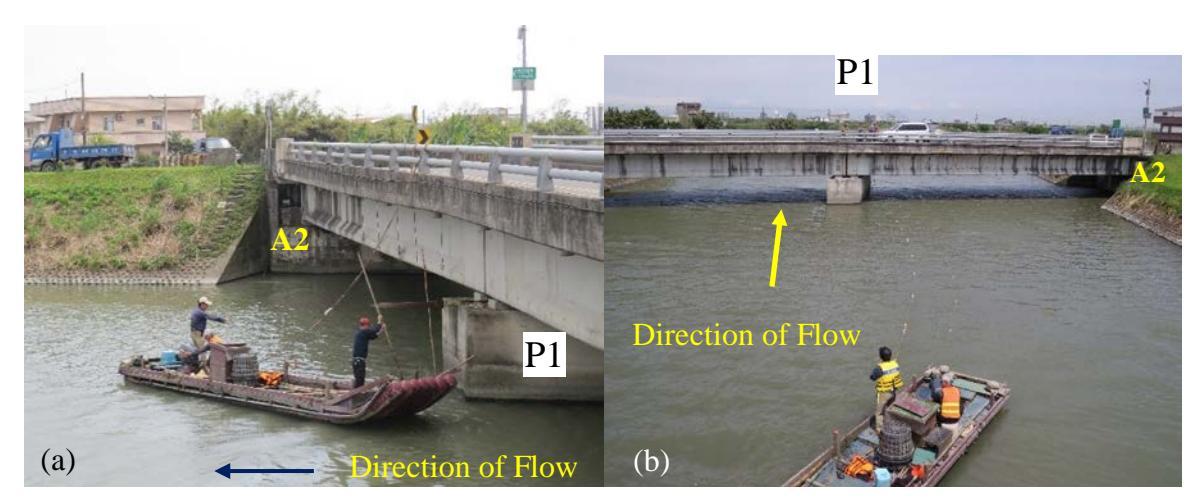
An electrical resistivity tomography technique with SYSCAL Pro, Switch Pro, termination strip, and electrode probes were utilized to display the electronic potential field on the target bridge. The survey line of an overwater electrical resistivity tomography inspection was settled parallel to the direction of flow and kept a distance of 0.5 m away from the pile bents (as shown in figure 3). One survey cable section with electrodes was hanged downward from the bridge deck, dragged to the downstream side with a fishing raft, and fixed the cable end on bamboo staffs. Similarly, another survey cable section with electrodes was dragged to the upstream side and fixed on another end with bamboo staffs as well. Being tied with empty plastic bottles, all electrodes were kept floating nearby the water surface of the drainage canal. The total survey length was 150 meters long and set with an electrode spacing of 3 meters.

Figure 3. Overwater electrical resistivity tomography inspection on (a) downstream side; (b) upstream side of a submerged bridge pier.

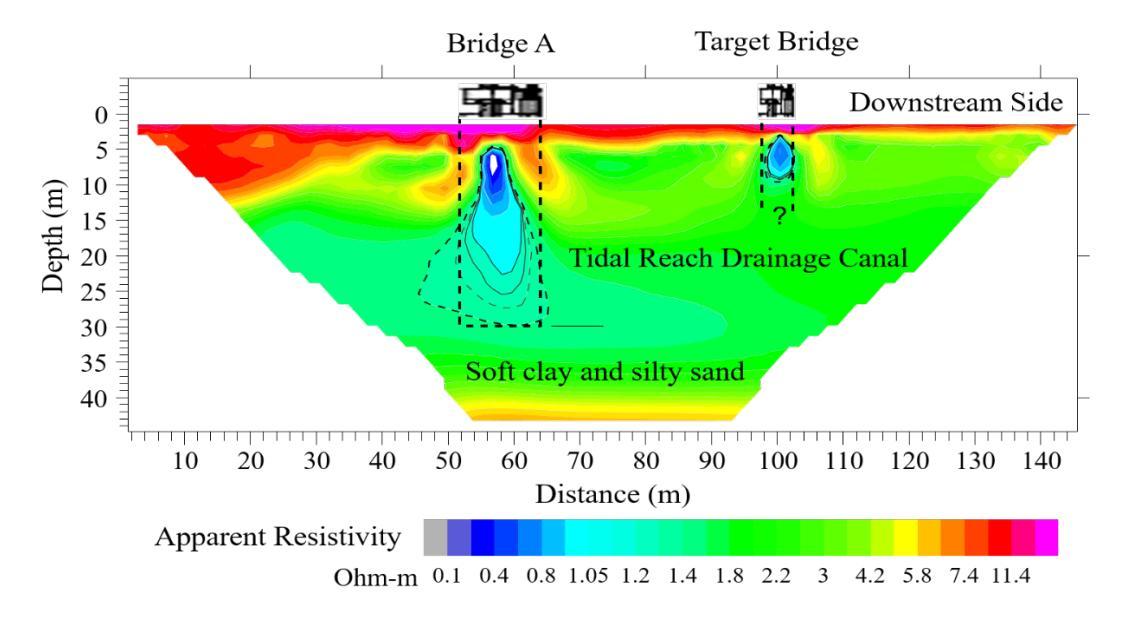
Another bridge, named as Bridge A, was 40 meters away from the upstream side. The locations of pile bents were marked in the resistivity image, as shown in figure 4. Using a pole-diploe inspection mode, two pretty low resistivity contours, shown as grey and light blue scales, were marked as dashed rectangles, underlying right below two bridge piers. These represented the locations with a relatively high content of reinforced bars existing in the pile bents. Theoretically, the bottom of the dashed rectangles was identified as the foundation bottom. The pile bent depth on the target bridge was identified as 10 meters, much shorter than its designated length, 31.8 m. This could be affected by flowing saline water. Repeated scour and deposits weakened the interface among saline water, soft soils, and piles bents in this tidal reach canal. The resistivity image obviously indicated a relatively high salinity in river and failed to identify the foundation depth on the target bridge.

Figure 4. Overwater electrical resistivity image profile across the submerged bridge piers.

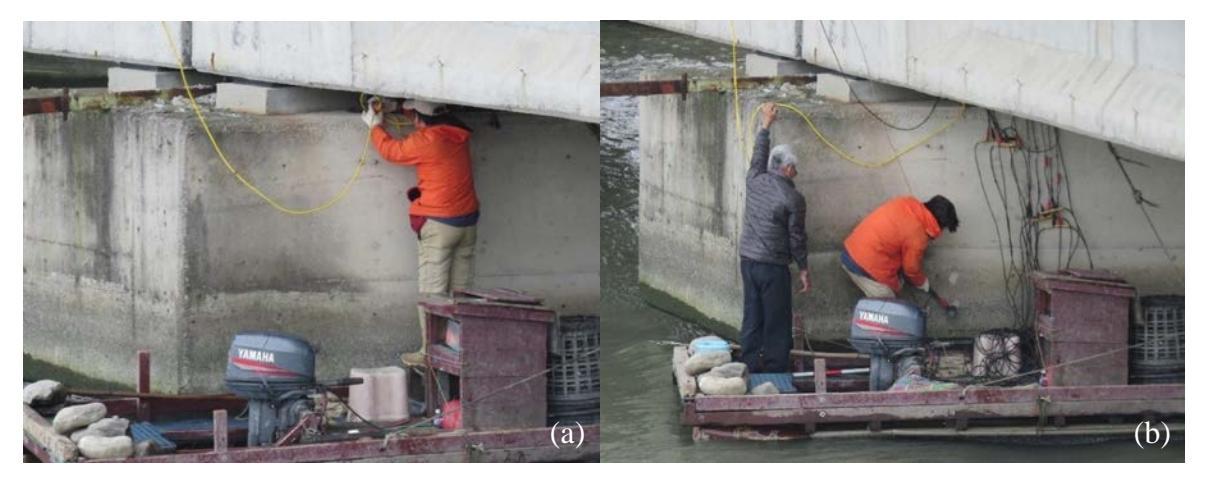
The modified ultra-seismic inspection [3] was executed on the pier cap supported by submerged pile bents due to a high tidal level. The transducer packet was fixed at the top position of the pier cap and the measured transient-state seismic waves were recorded with a Geometrics multi-channel Strata View seismography set (figure 5(a)). An investigator repeatedly struck the lateral side of the pier cap with a hand-held hammer in an equidistant fashion (0.2 m) from the cap top down to water surface (figure 5(b)). As the impact waves traveled downwards through the submerged and embedded components, the reflection waves would be created at the interface of the foundation bottom and underlying stratum.

Figure 5. Ultra-seismic inspection: (a) geophone installation; (b) striking on the pier cap side of a submerged bridge pier.

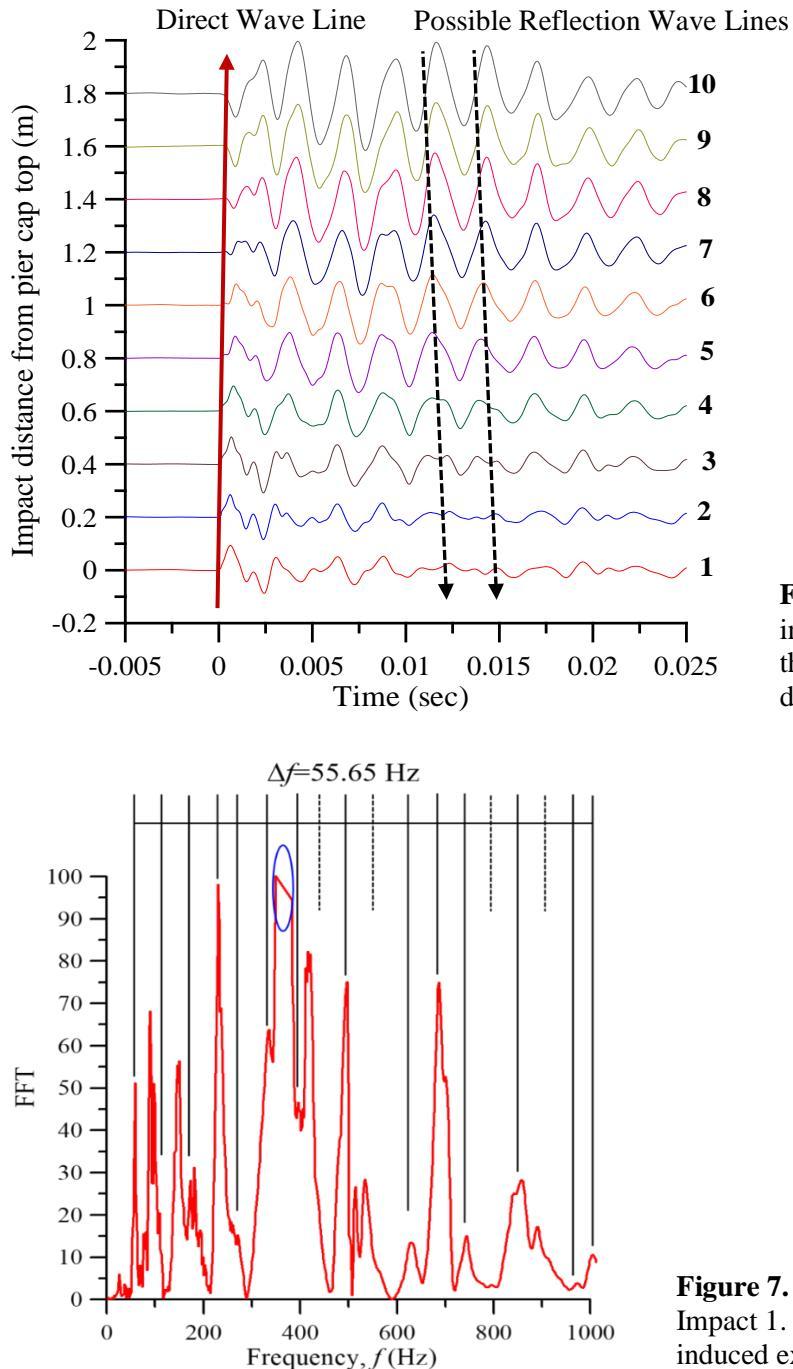
Figure 7. Vibration spectrum of Impact 1. (note: A cut-off at noise-induced extreme peak)

In order to improve the precision of using ultra-seismic inspection, the surface response timehistories are transferred into spectra for frequency analysis by using the fast Fourier transfer (FFT). All 10 velocity spectra have similar vibration response distributions. A typical spectrum response in Figure 7 indicates regular-span, Δf , resonance peaks and a single extreme peak at around 360 Hz induced by background noise (labelled with an ellipse). Based on the one-dimensional wave theory, the pile length, *L*, is given by [6, 4]

where C_{bar} is the bar wave velocity and Δf is the frequency span (i.e., 55.65 Hz). The pile bent length (including pier cap height) is estimated as 34.44 m, around a 2.5% error to the nominal length.
