Experimental investigations of the structural behaviour of simply support ferrocement-timber composite beams

Abstract. An experimental study of simply supported ferrocement timber composite members is presented in this paper. An adhesively bonded connection is examined. Sikadur 31 thixotropic epoxy resin adhesive is used as a shear connector layer. The main purpose of the research is generating data and providing information about the structural behaviour of proposed ferrocement timber composite (FTC) beams. Several parameters studied including thickness, and width of timber beams, the number of wire mash layers of ferrocement slab and the presence and absence of a bonding layer of the shear connector and the effect of sag and hog bending moment. Ferrocement-timber composite (FTC) beams are a relatively new civil engineering solution and their behaviour should be investigated to develop relevant methods for calculating their resistance. The slip and the pinnacle load limit for connector were resolved tentatively in two push-out tests. The authors examined the stiffness and the strength of the connection used to join a ferrocement slab with a timber beam. These parameters are funda

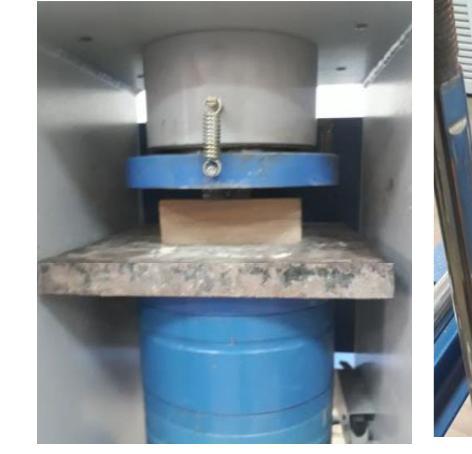
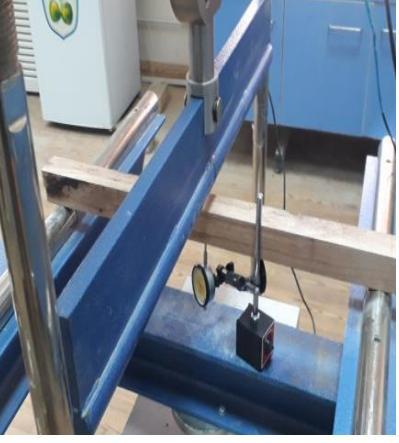
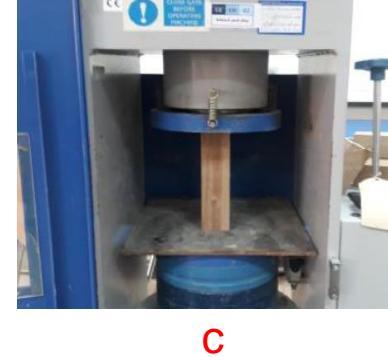
a Figure 1. a- Compressive parallel to the gain.

b- Compressive perpendicular to the gain.

c- static bending test.

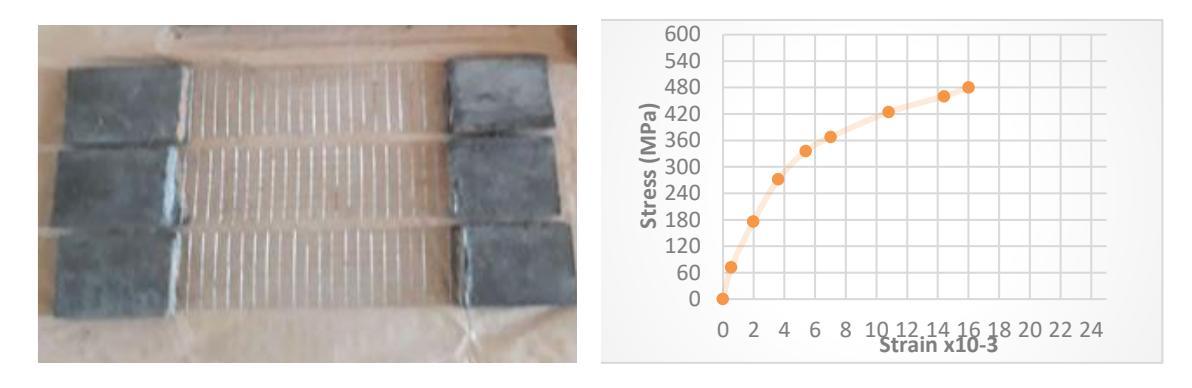
Figure 2. Stress-strain relationship for wire mesh.

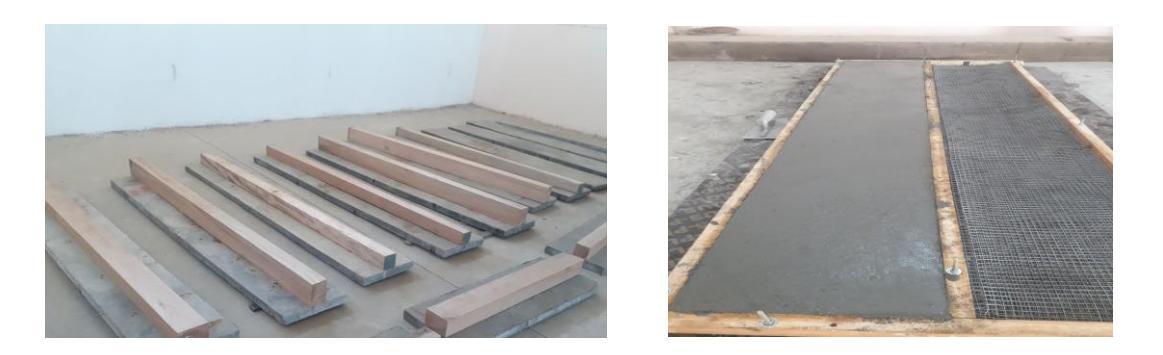
Figure 3. Configure of specimens.

Precast ferrocement panels were cast using plywood sheet molds having a nominal thickness of 12 mm. The long sides of the molds have sets of holes defining the position of the layers of mesh. The three and six layers of steel meshes were tied together using very fine steel wires and fixed to the mold through these holes. All specimens were tested after 30 days. In addition, timber members were prepared and cut with the required dimensions. The sides of timber members and ferrocement panel at which they connected were well cleaned. Then, the two components of composite beam, timber beam and ferrocement panel were joined together using epoxy adhesive (Sikadur 31). The thickness of epoxy layer was almost 3 mm. Next, the two components were pressed using a mechanical fastener prepared for this purpose along three days. The casting process of ferrocement members and assemblage of ferrocement with timber are illustrated in Figure 3.

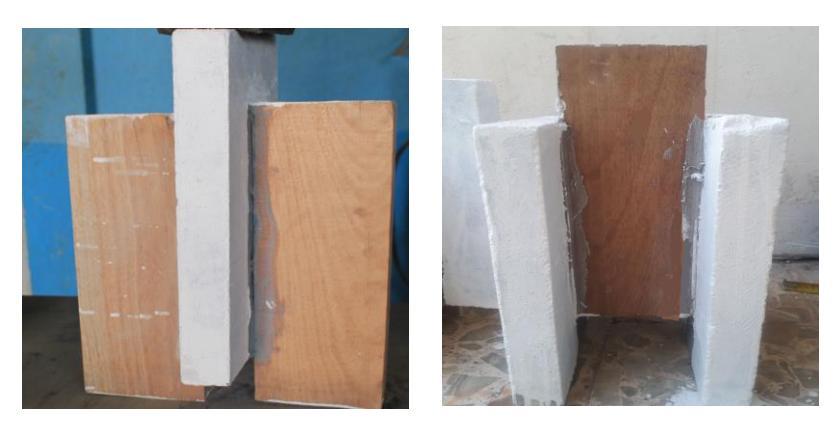
Figure 4. Push out specimen.

The connections between the ferrocement panel and timber beam should be checked through achievement of push out test. There is no codes or specifications concerned with push out test for adhesive bonding ferrocement-timber composite (FTC) members. Therefore, the model presented in this study was suggested according to British specification for steel-concrete composite beam. For this purpose, samples of push out test were made in two fashions. In the first fashion, the prepared push out sample consists of two segments of ferrocement with dimensions $(400 \times 300 \times 50)$ mm and one segment of the timber with dimensions $(400 \times 135 \times 85)$ mm (PUSH1). While, in the second style, it consists of two segments of timber and one segment of ferrocement with similar dimensions of the first fashion (PUSH2). Figure 5 illustrates the dimensions and styles of push out tests. As mentioned earlier, the samples were bonded with 3 mm epoxy adhesive and pressured by a mechanical clip and leave it for three days prior to the examination. The tests were done using the Universal Testing Machine (MARUI) 20-ton capacity. Load was applied on the specimen in constant increments at each load level up to the ultimate load, while the slip between the timber and ferrocement segments was measured. The dial gages were positioned to measure the slip at the interface of ferrocement and timber. The detailed and results of tested push-out specimens are summarized in Table (4). The failure modes of specimens were observed for both specimens. In the first failure mode of PUSH1, a thin layer of mortar was separated from ferrocement segment and remained attach to the timber section in the interface region. On the other hand, the second mode of failure of PUSH2 was characterized by splitting the timber section as shown in Figure 6. This indicates that there is no any debonding occurs between the two components (ferrocement and timber) and the adhesive epoxy layer provided an adequate bond between them. Hence, the bond using Sikadur 31 could considered to be perfect. Figure 6 illustrate failure of push-out specimens.

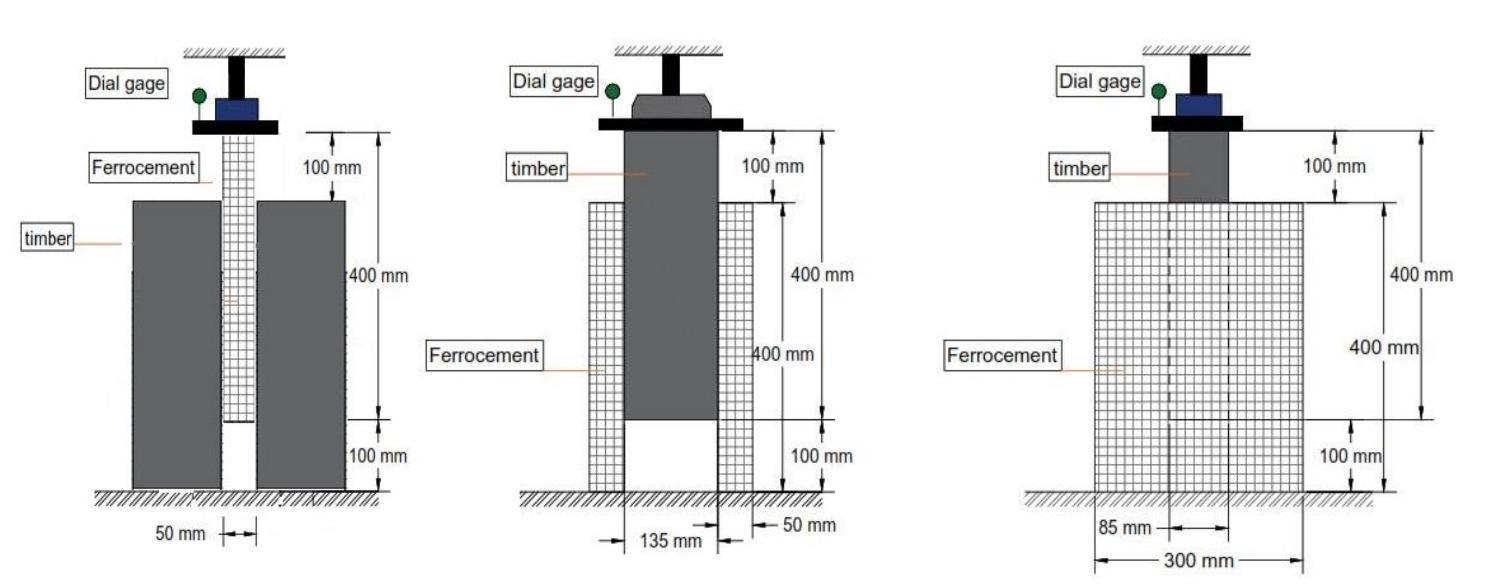
Figure 5. Dimensional drawing of Push out specimen.

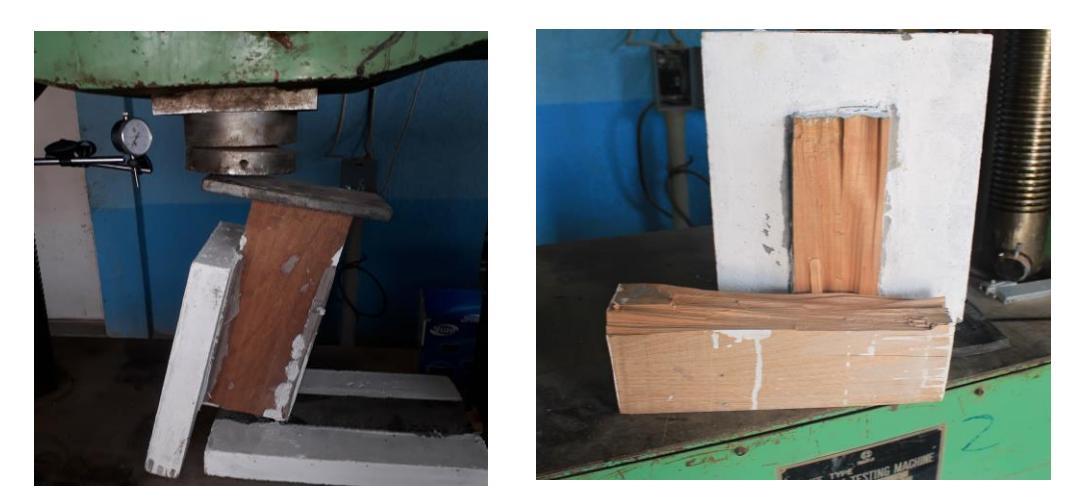
Figure 6. Failure of push-out specimens.

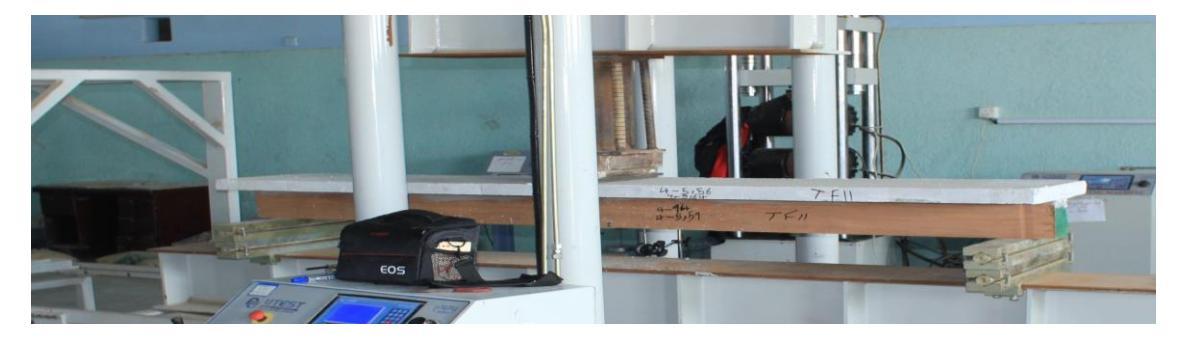
Figure 7. Testing setup.

increments were reduced in magnitude as the load reaches the ultimate load. TORSEN universal testing machine with capacity of 600 kN was used to apply the load. The load was applied at the mid-point of beam span as shown in Figure 7.

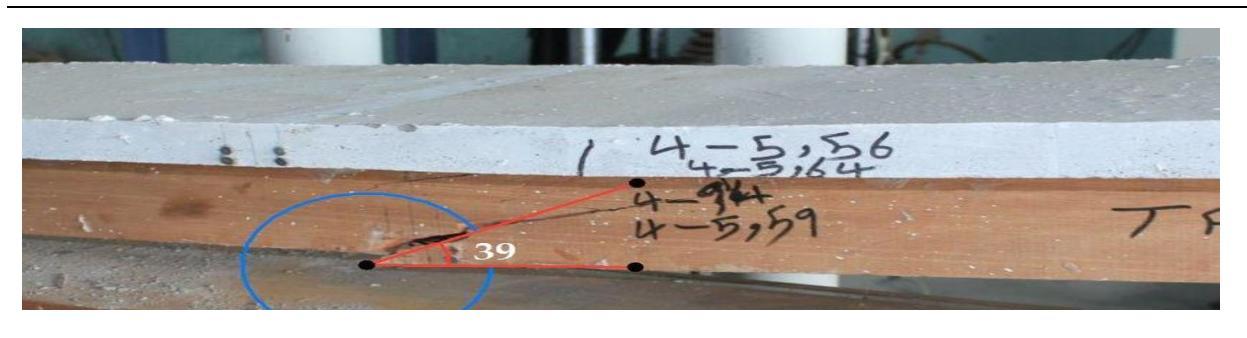
Figure 8. SpecimenTF9 after failure.

Figures 9 to 15 shows the results of the study of the composite ferrocement timber beam. The mid-span deflection from the laboratory tests is shown in Table 5 and 6. While Figure 8 and 9 show a number of models after the failure process.

Various modes of failure are observed during the static tests of the composite beams. The global response of load-deflection relationship of composite beams shows a linear elastic stage followed by a nonlinear behaviour. Under serviceability limit state conditions, no cracking is detected during the loading period. After the initiation of flexural cracks, the stiffness of beams reduces and the linear loaddeflection behaviour vanishes when the internal steel wire mesh begins to yield. The non-connected composite beam (TF-7) suffered from excessive tensile cracks in ferrocement at the end of the linear behaviour of timber beam while bending in timber continues to increase, then cracks begin in the timber beam at the mid-span towards the support until the stage of failure. The composite beam specimens subjected to sagging bending moment (The ferrocement is at the top and the timber at the bottom failed firstly by the cracks in the ferrocement at mid-span tension zone). Then cracks begin in the timber where there is almost a small incision in the middle in the tension zone begins to grow by increasing force. Then the cracks in the ferrocement will be displayed as well as in the timber and small cracks will begin in the epoxy bonding area. The failure cracks are occurring in the middle third region. Beams with sagging bending moment tensile failure in the timber beam but cracks started from the bottom surface of timber beam at the mid-span and propagated upward with an angle between 35° to 47° with the horizontal. After increasing the load, the cracks extended towards the support.

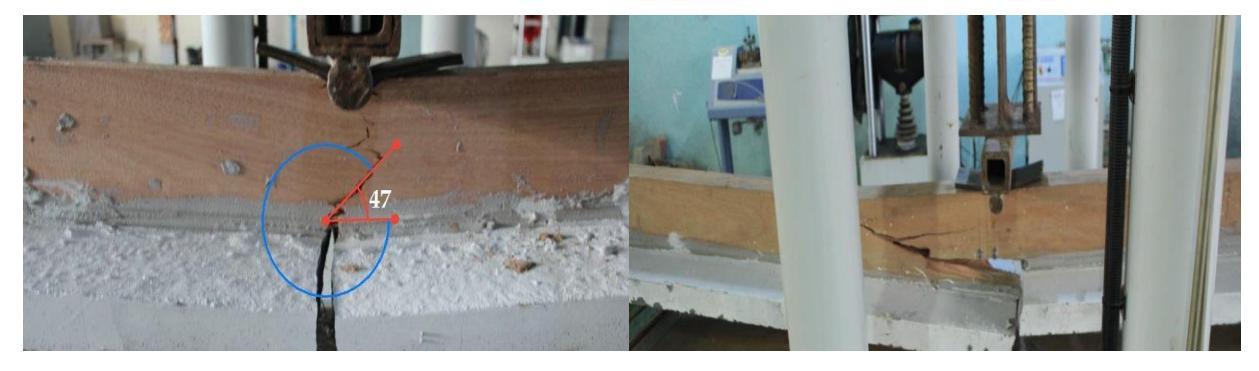
Figure 9. composite beam under hogging bending after failure

The failure of beams in this case is characterized by cracking in the tension zone of ferrocement slab and increasing deflection with a drop-in load recorded by the testing machine. The first crack appeared at the bottom surface of ferrocement slab when the load almost reaches (0.3Pu). After that, the cracks propagated upward to the top surface of ferrocement slab at the load nearly approaches (0.6Pu). The results of sample are shown in table 6. The crack width increased with the increase of the applied load and led to failure of specimens.

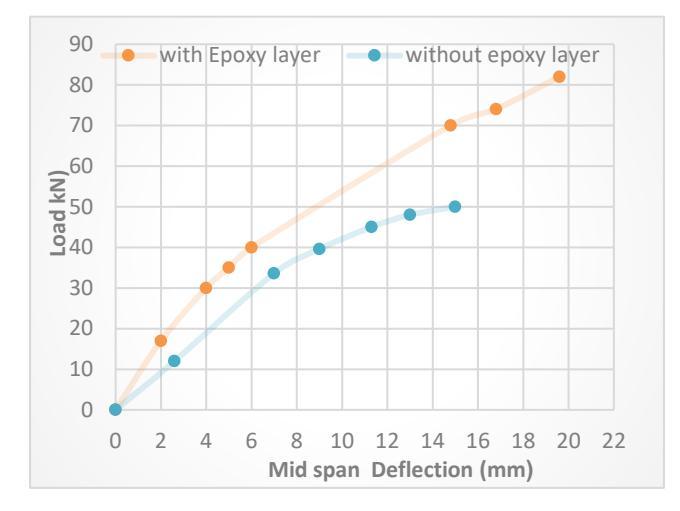
Figure 10. Variation of midspan deflection for composite beams without shear connecter and with connecter.

Figure 10. shows the load midspan deflection relationships for composite beam without adhesive layer (T-F7) compared with composite beam that connected by adhesive layer and same dimensions (TF11). It can be seen the load is increase from 60 kN for TF-7 to 82 kN for TF11 with a reduction ratio 26.8% and also the deflection is increase from 13 mm for TF-7 to 18 mm for TF11 with a reduction ratio 27.7%. It can be notice that a clear increase of load and deflection when using of epoxy as a bond between the individual parts (timber beam and ferrocement panel). On the other hand, the composite beam subjected to hogging bending moment (timber is at the top and the ferrocement is down) the failure of beams in this case, is characterized by cracking in the tension zone of ferrocement slab and increasing deflection with a drop-in load. After that, the cracks propagated upward to the top surface of ferrocement slab. The crack width increased with the increase of the applied load and leading to failure of specimens. we noticed a crack in the middle of the ferrocement but the composite beam still did not fail. This indicates that a crack in the ferrocement was to obtain homogeneity between the strains beyond (0.003) for ferrocement. No local buckling in the timber beams was noticed at the failure of these composite beams.

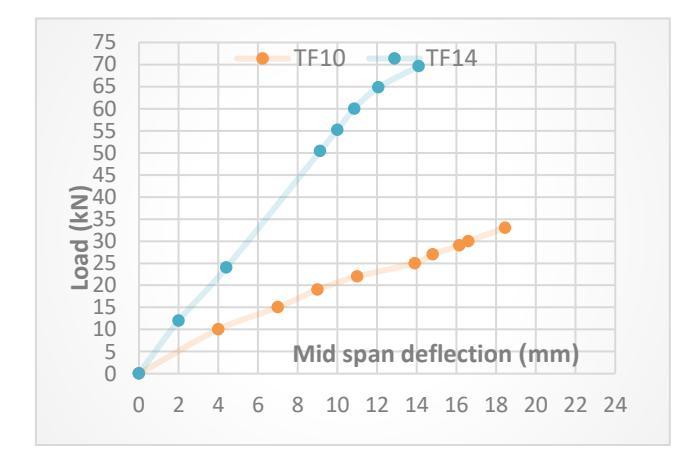
Figure 12. Variation of midspan deflection with load for composite beams the variable is timber (8.5X8.5) (8.5X19).

Figure 12. show load midspan deflection relationships for composite beams with different timber beams width (85 and 190) mm and the same depth 85mm when the width increases from 85 mm for beam TF10 to 190 mm for beam TF14 the extrapolated deflection value at ultimate load increase from 17 mm to 18.45 mm with increase ratio of 8.2%. While the ultimate load Increases from 33 kN to 74.5 kN respectively.

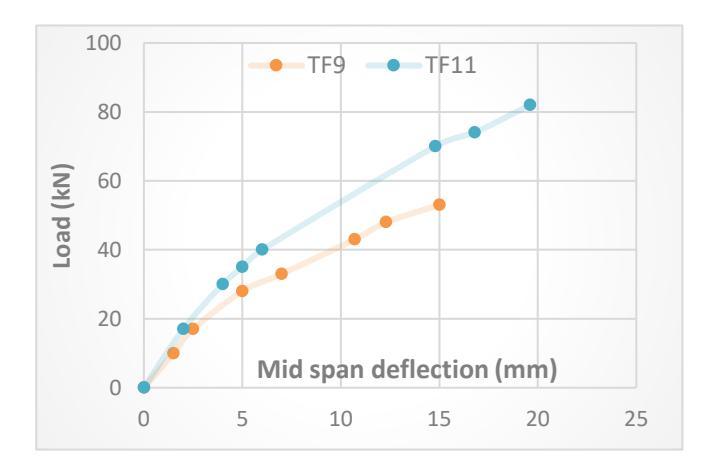
Figure 14. Variation of midspan deflection with load for composite beams the variable is number of wire mesh.

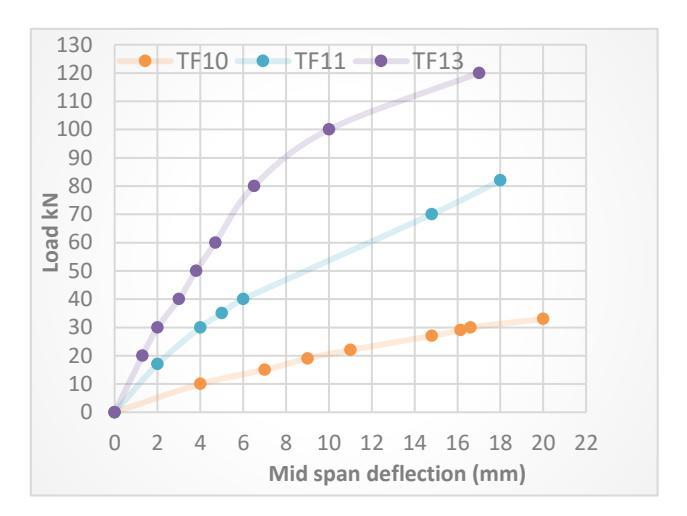
Figure 11. Variation of midspan deflection with load for composite beams the variable is timber depth.

Figure 11. show load mid-span deflection relationships for composite beams (TF10, TF11 and TF13) with different timber beam depth (85mm,135mm and 190mm) respectively, with the same width. The extrapolated deflection value at ultimate load decreases from 18.45 mm to 18 mm to 14mm respectively, with a reduction ratio of 24% and 23%. While the ultimate load decreases from 120 kN to 82 kN to 33 kN respectively. With a reduction ratio of 33.33% and 72.5%. So, when the depth of timber increases, the ultimate load increases and the midspan deflection decreases.

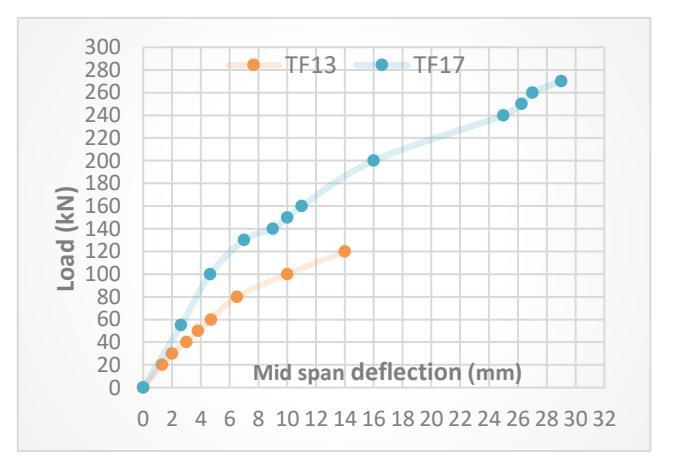
Figure 13. Variation of midspan deflection with load for composite beams the variable is timber (19X19) (19X8.5).

Figure 13. Show load midspan deflection relationships for composite beams (TF17 and TF13) with different timber beam width (85mm and 190mm) and the depth is equal (190mm). The extrapolated deflection value at ultimate load decreases from 29 mm for TF17 to 14 mm for TF13, with a reduction ratio of 51.7%. And ultimate load decreases from 270 kN to 120 kN with a reduction ratio of 55.5%. So, there is a big and noticeable change in ultimate load and deflection in the case of the large depth timber. Figure 14. Shows the load midspan deflection relationships for composite beam with (5 and 3) layers of wire mash in ferrocement slab TF9 have 3 layers of wire mash and TF11 have 5 layers of wire mash and same dimensions of composite beams. The load is increase from 53 kN for TF9 to 82 kN in TF11 with a reduction ratio of 35.4%. And also the deflection is increase from 12 mm for TF9 to 18 mm for TF11. with a reduction ratio of 33.3%.

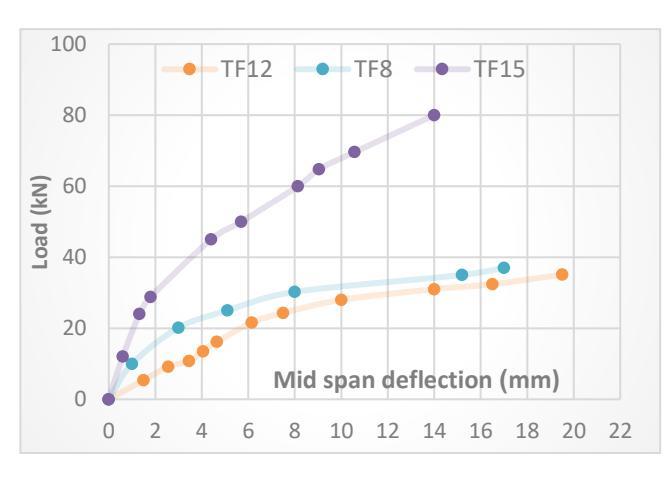
Figure 15. The effect of timber beam depth on variation of midspan deflection With load for composite beams hogging moment.

Figure 15. shows the effect of the depth of timber section on load-midspan deflection response for composite beams tested under hogging bending. The depth of timber beams is (85, 135 and 190) mm for composite beam (TF12, TF8 and TF15) respectively, while the width of those samples is equal. The ultimate load is increase by 11 % and 53%, respectively. While the maximum deflection of these beams variation of deflection ranged 13% and 23%, respectively.

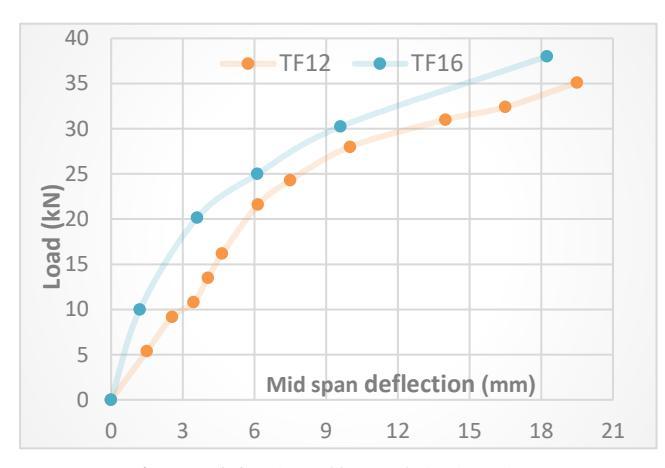
Figure 16. The effect of timber beam width on variation of midspan deflection with load for composite beams hugging.

Figure 16. show the effect of the width of timber section on load-midspan deflection response for composite beams tested under hogging bending. The width of timber beams is (85 and 135) mm for specimen TF11 and TF16 respectively, while the width of those samples is equal. It can be seen that the ultimate load is increase by percentage 7.9 %. While the maximum deflection of these composite beams increased by percentage 7.7%.
