# Comparative study on flexural behavior of corroded RC beams strengthening using near surface mounted GFRP elements

To cite this article: Saad Albadri et al 2020 IOP Conf. Ser.: Mater. Sci. Eng. 988 012048

## Saad Albadri<sup>1</sup>, Majid Muttashar<sup>2\*</sup>, Hamid Kazemi<sup>1</sup>, Ali Sadeghi<sup>1</sup> and Hayder Oleiwi<sup>2</sup>

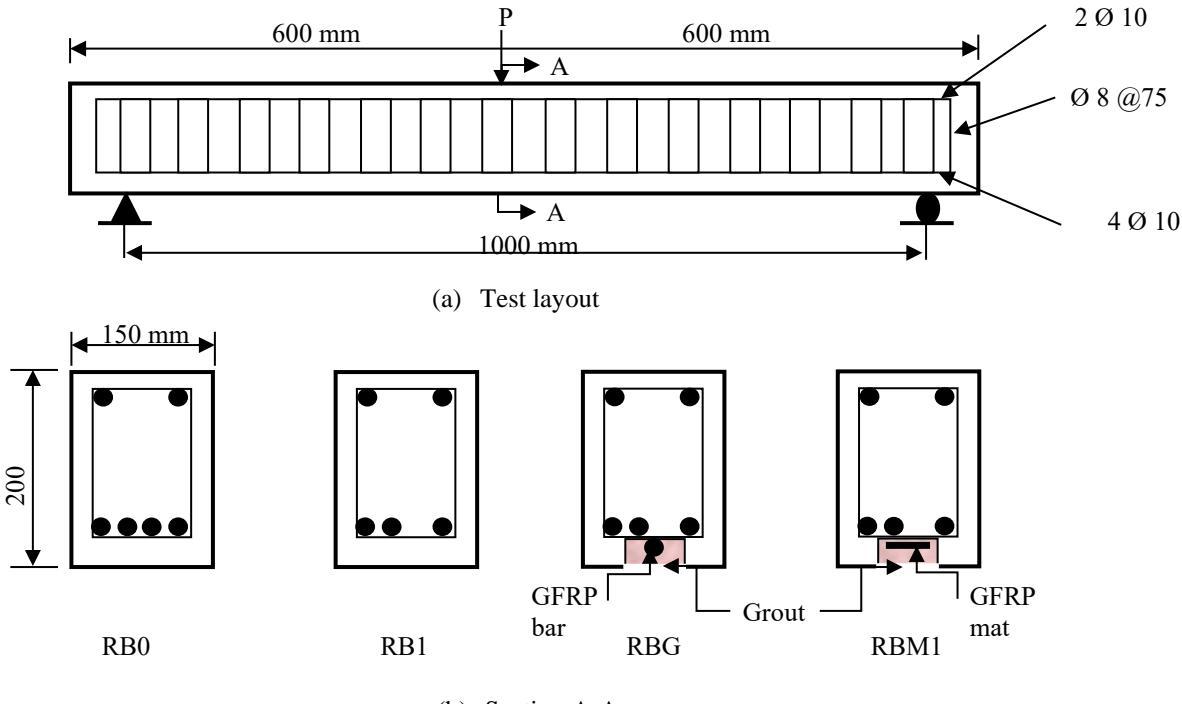
(b) Section A-A

Figure 1. Specimens layout and details of the reinforcement

In the experimental work, 4 reinforced concrete beams of 1200 mm long, 150 mm wide and 200 mm height were tested. One beam was used as a reference beam (RB0). The other three beams were subjected to simulated corrosion of 25%. This has been achieved by removing one bar from the main reinforcement in the tension zone. Two of the corroded beams (RBG1) and (RBM1) were strengthened using near surface mounted technique with one GFRP bar and 4 layers of GFRP mat, respectively. While the other beam (RB1) was left un-strengthened for comparison. The beams layout and details of reinforcement are shown in Fig.1 and summaries in Table 2. All beams were tested following three points loading method for the flexural capacity.

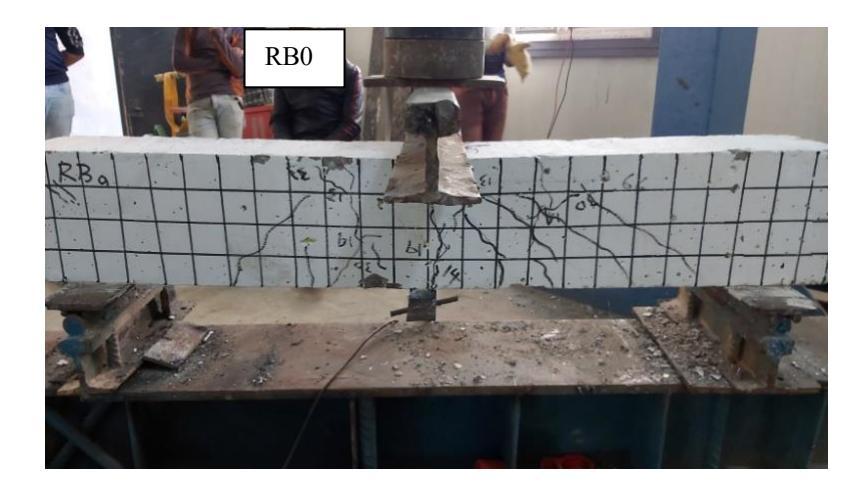
Fig. 2 shows a photograph for the crack spread of the reference beam RB0. The applied load for each increment is marked on the beam next to the cracks location. The photograph indicates that the crack patterns of the reference beam are mainly flexural. The first crack was observed at the mid span of the beam under the applied load point. The length and numbers of the flexural cracks then increased as the applied load increased until failure. Figure 4 shows the crack patterns and failure modes of the unstrengthened and strengthened corroded beams. It can be seen that all the three corroded beams showed similar patterns of the flexural cracks to that of reference beam RB0 up to failure. However, the number and length of the cracks of strengthened beams RBG1 and RBM1were higher than the unstrengthened beamRB1which indicates the improvement of the flexural behaviour. On the other hand, beam RBM1 that strengthened with GFRP mat showed less cracks distribution at failure which reflect the lower failure load compared to RBG1strengthened beam. For all the tested beams, the cracks continued propagating starting from the mid span of the beam in a vertical direction with the increase of the applied load. At the failure load, pure flexural cracks were observed for all tested beams without any concrete crush at the top of the cross section of the beams.

Figure 2. Crack pattern and mode of failure for the uncorroded reference beam

- It is noted that the fracture modes of the reference beam are mainly flexural. The initial crack was occurred under the applied load point
- Strengthening corroded beam with one bar of GFRP (RBG1) has improved the initial crack to be recorded at load level of 18 kN compared to 13 kN for the un-strengthened corroded beam. In contrast, there was no improvement for the beam that strengthened with GFRP mat (RBM1)

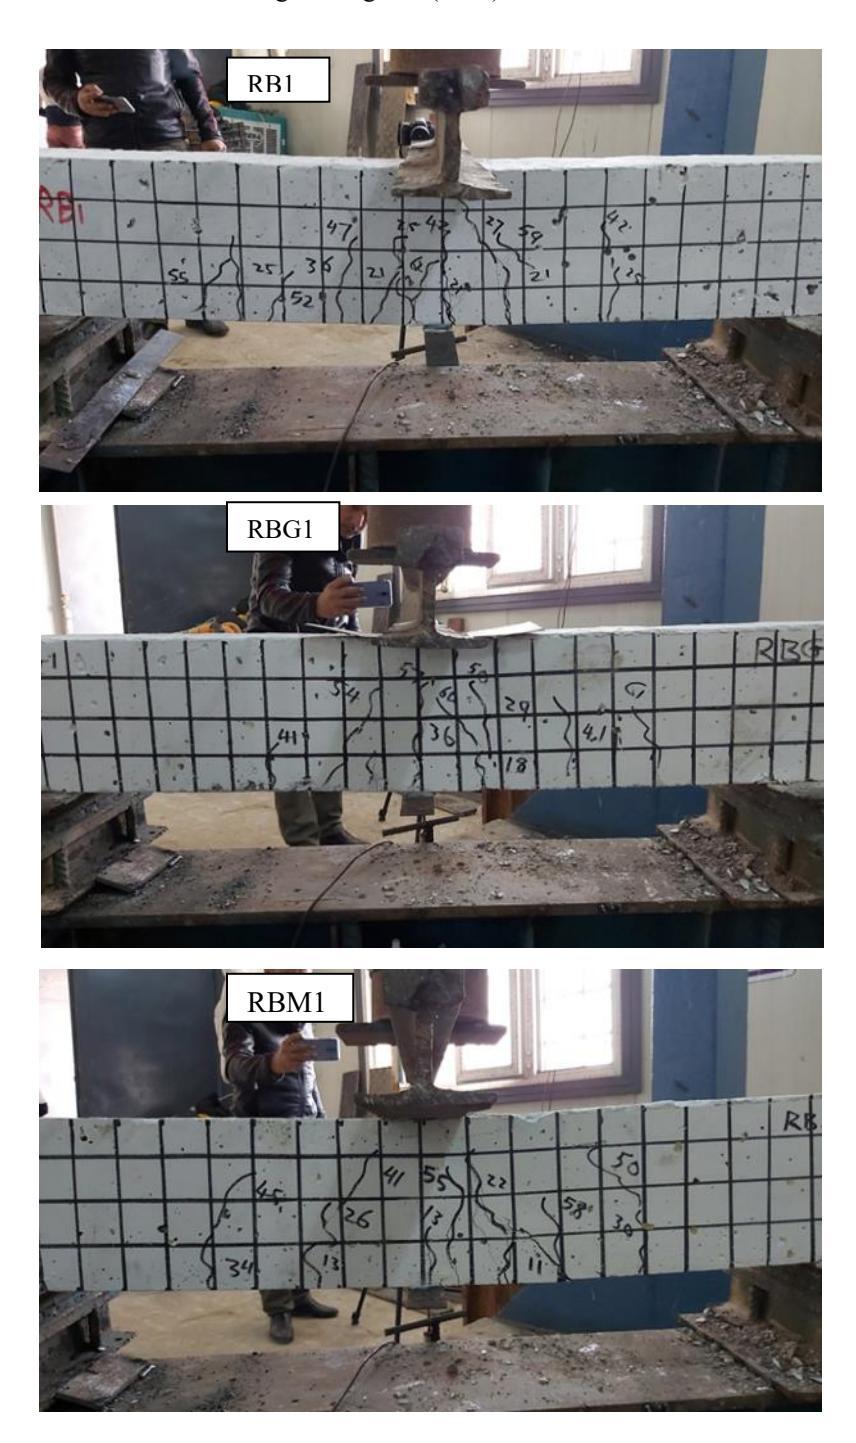
Figure 3. Crack pattern and modes of failures for the corroded beams

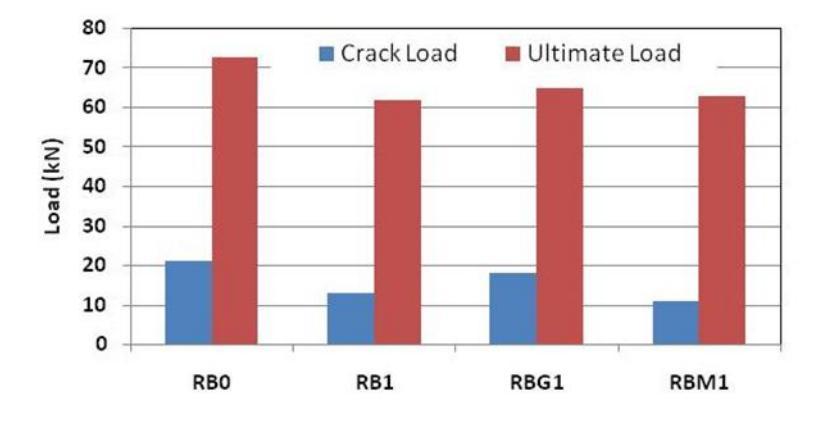
The crack load, yielding load and ultimate load in addition to yield deflection and ultimate deflection were summarized in Table 3. A comparison between the crack load and ultimate load for the tested beams were shown in Fig. 4. The first visible crack of the reference beam RB0 was observed under the applied load point in the tension zone at load about 21 kN. After increasing in the number and length of flexural cracks, the reference beam failed at ultimate load of 73 kN. This load level is comparable to the theoretical failure load of the reference beam. The crack load of un strengthened corroded beam RB1 was initiated at 13 kN at the mid span. Consequently, it fails with ultimate load of 62 kN.

A strengthened corroded beam with one bar of GFRP (RBG1) has improved the initial crack to be observed at load level of 18 kN. In contrast, there was no improvement for the beam that strengthened with GFRP mat (RBM1). Strengthened beams RBG1 and RBM1 showed very limited increase on failure load compared with un-strengthened beam RB1. The ultimate load of beams RBG1 and RBM1 were 65 and 63, respectively

Figure 4. Initial cracking and maximum loads of the tested beams

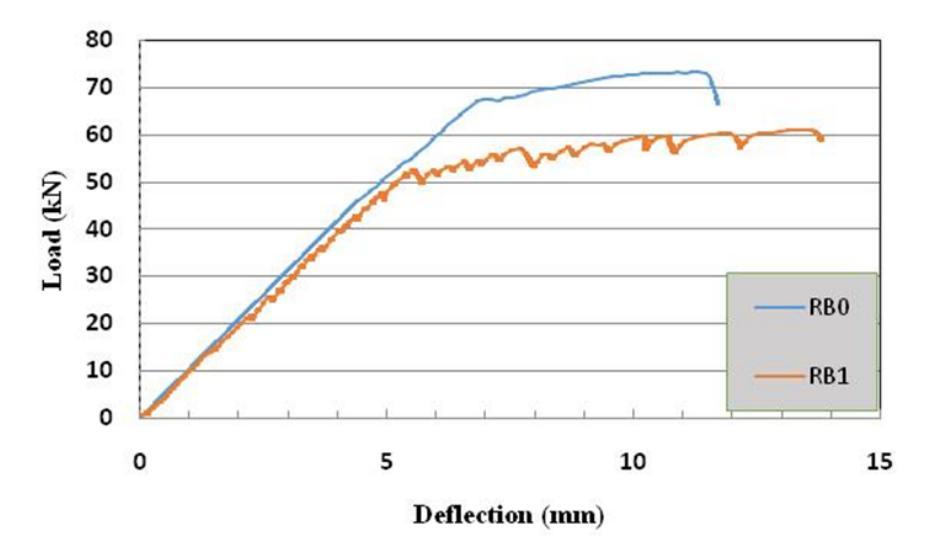
Due to the amount of time that required for the natural corrosion process, the corrosion damage of reinforced steel was simulated by removing one of the four tension bars. This gives a simulated corrosion percentage of 25% of the tension steel area. Fig. 5 clearly shows the effect of removing one steel bar from the tension steel of beam RB1 on the ultimate load capacity. It is obvious that while longitudinal tension bars number decreased the load carrying capacity decreased. The failure load of un-strengthened corroded beam RB1 decreased by 15%, compared with the reference beams RB0.Similarly, the first crack load and yielding load decreased as presented in Table3. This decrease however followed with noticeable increase in the ductility of the tested beam. It should be mentioned that all the tested beams exhibited pure flexure failure and showed flexural cracks mode along the pure flexural span.

Figure 5. Applied load and recorded deflection curve of un-corroded and corroded beams

- It is obvious that the ultimate load capacity, the initial crack load and yielding load decreases with the decrease of longitudinal tension bars number.

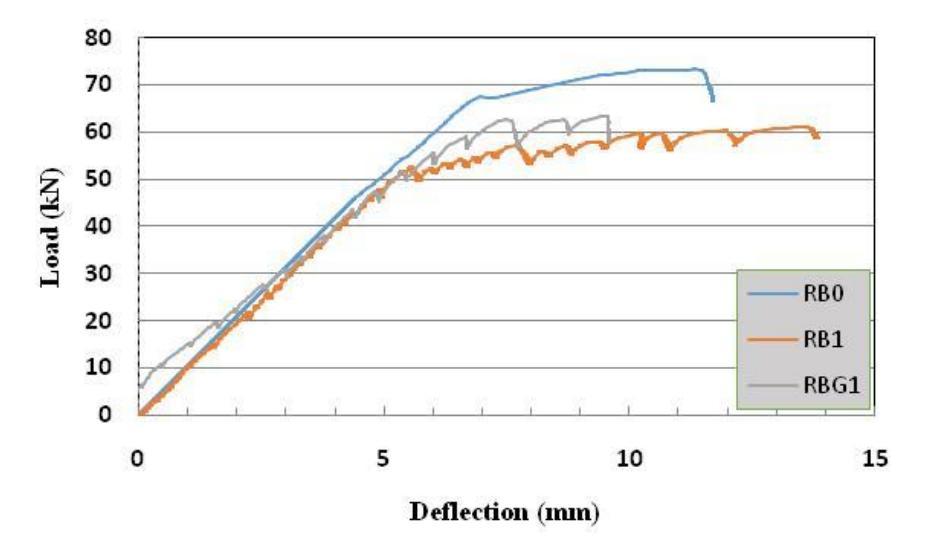
Fig. 6 shows the curves of the applied load and the recorded deflection of the reference beam RB0, unstrengthened corroded beam RB1and corroded beam strengthened with one GFRP bar RBG1. The crack load of the strengthened beam RBG1 was higher than it counterpart corroded beam RB1which reflect the improvement of the crack capacity of the beam. However, the enhancement seems to be limited to 85% of the un-corroded Reference beam RB0. Even the yield load was increased compared to the un-strengthened corroded beam RB1, the failure load of the strengthened beam was only 3% higher than its un-strengthened beam counterpart. Similarly, it accounts for 89% of the un-corroded reference beam. This behavior might be resulted from the brittle behavior of GFRP bar which shows noticeable improvement until yielding stage. Although both un-corroded reference beam RB0 and corroded strengthened beam RBG1 showed comparable ductility index, the brittle behavior of GFRP bar affects the ultimate carrying load capacity of the strengthened beam

Figure 6. Effect of strengthening with one GFRP bar on load -deflection curves

- The crack load of the strengthened beam RBG1 was higher than it counterpart un-strengthened corroded beam which reflect the improvement of the crack capacity of the beam. However, the enhancement seems to be limited to 85% of the un-corroded reference beam RB0. Even the yield load was increased in comparison with the un-strengthened corroded beam, the failure load of the strengthened beam was only 3% higher than its corroded beam counterpart. Similarly, it accounts for 89% of the un-corroded reference beam.

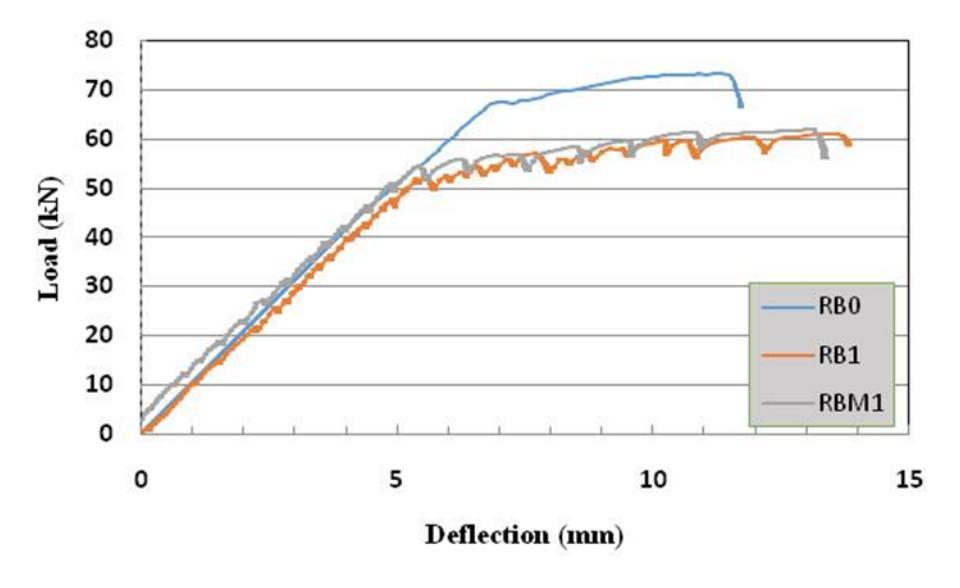
Fig. 7 displays the performance of strengthening with 4 layers of GFRP mat on load- deflection behavior of corroded beam (RBM1) in comparison with the behavior of un-strengthened corroded beam (RB1and un-corroded reference beam RB0. The presence of GFRP mat in the section had no

effect on both the crack and ultimate load capacity of the beam. This behavior could be attributed to the limited bonding strength between the GFRP mat and the concrete surface of the corroded beam. As a result, the difference in the ductility index of the strengthened and un-strengthened corroded beams was limited to only 7%.

Figure 7. Effect of strengthening with 4 layers of GFRP mat on load –deflection curves

- The presence of GFRP mat in the section has no impact on both the crack and ultimate load capacity of the beam.
