## A Sensor Fault Detection Methodology applied to Piezoelectric Active Systems in Structural Health Monitoring Applications

To cite this article: D Tibaduiza *et al* 2016 *IOP Conf. Ser.: Mater. Sci. Eng.* **138** 012016

**D Tibaduiza<sup>1</sup>, M Anaya<sup>1,2</sup>, E Forero<sup>1</sup>, R Castro<sup>1</sup>, F Pozo<sup>2</sup>.**

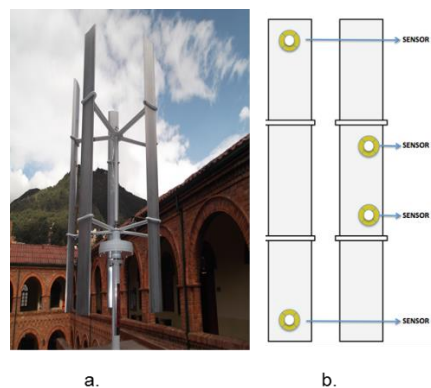
**Figure 1.** a) Vertical axis wind generator ALEKO WGV75W [9]. b) Distribution of the piezoelectric transducers.

For the experimental setup a blade from a vertical axis wind generator ALEKO WGV75W was equipped with four piezoelectric sensors which were distributed over the two external faces, (see figure 1). The inspection process is performed by the PZTs working in different actuation phases as in [8], this active system uses each sensor acting as receiver and as actuator in the four different phases of the experiment. The excitation input was a 50 cycles and 100 KHz burst signal with 8 V of amplitude, data were collected at a 20 MHz sample rate, and organized by sensor actuation phases as in [10]. The signal generation and acquisition program were developed in MatLab®.

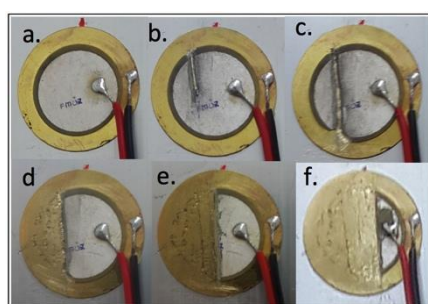
**Figure 2.** a) Undamaged sensor. b) Crystal middle cut at 25% line. c) Crystal complete cut at 25% line. d) Crystal 25% removal. e). Crystal 50% removal f) Crystal 75% removal.

Eight damages were induced over one sensor, they are described in Table 1 and their appearance is shown in figure 2. Five of the eight damages are related to the piezoelectric crystal with cuts and removal of a certain area, the other three are related to the debonding of the metal plate of the sensor. Both, crystal removing and debonding damages are supposed to be critical in the actuation mode, since these can change the signal applied to the structure. In the same way, in the data acquisition, these damages can affect the data reliability since the mechanical transduction to the electrical field which is going to be corrupted for the cracks in the crystal and to the incomplete energy received (case of debonding).

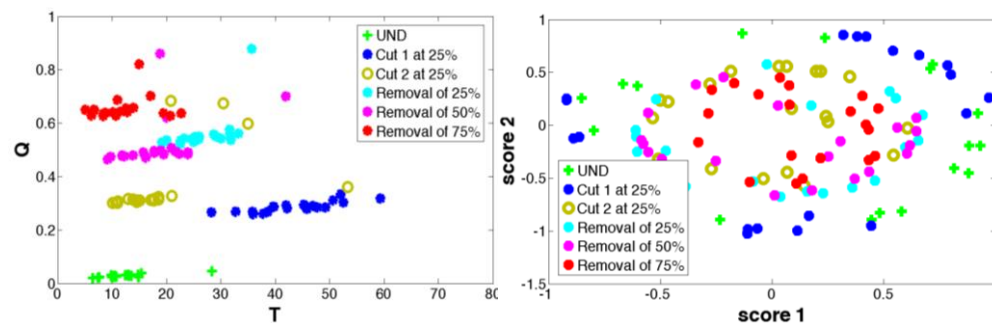
**Figure 5.** T-Q PCA indices and Scores 1-2 for the 5 damages induced over the piezoelectric crystal. (actuation phase 2)

As first outcome, Figure 5 shows the score and damage index plots using data from undamaged sensor, crystal cuts and removals were organized to evidence if each sensor fault could to be recognized by comparing with the baseline. By a simple comparison, can be concluded that in this case, score plot with just two components is not able to discern the presence of faults, however the use of the damage indices allow to determine the presence of all damages and some differences between them. Similar results are obtained in each actuation phase.

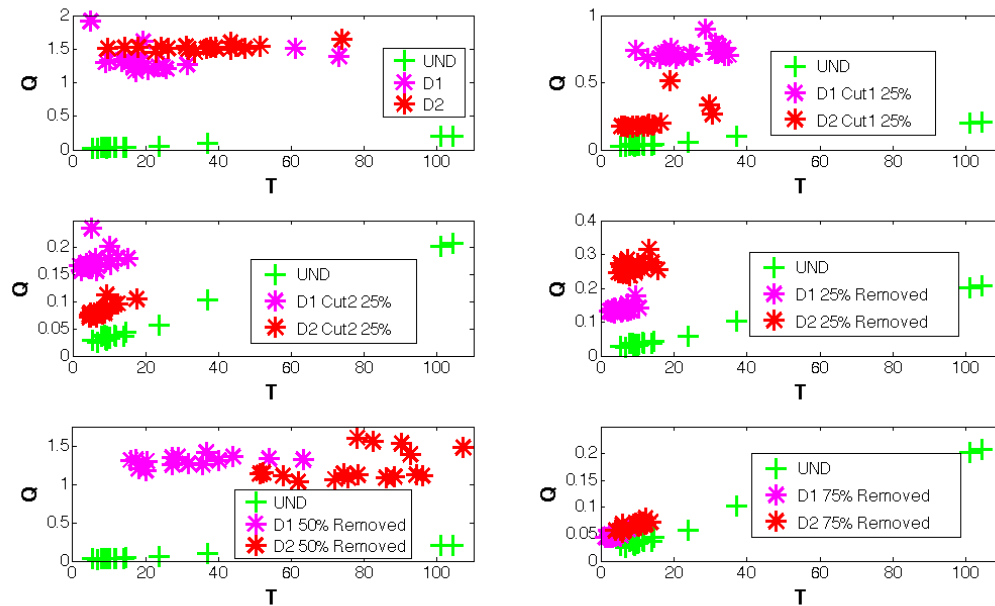
**Figure 6.** T-Q PCA indices for the 2 impedance damages over the structure in a. undamaged sensors b. fault the damages are measured from the 5 faults induced over the piezoelectric crystal (actuation phase 1)

Damages over the sensing system maybe critical, but in some cases it is not possible to replace or repair the sensors immediately. Considering this situation, the second test was performed by including simulated damages to the structure when one of the sensor is known as with a fault. Figure 6 shows the results in the use of the damage indices, as it is shown both damages can be separated from undamaged, however it is necessary to highlight that baselines were built with the sensor in the different fault conditions, this result allow to confirm that the pattern recognition approach allows to determine the presence of damages in spite of the faults in a sensor.

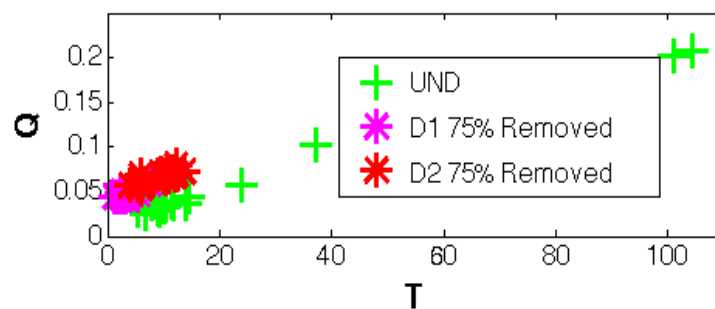
**Figure 7.** T-Q PCA indices for the 2 impedance damages over the structure, damages are measured from the 75% crystal over the piezoelectric.

Evaluating the rest of the actuation phases, similar results are obtained, although for the Phase 1 which includes the fault sensor at 75% crystal removal case, the damages seem to be close enough from each other, is the only case where they behave like this (figure 7).

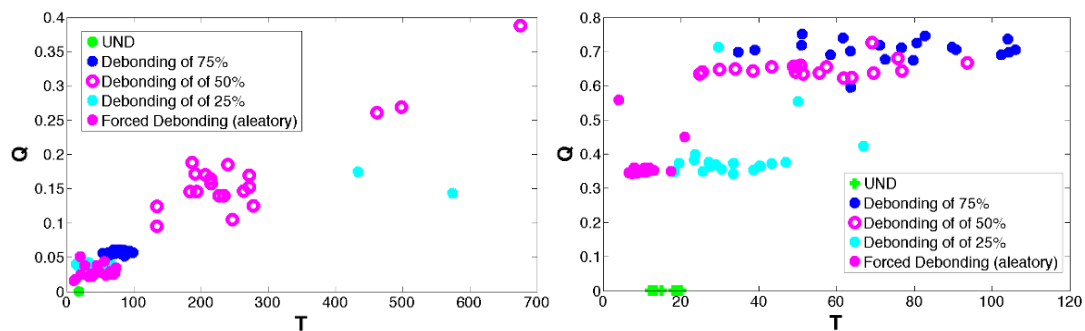
**Figure 8.** T-Q PCA indices for the debonding damages over the structure. For the actuation phases 1 and 2.

As third experimental validation, the detection of debonding was performed. Figure 8 presents the results when an incremental debonding is studied in two actuation phases. As it is possible to observe, the undamaged state is separated from the different faults.
