First results from the CMS SiPM-based hadronic endcap calorimeter

To cite this article: Federico De Guio and on behalf of the CMS Collaboration 2019 *J. Phys.: Conf. Ser.* **1162** 012009

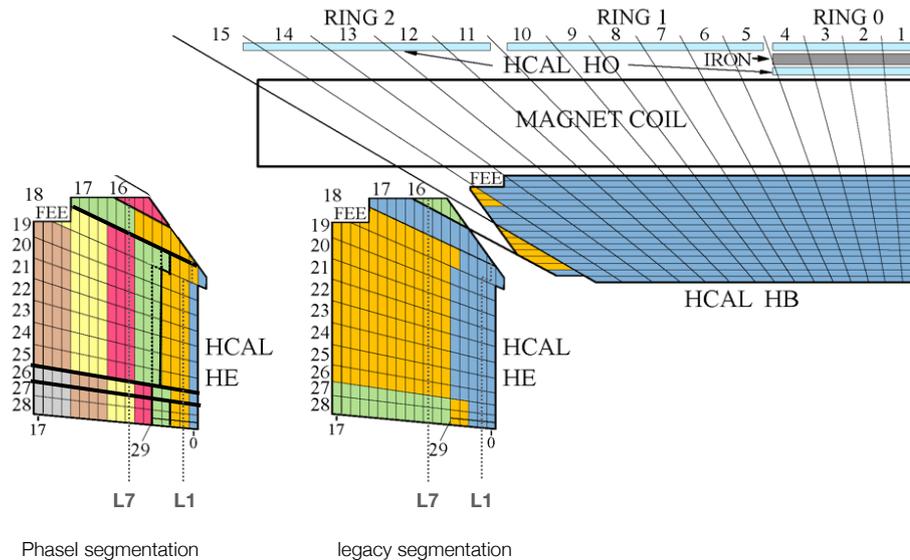
Figure 1. Longitudinal section of the HB, HE and HO detectors. The segmentation of the upgraded HE (left) is compared with the one for the legacy detector (right).

During the 2016-17 extended year-end technical stop, four of the Hybrid Photo Diodes (HPDs) in the HE (sector HEP17, covering a $\Delta\phi = 20^\circ$ wedge and the entire HE pseudorapidity range in the positive z hemisphere) were replaced with Silicon Photomultipliers (SiPMs) as part of a first stage of the HE Phase-1 front-end upgrade. The new photodetector brings many advantages and among those a $\times 2.5$ higher photo detection efficiency (PDE) and a $\times 400$ higher response that allow for mitigation of scintillator radiation damage and to read out the channels with an increased longitudinal granularity (up to 7 depths, Fig. 1).

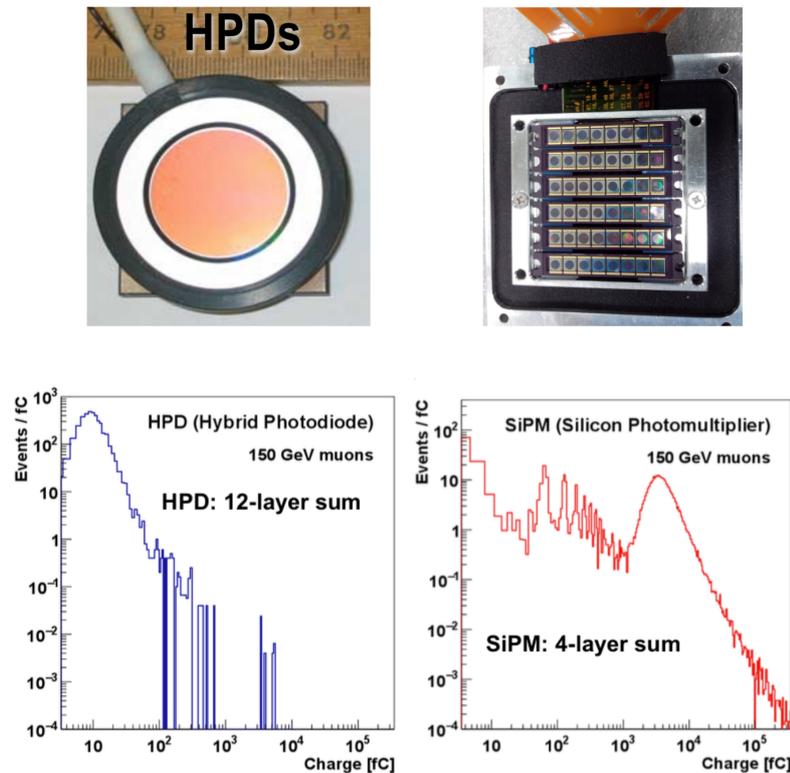
Figure 2. Top left: picture of an HPD. Top right picture of a SiPM. Bottom: energy spectrum for 12 (4) layers read out by a HPD (SiPM). Data includes a combination of pedestal and 150 GeV muon data.

The pictures of a HPD and a SiPM sensor are shown in Fig. 2 together with the charge spectrum as measured with the two photosensors at the test beam with 150 GeV muons. Single photoelectron peaks are visible for the SiPM case showing the excellent sensitivity of the upgraded readout to a low amount of light.

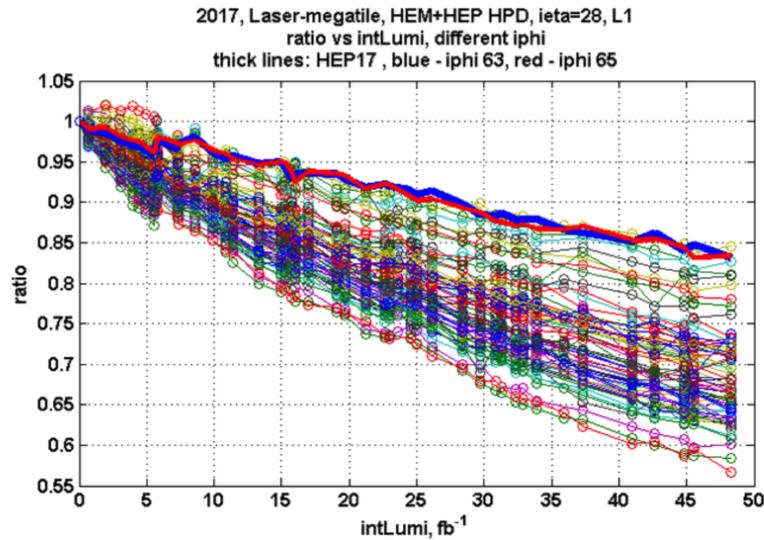
Figure 3. Signal loss in the HE detector (L1, $i\eta = 28$) as a function of integrated luminosity in 2017. The lines represent the response loss of all 72 tiles at different φ sections, and at the same η and layer position. The thin lines correspond to individual tiles read out by HPDs, while the two bold lines correspond to the tiles read out by SiPMs.

The upgraded wedge has allowed to make a direct measurement of radiation damage of HE scintillators read out by SiPMs and compare with the performance from the HPD-based readout. The analysis of the 48.3 fb^{-1} delivered to CMS in 2017 confirms that a large fraction of signal loss in HE, up to 60%, is caused by HPD deterioration instead of being exclusively due to radiation damage of the scintillator. Figure 3 shows the signal loss in the front part and high η region of the HE detector as a function of integrated luminosity in 2017. The lines in represent the response loss of all 72 tiles at different ϕ sections, and at the same η and layer position. Thin lines correspond to individual tiles read out by HPDs, and the two bold lines correspond to the tiles read out by SiPM photodetectors. The figure illustrates that the signal loss for two scintillator tiles read out by SiPMs is smaller compared to scintillator tiles read out by HPDs.

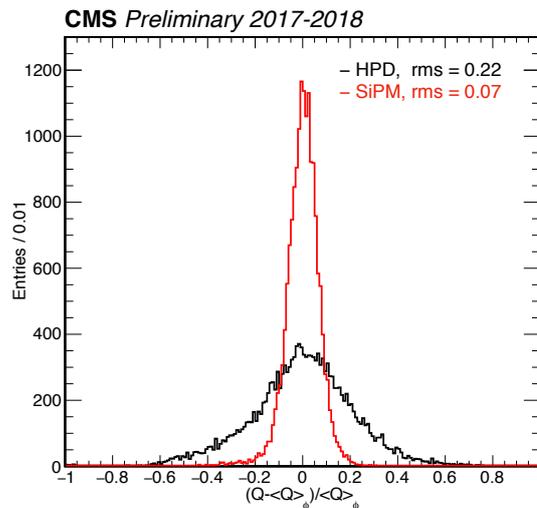
Figure 4. The signal from ^{60}Co wire-source inserted into tubes embedded in HE megatiles is used to compare the relative response of channels at the same η and depth. After the channels readout based on HPDs (black) was replaced with SiPMs (red), a much improved uniformity of the raw response is achieved.

After all the HE channels have been with SiPMs, a much improved uniformity of the raw response along φ has been achieved. This effect is already visible in the data collected while inserting a ^{60}Co wire-source into tubes embedded in HE megatiles during the installation phases of the new sensors (Fig. 4).

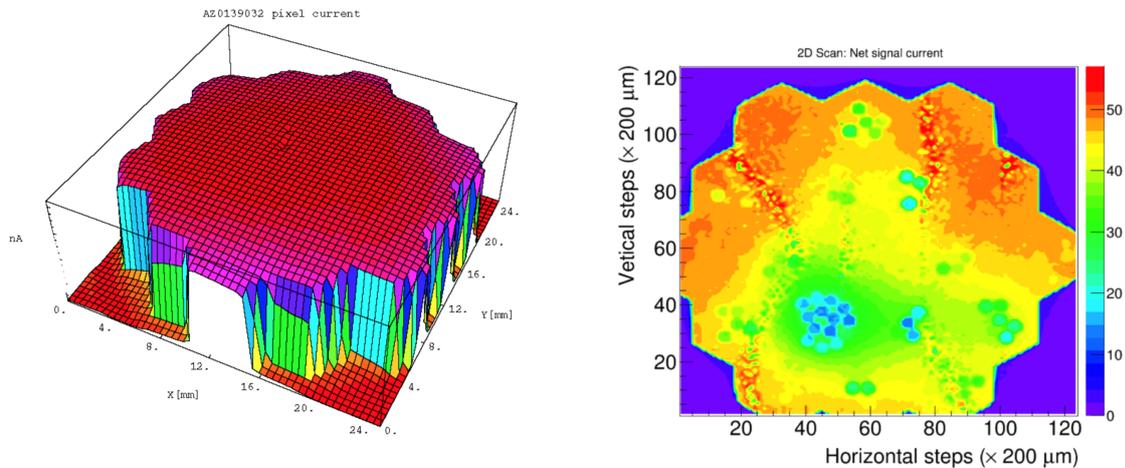
Figure 5. Scan of HPD photocathodes using laser light. The z-axis is proportional to the response of the device. Left: a new HPD scanned before installation on the HCAL detector; the response is uniform across the entire device. Right: a highly damaged HPD extracted from the HE wedge (HEP17) upgraded to SiPM readout in EYETS 2016-17.

Following the removal of HPDs from HEP17, a post-mortem scan with laser light was performed on the photocathode of a highly damaged HPD. The results of the scan are shown in Fig. 5 and compared to a scan performed on a new HPD at the time of detector construction. The response is reduced in a highly not uniform way and, in addition, localized damage spots have appeared at the locations of incoming light from single fibres from the scintillators. This is what should be expected if the damage was caused by ion feedback.

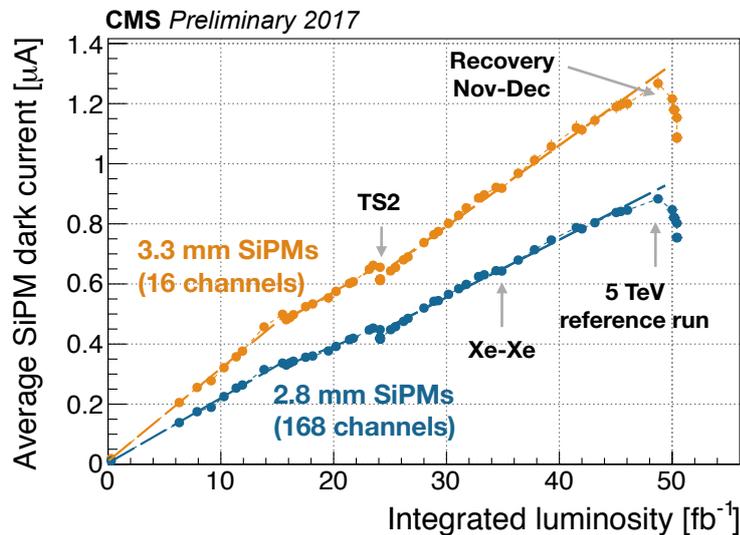
Figure 6. Dark current increases with integrated luminosity with a slope which is proportional to the SiPM area. Deviation from the linear behaviour is due to the recovery time in absence of beam and variation in instantaneous luminosity. The evolution of the dark current in 2017 is shown.

Two parameters of each SiPM channel have been monitored regularly during the year. On one side the gain was checked to assess the stability of the response making sure that it is not subject to unexpected drifts. The measurement of the distance between single photo-electron peaks in pedestal runs confirmed the gain stability at the 1% level for all channels. On the other side the amount of dark current, which is expected to increase as a function of the integrated luminosity with a slope which is proportional to the SiPM area (Fig. 6), was also monitored. At the end of 2017 the level of noise for SiPMs was measured to be ~ 35 MeV, very low if compared to the typical HPD noise which is instead ~ 300 MeV in the HCAL endcaps (Fig. 7). By the end of

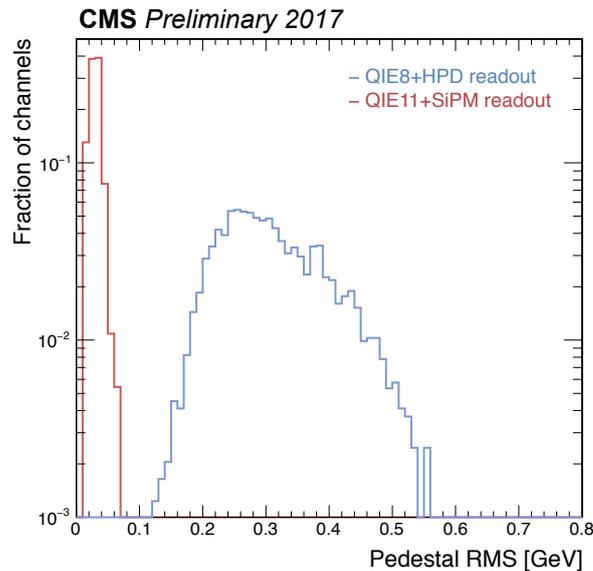
Figure 7. The RMS of the pedestal integrated in a 50 ns window is compared for channels with QIE11+SiPM readout (red) and channels with QIE8+HPD readout (azure). A pedestal run collected at the end of 2017 is used.

the LHC Run3 (500 fb^{-1}) when the endcaps of the CMS will be dismantled, the noise in HE due to the increase dark current is expected to be slightly above 100 MeV.

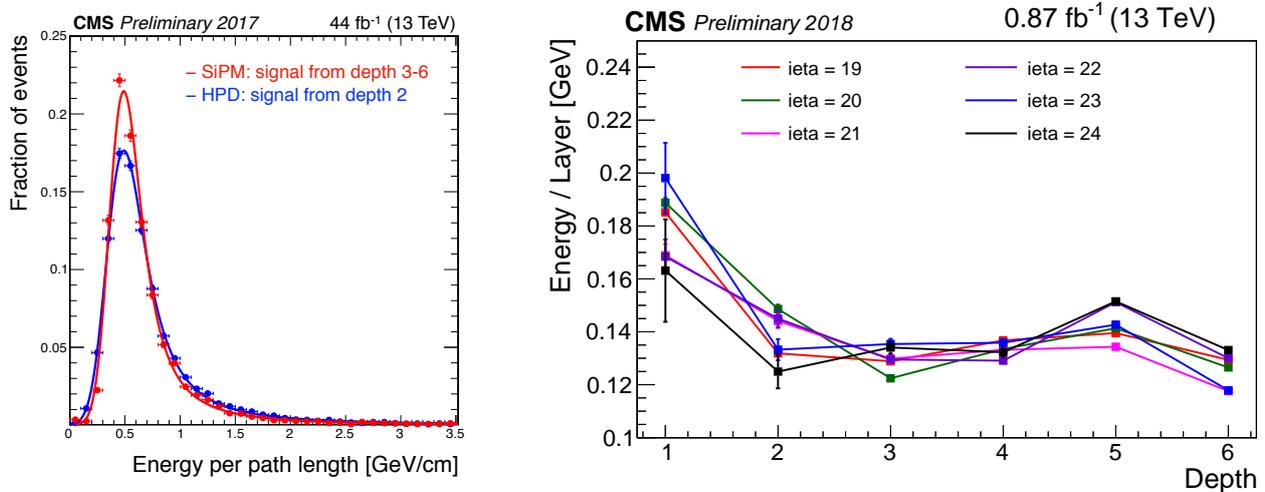
Figure 8. Left: the reconstructed muon signal from collision events in a HE tower readout via SiPM ($\eta=24$, $\phi=63$) is compared with the signal from a tower readout via HPD ($\eta=24$, $\phi=63$). The signal is divided by the muon track length in the active material. Right: Muon deposits in HE towers for different η regions and depths. Muons from collision events are considered when their track traverses the HCAL while remaining within the same tower. The muon signal peak is fitted with the convolution of a Gaussian and a Landau. The Landau location parameter is divided by the number of scintillator layers in the considered depth.

the energy deposited in the HE by muons that traverse the scintillator tiles can be used to inter-calibrate the response of different depths. Muon tracks are reconstructed in the inner and outer tracking system of CMS and extrapolated to the front and back layers of the HCAL using momentum and B-field information. Tracks that go through HE while remaining into the same tower are selected and the energy spectra are fitted using a gaussian and landau convolution function with the mean of the gaussian to be zero. The landau location parameter is used as the most probable value for the muon energy deposit in the HCAL depths and it is found to have a negligible dependence on the muon momentum in the range of the selected muon sample. In Fig. 8 the reconstructed muon signal from collision events in a HE tower readout via SiPM is compared with the signal from a tower readout via HPD (left). A clear improvement in the resolution of the reconstructed muon peak is visible thanks to the upgraded readout. To be kept in mind that, due to the increased longitudinal segmentation of the upgraded detector, the same portion of scintillator material read out by a single HPD channel, is readout via 4 SiPMs. The measured amount of energy per layer as a function of the depth number is also shown (right) and corresponds roughly to ~ 5 pe/MIP/layer as measured at the test beam. To be mentioned that the HE detector has a constant sampling fraction for depth 2 to depth 6, while the amount of passive material in front of depth 1 is larger.
