Moisture related challenges in the Greenlandic building sector – results from a survey

To cite this article: E J de Place Hansen 2021 *J. Phys.: Conf. Ser.* **2069** 012072

E J de Place Hansen

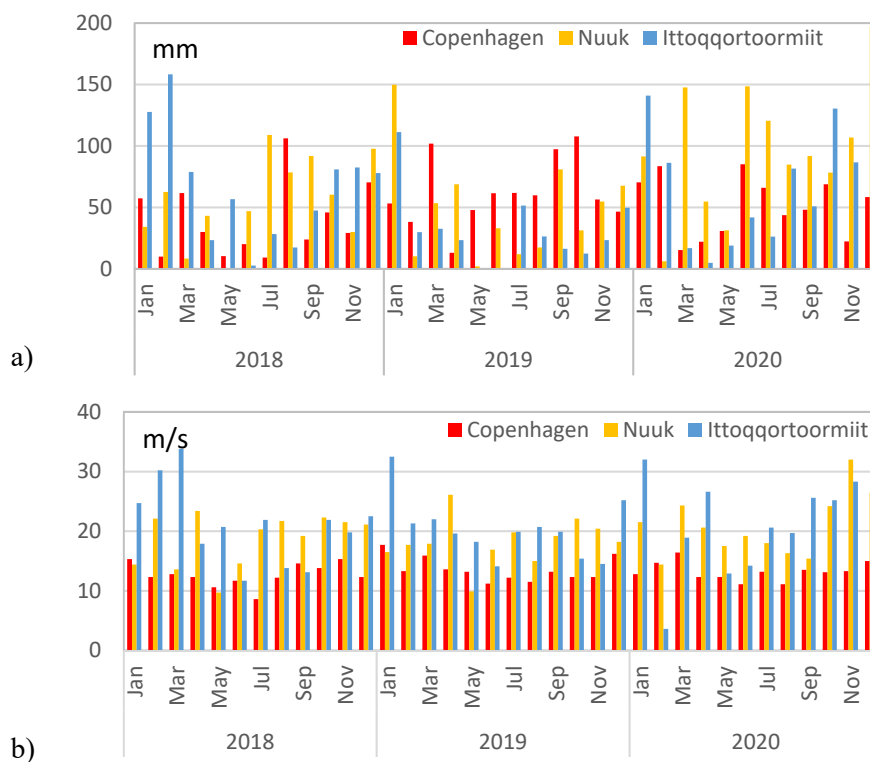
Figure 2. Precipitation [mm] (a) and wind speed [m/s] (10 minutes maximum) (b) in Copenhagen, Nuuk and Ittoqqortoormiit. Monthly average values for a 3-year period (Jan 2018 – Dec 2020) to illustrate variations. [2].

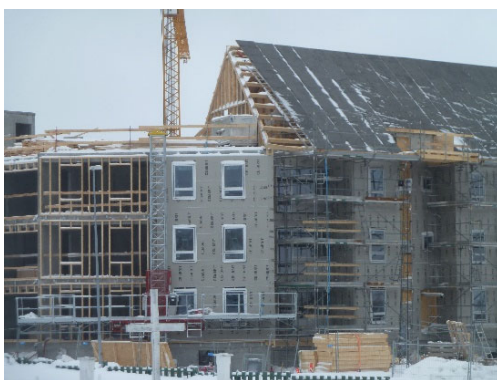
Figure 3. Multi-storey building with wood-based facades before and after installing wind barrier, and wood-based roof construction with roofing felt.

Solutions that do *not* work were very much related to not having designed the construction towards the weather conditions, including high rain load (esp. in the southern part of Greenland) and heavy wind. In the case of wood-based facades, widely used in Greenland (Figures 3 and 4), it was pointed out that the cladding was often not sufficiently tight which means that the wind barrier became heavier exposed than expected. As an example, one of the respondents experienced wind barriers not being properly air tight, either due to the material itself or the joints. Cold wind could then enter further into the construction, eventually reach the vapour barrier and giving rise to condensation on the interior side. A vapour barrier was regarded by the respondents as vital to avoid moisture entering the building envelope and to avoid outward bound convection, lowering the effect of the installed insulation.

As Greenland consists of cities with more than 1000 inhabitants living in multi-storey buildings constructed as shown in Figure 3 and small villages with about 50-100 inhabitants mainly living in wooden houses (Figure 5a), guidelines targeted at these two types of buildings might be the most important task to carry out. The results from this survey might not be surprising, but it has not been systematically documented at this scale before. At present, following the setup of GBR (Section 2), guidelines should be quite specific and explainable, however not too rigid as this risks to counteract innovation. This is considered more relevant to introduce than a complex guideline as the Danish [6] that even might not be used, as seems to be the case in Denmark.

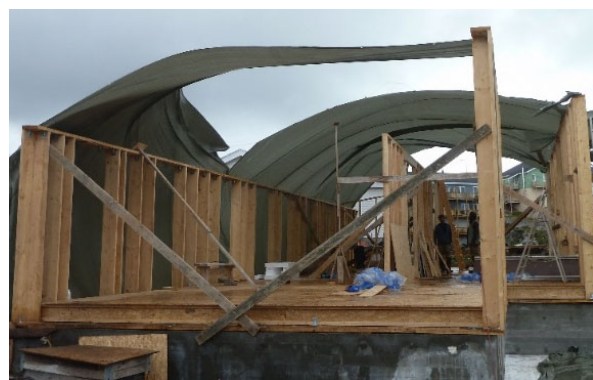
Figure 4. Windy conditions at building site during summer.

in Greenland. Even a simple cover can be a challenge (Figure 4). After closing the building envelope, and before installing thermal insulation, the building is heated by means of diesel generators to get rid of the built-in moisture as the natural drying potential in Greenland is quite limited; a time-saving but also expensive and not CO₂ friendly method.

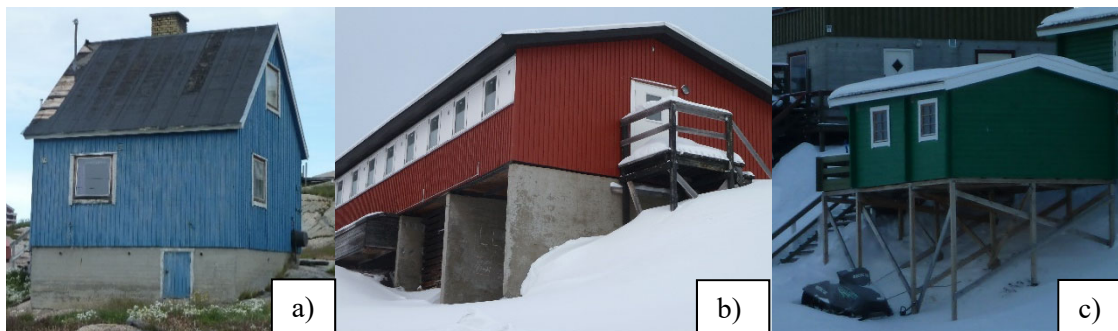
Figure 5. Different ways to support buildings in Greenland, a) a closed in-situ casted concrete construction with openings for ventilation, b) a partly open concrete construction, c) a wooden construction, leaving the floor construction fully exposed.

As most buildings in Greenland are placed on sloping terrain, often directly on rock surface, crawl spaces are very common in Greenland, this also reduces the risk of flooding, and avoids a cold lower floor [10]. The crawl space is closed either by in-situ concrete (Figure 5a) or a wooden frame covered with boards of a non-organic material. In other cases, the building is supported as shown on Figure 5b and 5c. This allows for water and melting snow to pass below the building, which is relevant in areas with high rain load or a lot of snow.
