Long-term operation of the multi-wire-proportional-chambers of the LHCb muon system

To cite this article: F.P. Albicocco *et al* 2019 *JINST* **14** P11031

ABSTRACT: The muon detector of LHCb, which comprises 1368 multi-wire-proportional-chambers (MWPC) for a total area of 435 m², is the largest instrument of its kind exposed to such a high-radiation environment. In nine years of operation, from 2010 until 2018, we did not observe appreciable signs of ageing of the detector in terms of reduced performance. However, during such a long period, many chamber gas gaps suffered from HV trips. Most of the trips were due to Malter-like effects, characterised by the appearance of local self-sustained high currents, presumably originating from impurities induced during chamber production. Very effective, though long, recovery procedures were implemented with a HV training of the gaps in situ while taking data. The training allowed most of the affected chambers to be returned to their full functionality and the muon detector efficiency to be kept close to 100%. The possibility of making the recovery faster and even more effective by adding a small percentage of oxygen in the gas mixture has

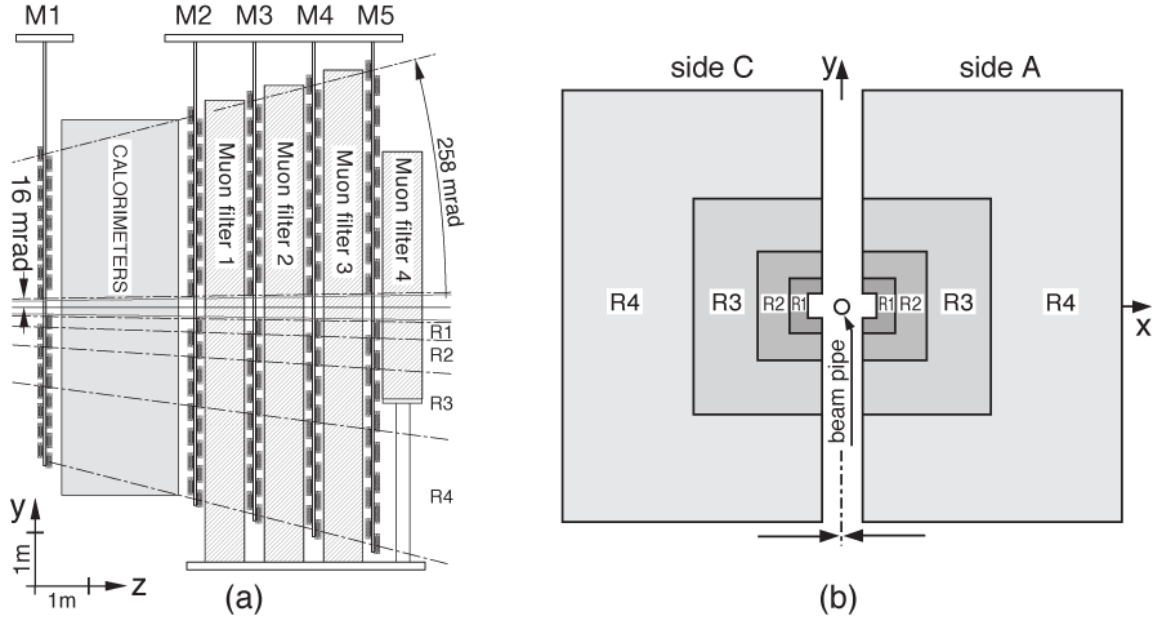
Figure 1. (a) Side view of the LHCb muon detector. (b) Station layout with the four regions R1–R4 indicated.

The muon detector of the LHCb experiment [1, 2] consists of five stations M1–M5, placed along the beam axis. Station M1 is located in front of the calorimeters and is used to improve the measurement of the muon transverse momentum for the first level trigger. Stations M2–M5 are placed behind the hadronic calorimeter and are interleaved with iron absorbers to select penetrating muons. As shown in figure 1, each station is divided into four regions R1–R4. The area of these four regions scales, from R1 to R4, with the ratios 1 : 4 : 16 : 64, while the irradiation per unit area decreases. In total, the muon detector is equipped with 20 types of chambers, varying mainly in size. MWPCs are used everywhere, with the exception of region R1 of station M1, where triple-GEMs [6] were adopted due to the higher irradiation.

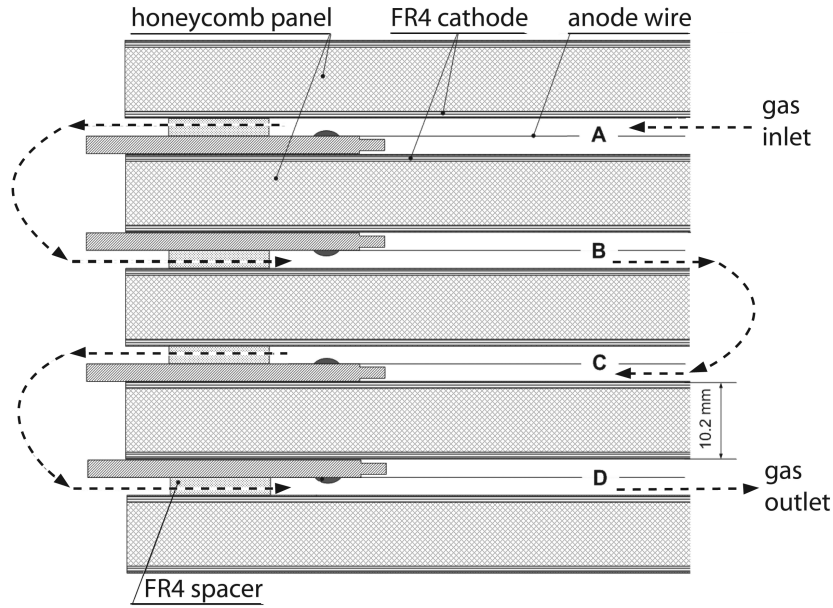
Figure 2. Cross section of a MWPC with four gaps indicated by A, B, C and D. The direction of the gas flow is shown by the dashed lines. On the detector, a maximum of 8 MWPCs are connected in series on the same gas line, for a total internal flux from 3 to 16 gas volumes per day, depending on the detector region. It should be noticed that the Muon gas system works in closed loop, recirculating typically 90% of the gas.

Despite their different dimensions, each chamber has the same internal geometry apart from the number of gaps, as shown in figure 2. Anode planes are centered inside 5 mm gas gaps and are formed by $30 \mu\text{m}$ diameter gold-plated tungsten wires, with 2 mm spacing. The cathodes are made of FR4 fiberglass plates with two-sided $35 \mu\text{m}$ thick copper coating. In regions R1–R3 the cathodes have an additional gold coating of about 100 nm. Adjacent gaps are separated by panels made of honeycomb or rigid polyurethane foam, which provide precise gap alignment over the whole chamber area. The MWPCs in stations M2–M5 have four gaps, while station M1 is equipped with two-gap MWPCs, giving a total instrumented area of about 1650 m^2 (counting each gap separately).

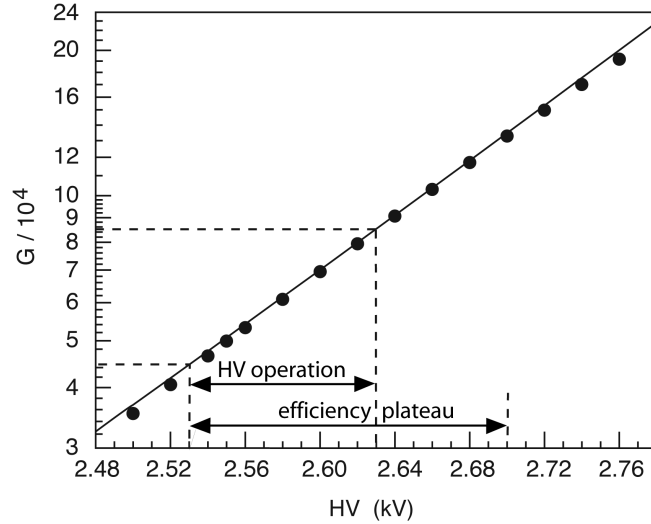
Figure 3. Gas gain as a function of HV setting in the LHCb muon MWPCs. The efficiency plateau and the HV operation range are indicated.

presence of CF₄ helps the initial cleaning of the electrode surfaces and prevents the formation of Si deposits during MWPC operation. It is also a benefit to suppress ME currents, as it has been verified in the tests of chambers conditioning before installation, as described in section 2.1. The gas mixture is supplied into the gaps sequentially, as shown in figure 2. The HV settings, within the detector efficiency plateau, vary between 2.53 and 2.63 kV. The corresponding gas gain ranges between 4.4×10^4 and 8.6×10^4 , as shown in figure 3 [8].

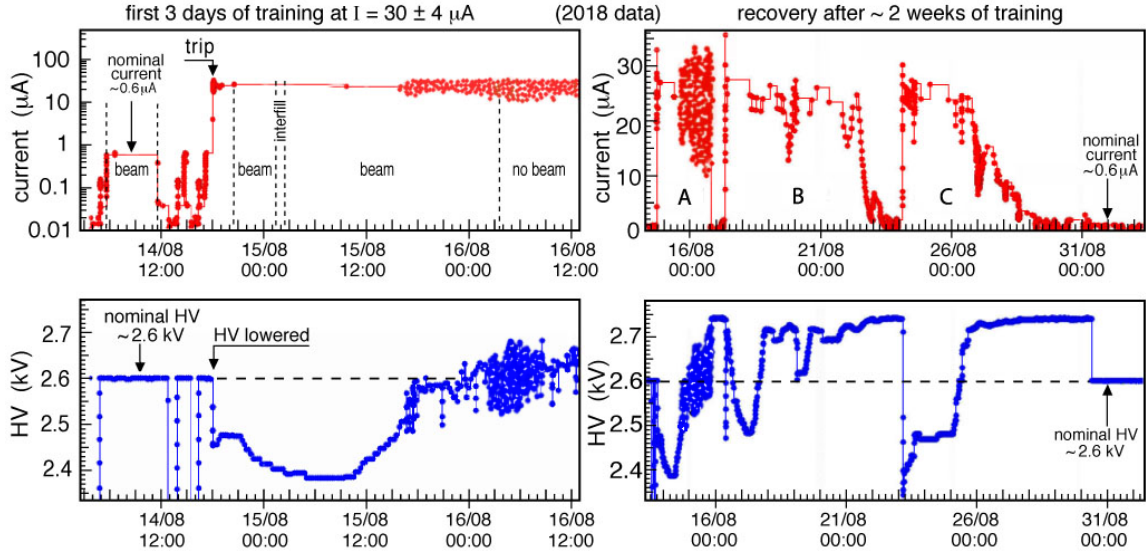
Figure 4. A typical example of the appearance of a self-sustained current and of the recovery procedure during normal LHCb operation with beams. The data refer to a gap in region M5R3. The plots on the left show the current (top) and HV setting (bottom) during a period of about 3 days around the first appearance of the HV trip and the subsequent start of HV training. The plots on the right show the current (top) and HV setting (bottom) during the full recovery procedure, which lasted about two weeks. The nominal HV setting for this gap is 2600 V; the average current in presence of colliding beams is about $0.6 \mu\text{A}$.

A typical example of the appearance of a self-sustained current, and the recovery procedure implemented in one of the MWPC gaps of the region M5R3 is shown in figure 4. For this chamber type, operating at a nominal voltage of 2.6 kV, the maximum current value in the presence of colliding beams is $\sim 0.6 \mu\text{A}$. As shown in the figure 4 (left), the HV channel powering this gap tripped due to the ignition of a high current exceeding the safety threshold set at $30 \mu\text{A}$. Following the trip, a specially developed algorithm reduces the HV setting, in steps of 50 V, until the measured current is again below the safety threshold. The operator is alerted as well, who then starts the training procedure.

During the training the HV is automatically decreased, or increased up to a limit of 2.75 kV, to keep the current in a range of high but safe values ($30 \pm 4 \mu\text{A}$ in this case). The MWPC is considered recovered when the current at the maximum HV accepted for the training (2.75 kV), drops to the normal value expected at this voltage in presence of colliding beams, and drops to zero in the absence of beams. If the same stable condition is kept for multiple days of operation with beams, the trained gap is put back in normal operation at the nominal voltage. The full recovery cycle for this gap is shown in figure 4 (right). In this particular case, after about two weeks, the self-sustained current definitively dropped down to zero. In more detail, three different cycles of recovery are visible (indicated as A, B and C in figure 4 right). The first cycle was completed in about three days, then a self-sustained current due to ME was initiated again in the presence of colliding beams, and the HV had to be reduced accordingly. The second cycle lasted for about one week, but at the end, the high current appeared again. Only after a third training period of about one week, the gap was fully recovered. The most probable explanation of this complex phenomenology is the subsequent appearance of ME in three different local regions in the gap. The probability to initiate a high current in the gap under recovery is much higher than under normal conditions, because of the higher voltage applied during training (2.75 kV), which provides a gas gain about three times larger than under nominal conditions (2.6 kV). The increased current of positive ions toward the cathode can then generate new zones where the thickness of a dielectric deposit no longer permits the full current flow from the film surface to the underlying cathode, causing an electric field sufficient to generate spontaneous secondary emission of electrons (see appendix A).

The gap taken as an example in figure 4 was recovered in a relatively short time. The average duration of the training procedure is about two months, and in some cases it required up to four months for the full recovery. Due to that, at the end of each year of operation, we concluded with up to 25–30 individual gaps under recovery procedure at the same time. It is worth noting though, that during this long training period, the detector efficiency is only marginally affected because the other gaps of the chamber, OR-ed in the readout, are operated at the standard conditions. Moreover in the gaps under training, a sufficiently high voltage is kept for most of the time and most of the readout channels remain efficient, since the high current concerns only a localized area. For these reasons we have never been able to measure any appreciable efficiency reduction during training.

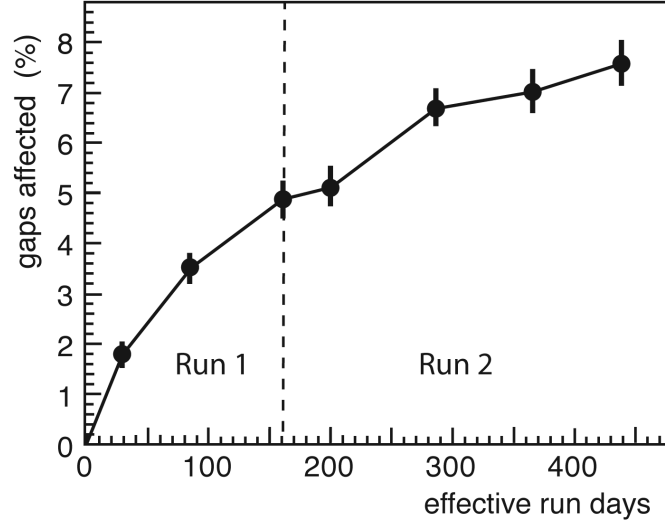
Figure 5. Accumulated fractional number of new trips observed in the detector, normalized to the total number of gaps (4944), as a function of the total number of effective run days integrated between 2010 and 2018. The values are evaluated at the end of each year of data taking. Errors are statistical.

In figure 5 the cumulative number of MWPC gaps affected at least once by HV trips, normalized to the total number of gaps (4944), is shown as a function of the total number of effective run days integrated between 2010 and 2018. The percentage of gaps affected after nine years of operation is below 8% which reflects the high quality standards maintained during the chamber construction. The 375 gaps affected are distributed over 259, out of the 1368 MWPCs, demonstrating that most of the time only a single gap in a chamber is affected by ME. Figure 5 shows also that the curve is flattening out over the years of system operation.

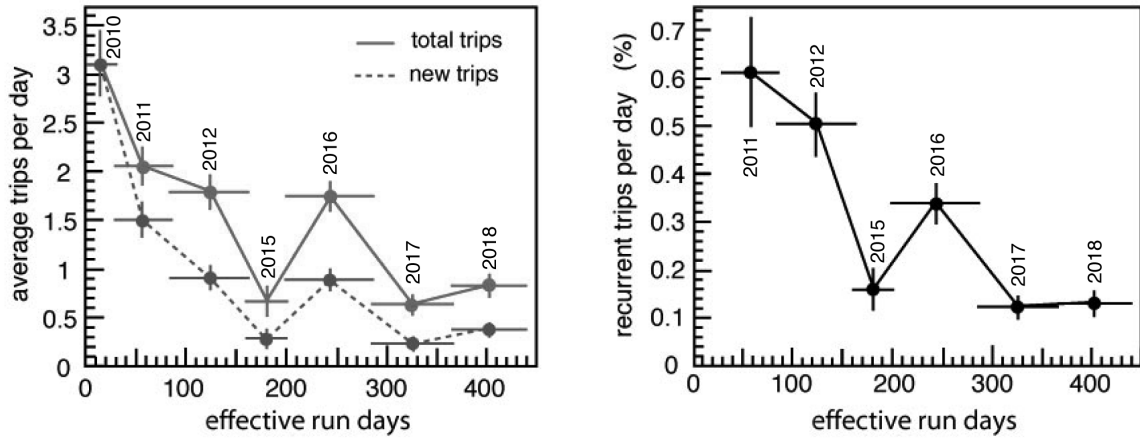
Figure 6. Left: average number of trips per day observed during each year of data taking, as a function of the total number of effective run days integrated between 2010 and 2018; the total number of trips is shown in red (full line), the number of new trips in blue (dotted line). Right: average number of recurrent trips per day observed during each year of data taking normalized to the total number of gaps already tripped in the past (points are evaluated starting from 2011). Errors are statistical.

The average number of affected gaps per day observed during each year of data taking is reported in figure 6 (left) for all gaps and for the ones affected for the first time. First of all we notice that the number of gaps with recurrent trips is much higher than expected by a random effect, given the very small percentage of gaps concerned. We also notice a decreasing trend of new trips, suggesting causes originating from the construction phase rather than from ageing or other possible problems occurring during the run. An exception to the decreasing trend is observed in the 2016 run, when we suffered from a sharp increase in the trip frequency, due to a sudden significant increase of the chamber gas gain. The cause could not be fully explained, but seems to be linked to a temporary unwanted change of the gas mixture. We notice also that the two minima of the trip frequency correspond to the two runs (years 2015 and 2017) in which the peak luminosity (and thus the chamber currents) did not exceed the values reached in previous years.

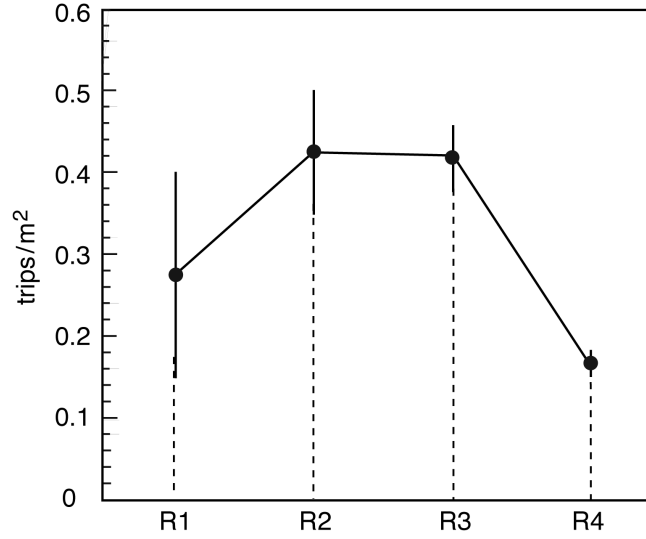
Figure 7. Number of HV trips in each region of the detector, normalized to the total instrumented area in the region, with statistical error.

In figure 7 the total number of HV trips per square meter of the detector active area, occurred in 10 years of operation, is shown separately for the four regions exposed to a particle flux per unit area strongly decreasing from R1 to R4. Despite the large statistical errors affecting the values in regions R1 and R2, based on 5 and 33 events respectively, the expected decrease with the radiation dose from region R1 to R3 seems to be contradicted. This is certainly due to the different treatment to which the chambers have been subjected. In particular, as discussed in section 2, most of the chambers of the inner regions R1 and R2 passed before installation through an additional step of the training procedure under irradiation at the GIF, which strongly reduced the trip probability during the following runs at LHC. Conversely the drop of trips in region R4, as compared to region R3 seems to follow the expected behavior, given by the reduced irradiation. In this case however, the observed trend could also be influenced by the better initial cleaning of the R4 gaps as mentioned in section 2.1.

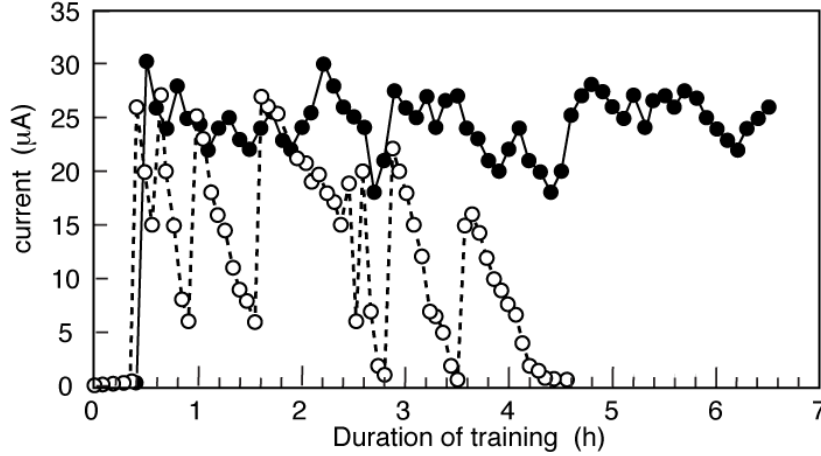
Figure 8. Current in the MWPC during the ME recovery training: nominal mixture (full circles) is compared with a mixture containing 2% of oxygen (open circles).

For each of the above zones, a recovery training as the one described in section 3 was first tried for few hours with the standard gas mixture in order to confirm what was observed on the apparatus. Then a new training was performed with a new gas mixture, adding $\sim 2\%$ of oxygen to the nominal one. In all cases the concerned area was kept under irradiation by the ^{90}Sr β -source. Figure 8 shows the results obtained for one of the gaps. With the standard gas mixture no current decrease is observed after more than 6 hours, consistent with what was obtained in the training with colliding beams. In the presence of oxygen, however, the initial current of $25\text{ }\mu\text{A}$ (initiated at the voltage of $2.6\text{--}2.7\text{ kV}$) drops sharply until it rises again in correspondence with a voltage increase carried out to maintain a high current level. After a few iterations the current finally drops to zero. The total time required to recover the ME zone in this case was around four hours. Similar results were obtained for all zones affected by ME, as listed in table 3. After the training with oxygen, all of the MWPCs above have been installed back on the apparatus and worked properly, with no recurrent trip during the full Run 2 of the LHC.

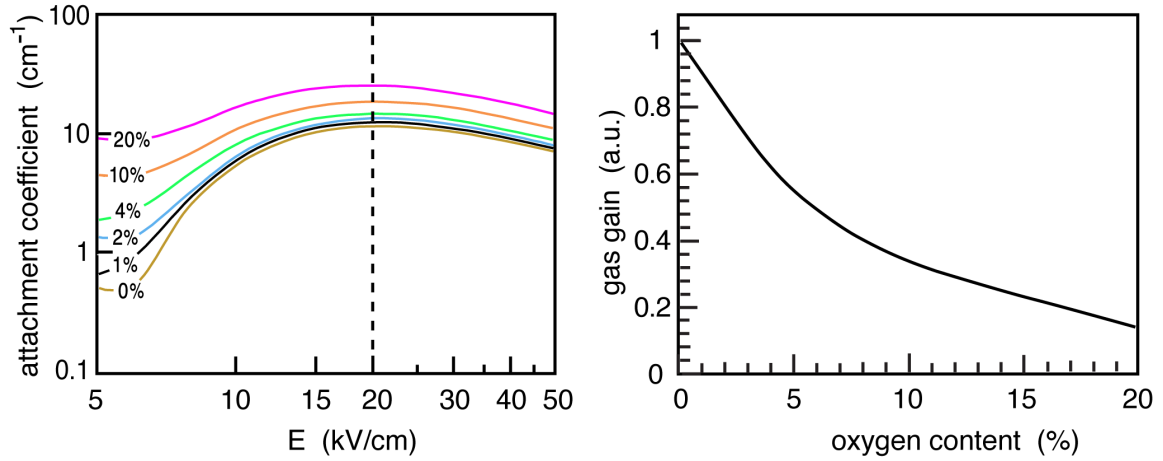
Figure 9. Left: electron attachment coefficient as a function of the electric field strength. Right: the gas gain as a function of the oxygen content.

To find the optimal amount of oxygen to be added to the working gas mixture, simulation studies for the muon detector MWPCs have been performed using the GARFIELD software package [20]. The results of the simulation are shown in figure 9. The electron attachment coefficient as a function of the electric field strength is shown in the left plot. The right plot shows the gas gain dependence on the oxygen content, where the latter is added to the standard 40% Ar + 55% CO₂ + 5% CF₄ gas mixture.

As a result, for 1–4% O_2 content the electron attachment coefficient increases substantially only in the drift region, especially near the cathode surface, where the electric field strength is about 6 kV/cm. Conversely, when oxygen content exceeds 10%, a noticeable electron attachment occurs throughout the whole drift path and the avalanche region. As a result, the MWPC gas gain at the operation voltage would drop by more than 60%, too much to be compensated by an increase of HV sufficient to support an effective etching process. In the test of accelerated recovery of the MWPCs a percentage as small as $\sim 2\%$ of oxygen was added to the nominal gas mixture and satisfactory results were obtained.
