## Prevention and control measures for coastal erosion in northern high-latitude communities: a systematic review based on Alaskan case studies

To cite this article: Min Liew *et al* 2020 *Environ. Res. Lett.* **15** 093002

# Environmental Research Letters

## Topical Review

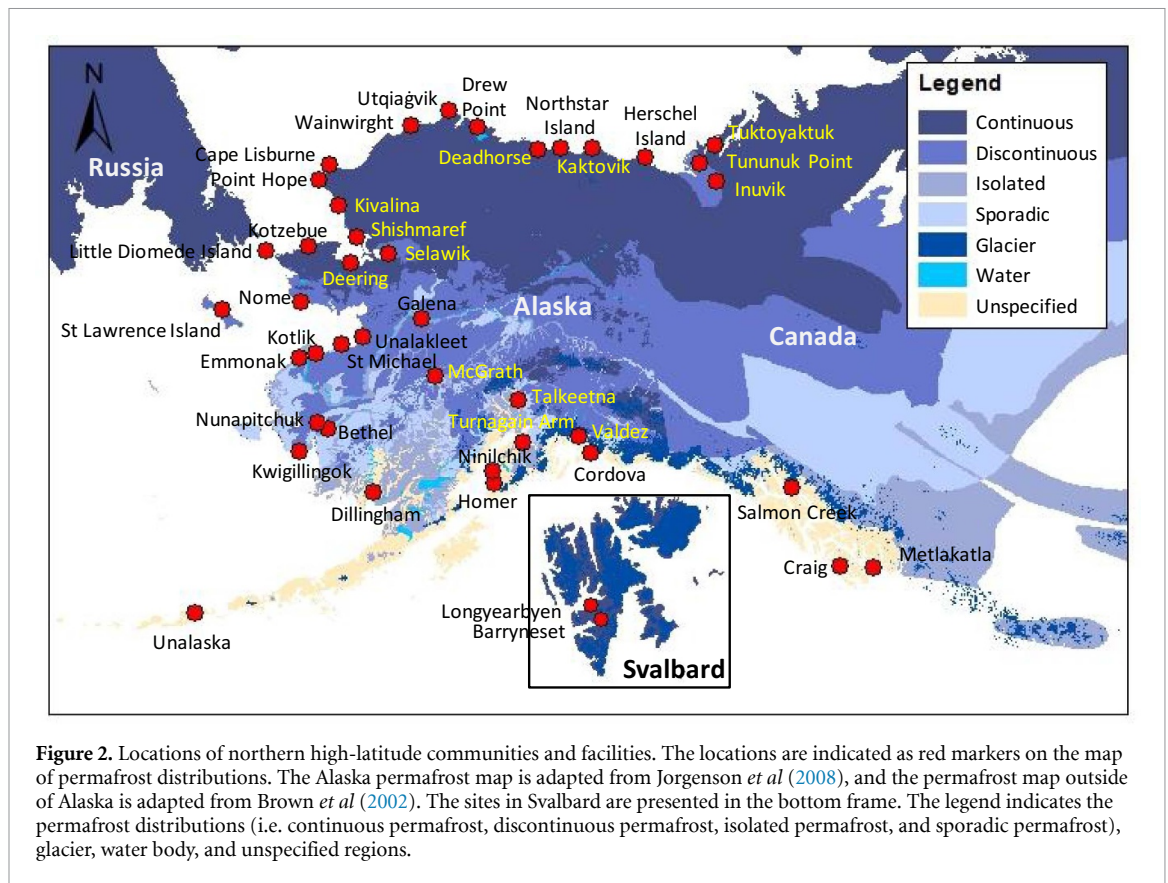
All structural erosion control measures presented in this article are classified into several categories as shown in figure 1. Two major categories are (A) techniques that are currently employed on northern high latitude coasts and (B) techniques that are not yet tested on northern high latitude coasts. Sub-categories that follow Categories A and B are techniques that have been implemented (1) in full scale, (2) in small-scale research projects or physical models, (3) in laboratories or numerical models, and (4) in small scale non-engineered projects. In this study, a structure is considered failing when it has been destroyed or displaced by environmental impacts (e.g. wave impacts, surges, sea-ice impacts, and permafrost thaw) and the repair would cost more than replacement. Another failure type refers to the ineffective measures where erosion exceeds the expected or predicted rates of erosion. A successful case refers to a measure that is not damaged or only slightly damaged when the encountered storm events are less severe than or equally severe to the design events. A measure is also considered successful if it is able to slow down or prevent erosion within the period of its designed service life when compared to adjacent sites with no coastal protection.

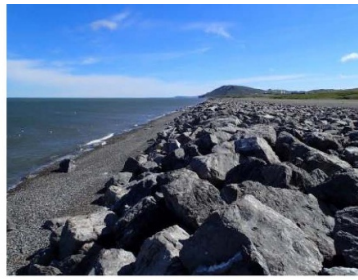
(a) Rock revetment  
(Cape Lisburne, Alaska)

latitudes as presented in supplementary table S2. The materials include rocks (figure 3(a)), sandbags (figure 3(b)), articulated concrete mats (figure 3(c)), Core-loc<sup>TM</sup> units, timbers, and gabions. Among all materials, revetments built with rocks have been implemented and tested in the harsh Arctic environment and were observed to have fewer failure cases. Revetments built with sandbags have also been proven effective as temporary and semi-permanent measures. USACE (2009c) has conducted physical models to further optimize the stability of revetments built with sandbags. In general, revetments usually require maintenance throughout their service life as they can be easily displaced and destroyed during storm events or by sea-ice floes. Despite this limitation, revetments are preferred over seawalls, bulkheads, and other offshore structures due to the low costs and easy construction, inspection, and decommissioning (USACE 2018).

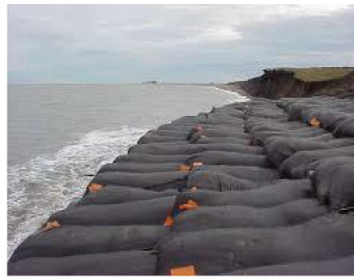
(b) Revetment using sandbags  
(Kaktovik, Alaska)

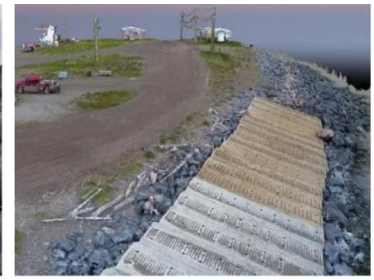
(c) Revetment using  
articulated concrete mats  
(Tuktoyaktuk, N.W.T.)

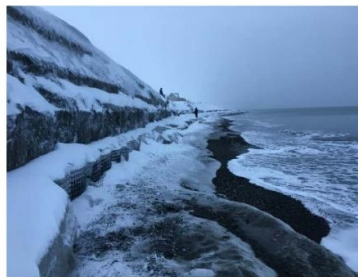
(d) Seawall using gabion  
baskets with rocks  
(Utqiagvik, Alaska)

Seawalls (figure 3(d)) and bulkheads (figures 3(e)–(f)) have also been constructed in northern high-latitude coastal communities. Similar to revetments, bulkhead and seawalls protect permafrost bluff faces from the development of niches, a critical stage in shoreline collapse (Hoque and Pollard 2009, USACE 2018). For bulkheads, only one successful case using vertical sheet-piles is found in the literature review (USACE 2009a). Bulkheads made of Longard tubes<sup>TM</sup> and pipe-piles were easily subjected to vandalism (Shah 1982) and excessive deflection

(USACE 2007a, 2009d), respectively. Whereas, one successful case using a seawall made of logs is found to be effective in mitigating fluvial erosion where the crib walls were constructed (USACE 2007h). Seawalls made of gabions were not as effective due to potential sagging and settlement (USACE 2009b); while seawalls made of sheet-piles were not cost-effective, for example, a sheet-pile wall in a project proposal was estimated to cost more than \$31 million (in 2007 US dollars) for a 1 km long coastline (USACE 2007k). The groin system is a less common option in northern high-latitude coastal communities with only one case study presented in supplementary table S2. Due to their complex offshore construction, groins are especially vulnerable to damage from sea ice (USACE 2018). This paper is unable to identify a successful case study that used groin systems alone to mitigate erosion impacts. The erosion in Tuktoyaktuk in northwestern Canadian Arctic was reduced when the groin systems were installed together with bulkheads (Shah 1982). Similar to groin systems, offshore berms are not preferred at northern high latitudes due to costly and complex offshore construction. This option was once considered in the feasibility report in Kivalina but was eventually eliminated (USACE 2007k). Overall, failures of seawalls, bulkheads, and groin systems are associated with displacement, deflection, settlement, vandalism, and material ruptures as presented in supplementary table S2.

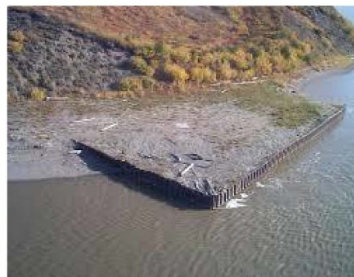
(e) Bulkhead using sheet-  
piles (Tununuk Point,  
N.W.T.)

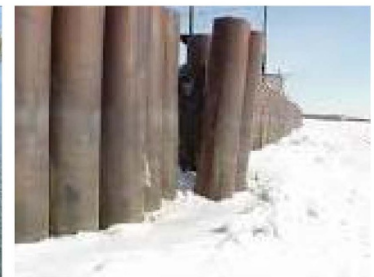
(f) Bulkhead using pipe-piles  
(Bethel, Alaska)

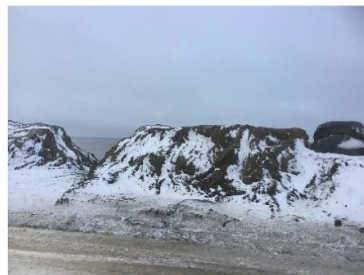
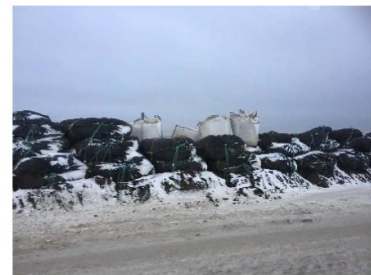
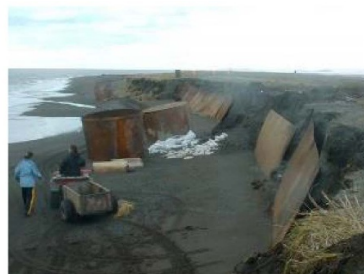
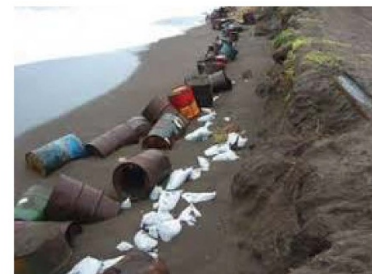
(g) Sand berms  
(Utqiagvik, Alaska)

(h) Sandbags  
(Utqiagvik, Alaska)

(i) Metal scraps  
(Kivalina, Alaska)

(j) Tar barrels/drum  
(Kivalina, Alaska)

**Figure 3.** Various types of erosion control measures that have been employed at northern high latitudes. The photos were all taken at communities in the northern high-latitude regions. Image courtesies of U.S. Army Corps of Engineers, Alaska District (a), (b), (f), Dustin Whalen (c), Alaska Division of Homeland Security and Emergency Management (d), Worley Parsons (e), Millie Hawley (©2005) (i), and Janet Mitchell and Center for a Better Life (j). (g) to (j) are non-engineered expedient measures carried out during emergency.

In the event of an emergency, sacrificial structures have been constructed as expedient measures to minimize the erosion as shown in figures 3(g)–(j). The materials used in sacrificial structures include sandbags, supersacks, ripraps, sand berms, and root-wads. Although the materials are the same as those used in the construction of hard structures, these sacrificial structures are ineffective when they are not properly designed and constructed. When in short supply, these materials are substituted using scrap metal and concrete and other waste materials. Such materials can potentially cause pollution. Based on the case histories presented in supplementary table S2, these measures are often ineffective in preventing or slowing erosion and require maintenance after each storm event (USACE 2007a, 2007d, 2007f, 2007g, 2007j, 2008b, 2018, Jaskólski *et al* 2018) and may sometimes exacerbate the adjacent coastline due to material mining (Carter and Smith 2011). Root-wads and willow planting are the only case histories that have been effective in preventing erosion, but the project is located in Cordova, which is a non-permafrost region of Alaska affected by riverbank erosion as shown in table S2 (USACE 2007a, Smith 2008).

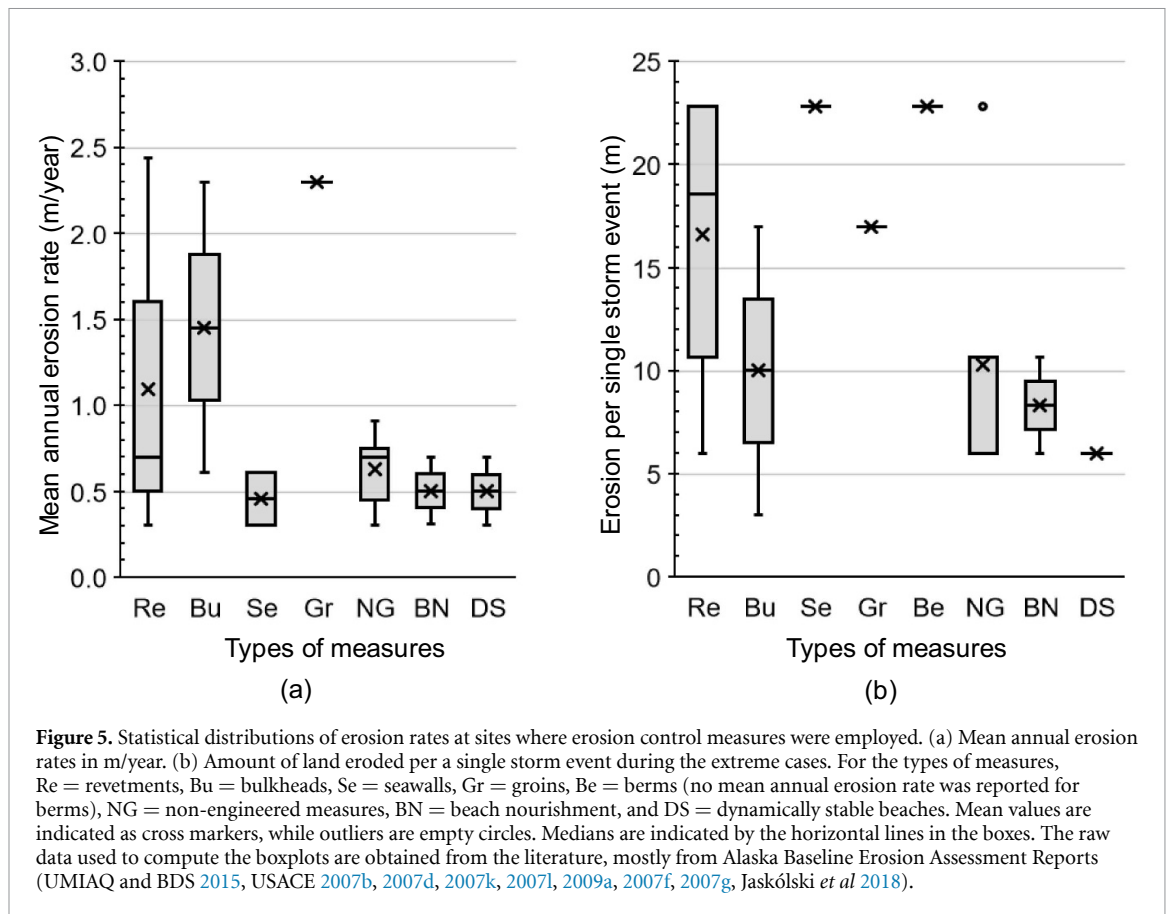
**Figure 5.** Statistical distributions of erosion rates at sites where erosion control measures were employed. (a) Mean annual erosion rates in m/year. (b) Amount of land eroded per a single storm event during the extreme cases. For the types of measures, Re = revetments, Bu = bulkheads, Se = seawalls, Gr = groins, Be = berms (no mean annual erosion rate was reported for berms), NG = non-engineered measures, BN = beach nourishment, and DS = dynamically stable beaches. Mean values are indicated as cross markers, while outliers are empty circles. Medians are indicated by the horizontal lines in the boxes. The raw data used to compute the boxplots are obtained from the literature, mostly from Alaska Baseline Erosion Assessment Reports (UMIAQ and BDS 2015, USACE 2007b, 2007d, 2007k, 2007l, 2009a, 2007f, 2007g, Jaskólski *et al* 2018).

Figures 5(a)–(b) shows boxplots of the mean annual erosion rates and erosion per single storm event reported at sites where the erosion controls were implemented. Numeric data used to generate the plots are included in supplementary table S3. As illustrated in figure 5(a), revetments and bulkheads have been employed for sites with a wide range of mean annual erosion rates (0.3–2.4 m/year). As expected, groin systems, which are an offshore structure, have been employed at sites with high mean annual erosion rates (2.3 m/year); whereas, beach nourishment, dynamically stable beaches, and other non-engineered measures have been employed at sites with low mean annual erosion rates (0.3–0.9 m/year). However, seawalls were employed at sites with low erosion rates (0.3–0.6 m/year). It could be possible that seawalls were constructed in these sites to slow erosion after extreme episodic erosion (figure 5(b)). Similarly, for revetments and bulkheads, the erosion reported per single storm event also ranged widely from 3.0 m to 22.9 m. The episodic events of erosion were at the lower ends for beach nourishment, dynamically stable beaches, and other non-engineered measures (6.0–10.7 m) with an outlier of 22.9 m for non-engineered measures. Seawalls, groins, and berms had been constructed at sites with high episodic erosion (17.0–22.9 m).

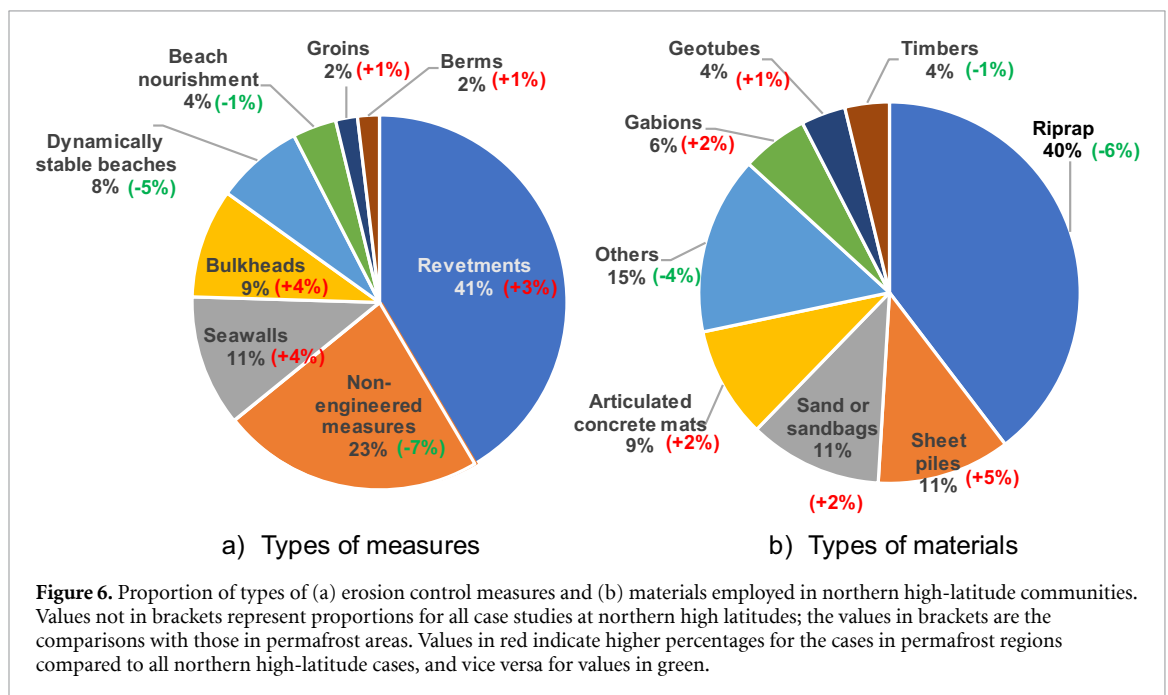
**Figure 6.** Proportion of types of (a) erosion control measures and (b) materials employed in northern high-latitude communities. Values not in brackets represent proportions for all case studies at northern high latitudes; the values in brackets are the comparisons with those in permafrost areas. Values in red indicate higher percentages for the cases in permafrost regions compared to all northern high-latitude cases, and vice versa for values in green.

Figure 6(a) shows the proportion of the types of erosion control measures employed in the northern high-latitude coastal and riverine communities. Based on a total of 53 cases, revetments were most

frequently employed (41%) and non-engineered measures were the second (23%). The measures that came after non-engineered measures are seawalls (11%), bulkheads (9%), dynamically stable beaches (8%), beach nourishment (4%), groins (2%), and berms (2%). Among the 53 cases at northern high latitudes, 38 of them were employed within permafrost regions (including continuous, discontinuous, sporadic, and isolated permafrost). For the rest of the cases ( $n = 15$ ), although they are influenced by northern high-latitude climate, they are located within non-permafrost regions. For the cases in permafrost regions, the percentage of revetments increases to 44% whereas the percentage of non-engineered measures reduces to 16%. Similarly, figure 6(b) shows the proportions of the types of materials. Among all the cases collected in northern high-latitude regions, riprap is the most frequently used material, accounting for 40% of the materials. Sand or sandbags and sheet piles are both the second (11% for each). For cases in permafrost regions, the percentage of riprap reduces to 34%, but both percentages of sand or sandbags and sheet piles increase to 13% and 16%, respectively. The percentage differences between counts in northern high-latitude regions and those in permafrost-affected northern high-latitude regions are indicated on the pie charts in brackets. The percentages of the measures (in table 1, the column ‘Grouped percentages’) computed in this study are compared to those (in table 1; the last column) reported in a survey ‘Alaska Community Erosion Survey’ conducted by USACE (2009f). In this survey (USACE 2009f), the Alaskan coastal communities were asked to indicate the types of materials

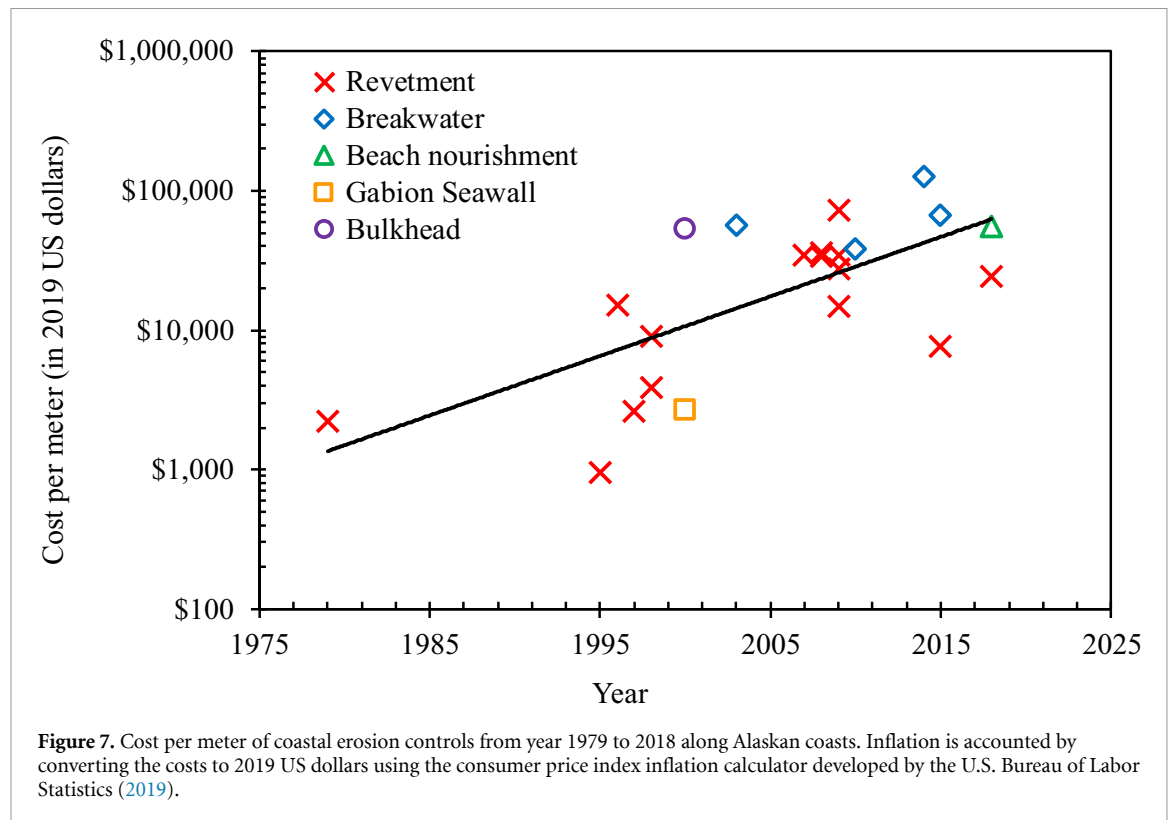
As shown in figure 7, the unit cost has increased (approximately 10% increase per year) in the past four decades. The costs of breakwaters (figure 7, blue diamond-shaped markers) and bulkheads (figure 7, purple circle marker) are above the average cost. The cost of gabion seawall construction is below average and beach nourishment falls on the average cost. Although the estimated cost of the beach nourishment seems to fall within the median range as shown in figure 7, its cost is considerably high when compared to the average cost in mid- to low-latitude regions. For an 8 km shoreline in Utqiagvik, AK (USACE 2018), for example, the initial cost of the beach nourishment was estimated at \$297 431 000 (in 2018 dollars). This results in a cost of approximately \$37 000 per meter for initial construction. However, in mid- to low-latitude regions, the initial construction cost for beach nourishment ranges from only \$6600–\$16 000 per meter of coastline (SAGE 2015). This infers that the initial cost to practice beach nourishment in a northern high-latitude region is at least 2 times the cost needed for a mid- to low-latitude region. Similarly, in mid- to low-latitude regions, the initial construction cost for bulkheads ranges from \$6600–\$33 000 per meter (SAGE 2015). However, the bulkhead in Dillingham, Alaska, which is a northern high-latitude village affected by fluvial erosion, costs about \$53 000 per meter in 2019 US dollars (USACE 2009d). This is equivalent to a cost that is approximately 1.6 to 8 times higher than the cost needed for a similar application at middle to low latitudes.

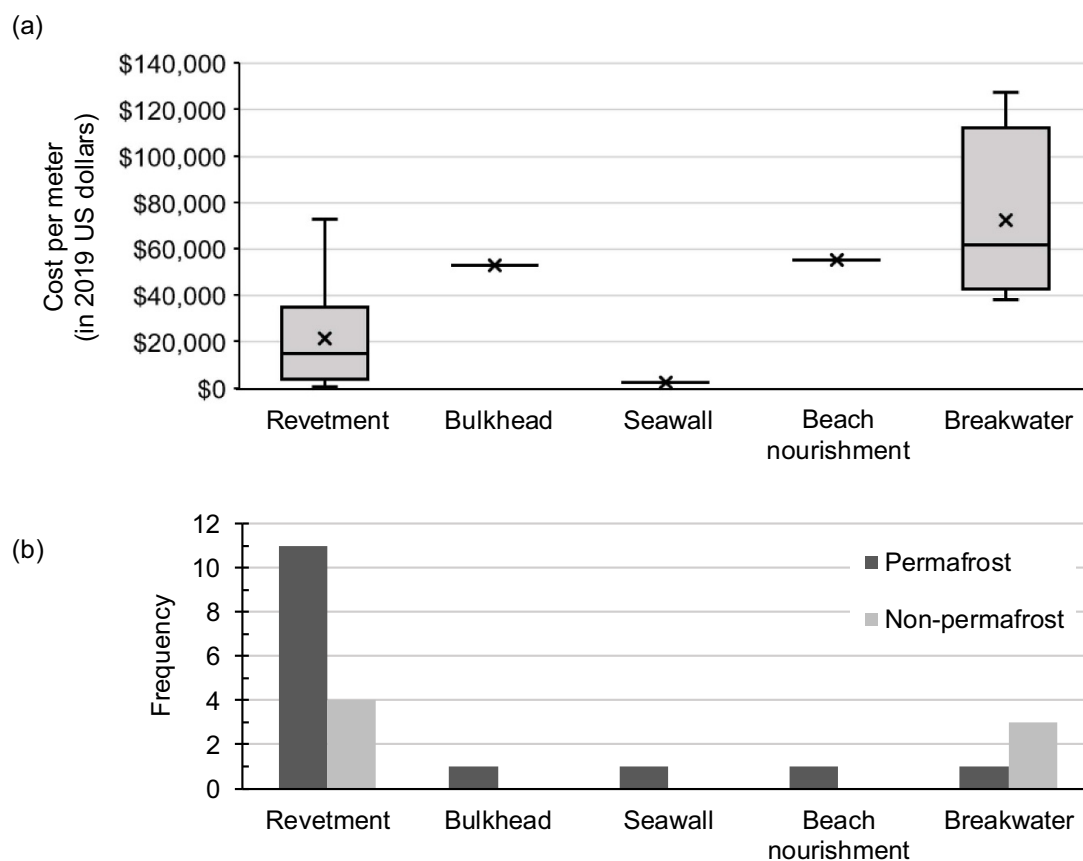
**Figure 8.** Statistical distributions of (a) unit cost in 2019 US dollars and (b) how frequently various types of coastal erosion controls are implemented. For the boxplots, mean values are indicated as cross markers; medians are indicated by the horizontal lines in the boxes. The vertical axis of chart (b) refers to the number of case studies.

A statistical analysis was further performed on the case studies with reported construction cost (figure 8). As expected, breakwater, which is an offshore structure, has higher median cost than the other measures (figure 8(a)). Such trend is much clearer when comparing breakwater to revetment but not the other measures since only one data point is available for bulkhead, seawall, and beach nourishment. The low unit cost of revetments may be one of the reasons that lead to the popularity of revetments (as illustrated by the high frequency of revetment in figure 8(b)) in controlling coastal erosion in Alaska.

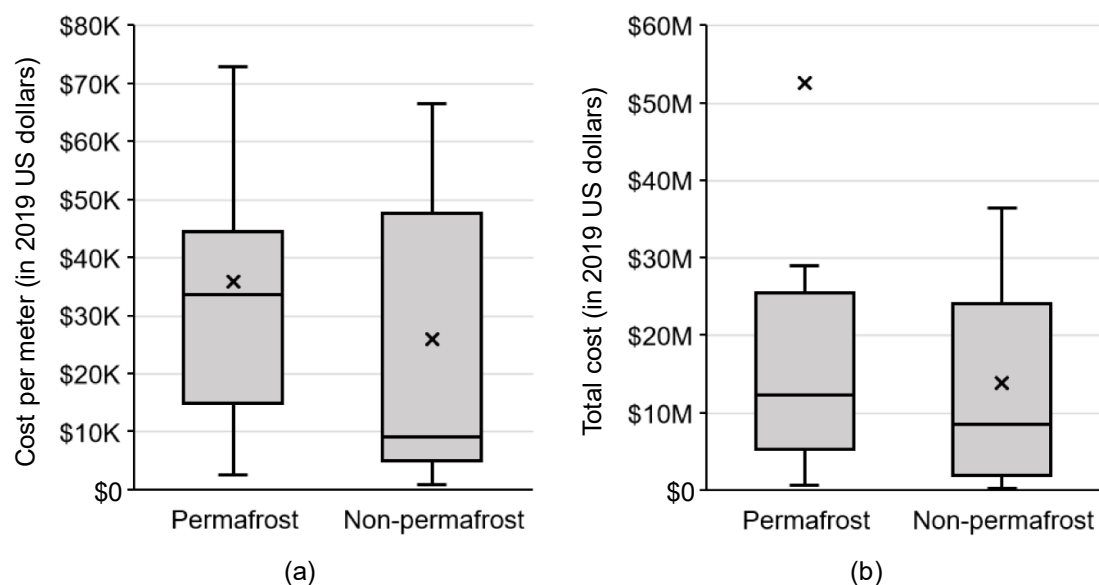
**Figure 9.** Comparison of costs (in 2019 US dollars) of coastal erosion control in permafrost ( $n = 15$ ) and non-permafrost ( $n = 7$ ) regions. (a) Unit cost. (b) Total cost. Mean values are indicated as cross markers. Note: the mean total cost for measures in permafrost regions is skewed by an outlier (i.e. a beach nourishment project that was proposed in Utqiagvik in 2018 and was projected to cost about \$439 M in 2019 US dollars), which is not presented in the chart, so that the boxplots can be better illustrated.

Although breakwater, which is mostly constructed in non-permafrost regions, has a higher median cost, the cost (both unit and total costs) of erosion control measures in permafrost regions is higher (in figures 9(a) and (b)). This is likely because a revetment costs more if constructed in a permafrost region, driving up the cost of overall measures. In addition, it is noted in figure 9 that the difference in medians between permafrost and non-permafrost is higher for the unit cost but not as much for the total cost. This is because the length of coastline protected by the measures in non-permafrost regions is generally longer.
