## The effect of earthquake on architecture geometry with non-parallel system irregularity configuration

To cite this article: Livian Teddy *et al* 2017 *IOP Conf. Ser.: Earth Environ. Sci.* **99** 012004

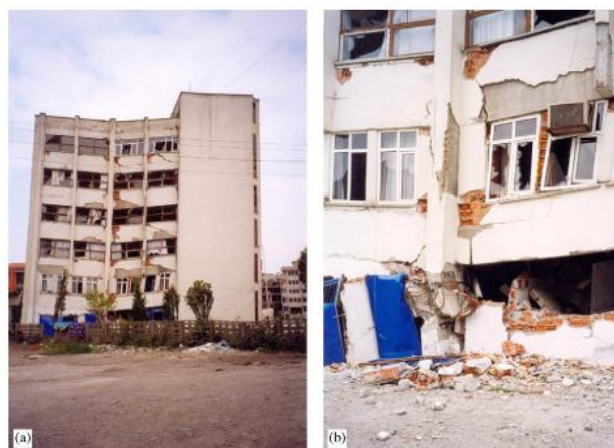
**Figure 9.** Building damage from torque eccentricity (source : [2]).

According to table 5, the models a-e does not form eccentricity or in other words, the center of mass and the center of rigidity are overlapped, making its eccentricity= 0. It also negates the potential for torsion in the building model. Therefore, the main eccentricity occurs by building mass geometry form, and the irregularity effect of the beam/column arrangement is relatively minimal but it can cause another irregularity, i.e. non-parallel irregular configuration. Eccentricity can cause torsion in the building, the causes include uneven loading, rigidity and strength, and others <sup>[7]</sup> (see figure 9).
